# **Cornerstone Inspection**

## **Property Inspection Report**

**645 Moss Ave, Paso Robles, CA 93446**

**Date of Inspection: 8/19/2026 Time: 9:00 AM**

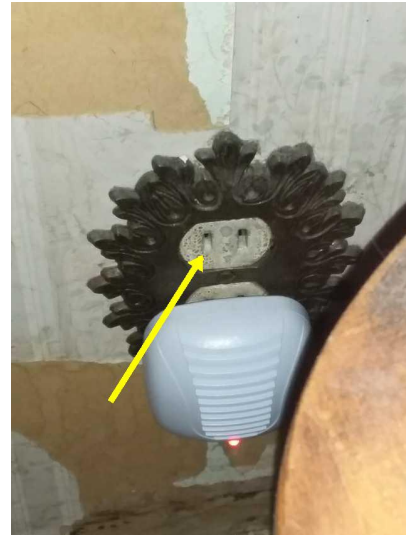
The ungrounded and obsolete outlets in the living room should be upgraded to include more modern and safer ones, which provide a pathway for the current to travel harmlessly to ground.

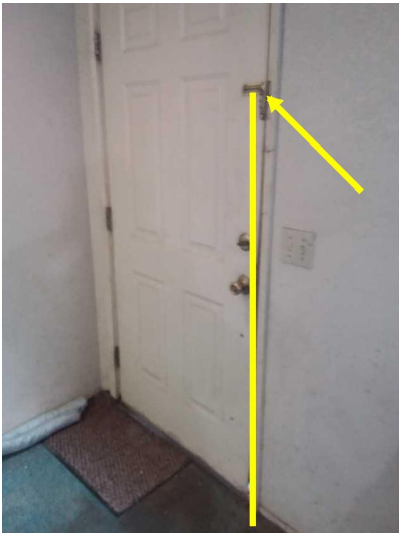
A secondary lock has been installed higher than 48 inches which could impede the exit of a child or short person.

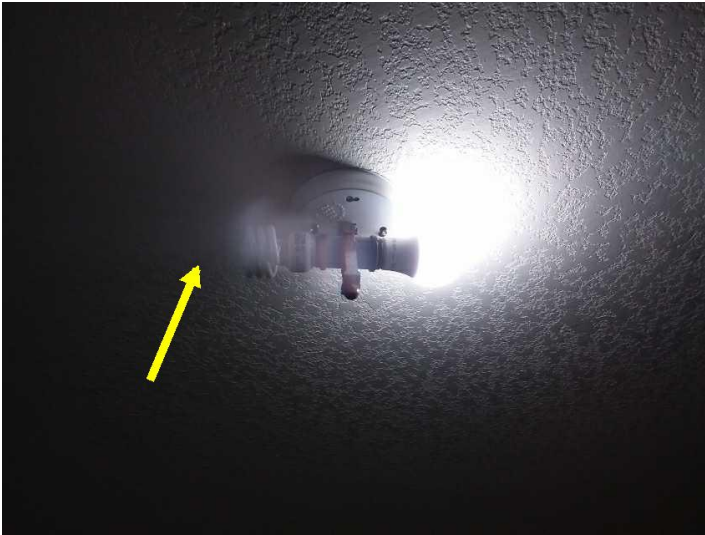
A ceiling light in the bedroom does not respond, and should be serviced.

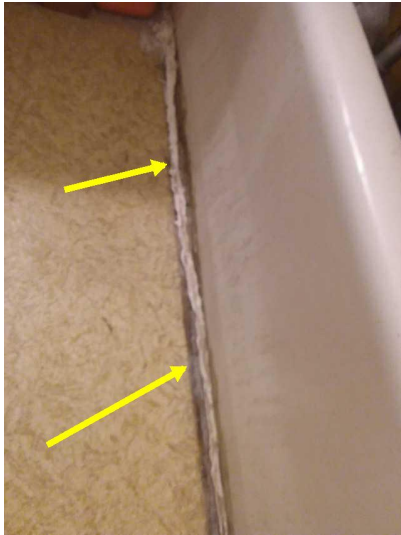
The vinyl floor is lifting where it meets the shower or tub and should be sealed.

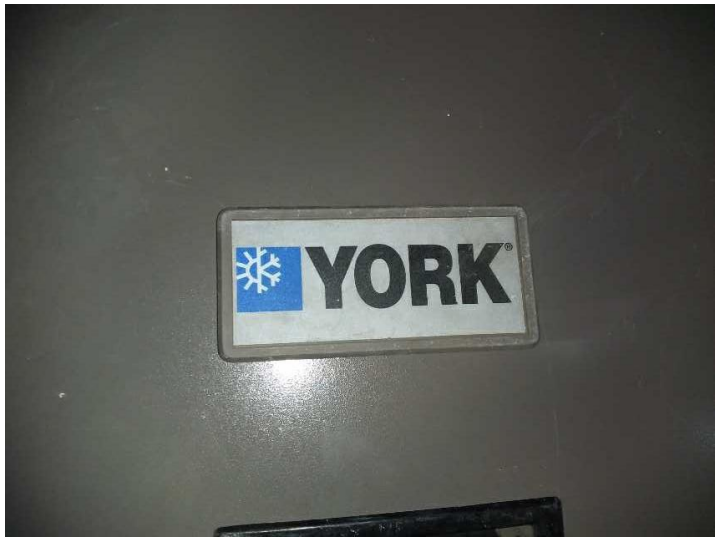
| Page 59 Item: 1 | Forced Air Furnace | <p>1.16. The furnaces are functional. However, they are beyond the commonly accepted design life of twenty years, and will need to be monitored more closely for evidence of metal fatigue. We recommend that you have it serviced and evaluated by an HVAC contractor prior to the close of the inspection period.</p> |

Central heat is provided by 2 forced-air furnaces that  
are located in crawlspace and stair closet.
