1628 Freeman Dr, Pine Mountain  
Club,, CA 93222

Emil Sarkisians  
11/07/2025

James Tomasko  
InterNACHI Certified Professional  
Inspector, CSLB General Contractor  
736872, DRE 1082969

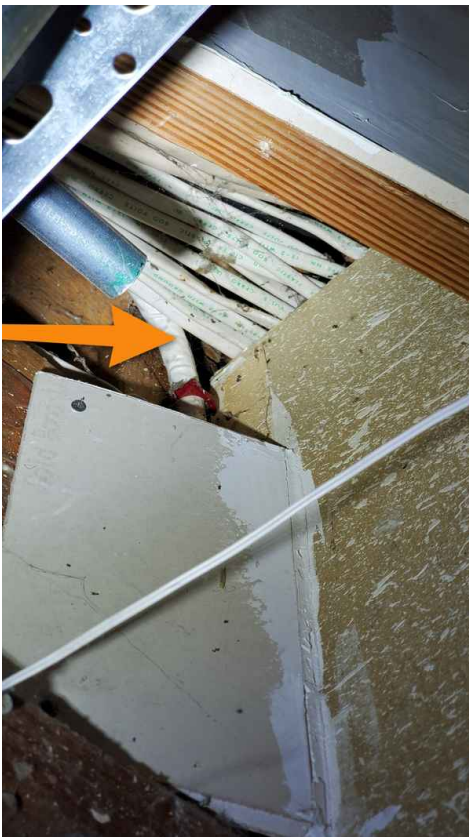
Firewall penetrations

#### **WALLS: DRYWALL DAMAGE, SEVERE**

The garage walls exhibited severe drywall damage. The Inspector recommends that before the expiration of your Inspection Objection Deadline you consult with a qualified contractor to discuss options and costs for repair.
