# JOHN ROBINSON'S INSPECTION GROUP

## RESIDENTIAL INSPECTION

2602 Upas St  
San Diego, CA 92104

08/18/2026

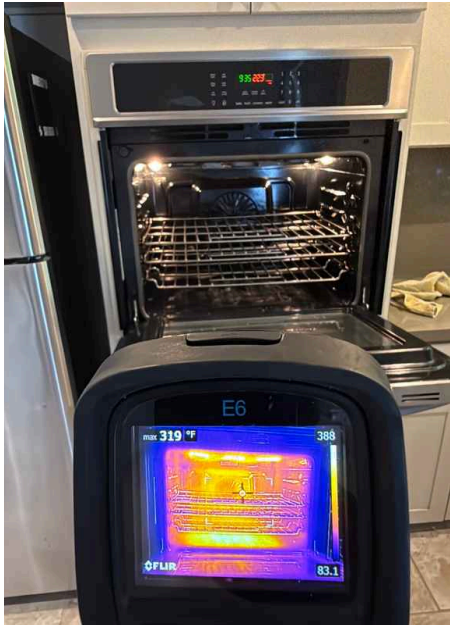
**OVEN: Thermal Image Showing Oven Working**

Infrared picture of the oven(s) in operation. The unit(s) appeared to be functional at the time of the inspection.

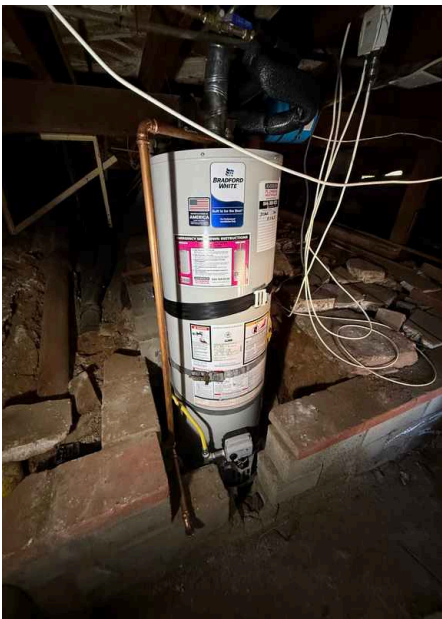
**WATER HEATERS, CONTROLS, FLUES AND VENTS: Picture of Water Heater(s)**

Picture of water heater(s).

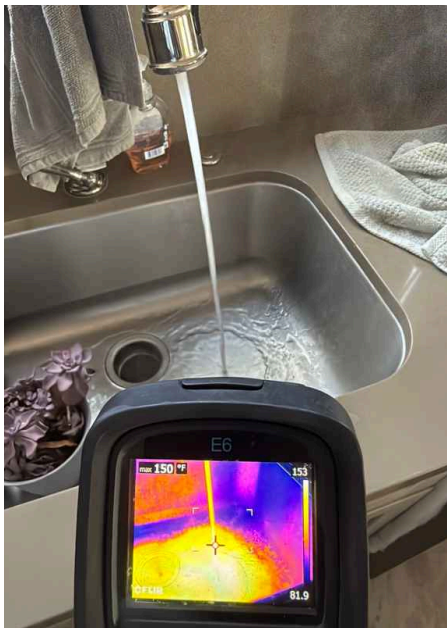
## WATER HEATERS, CONTROLS, FLUES AND VENTS: Thermal Image of Hot Water

Infrared image(s) showing the water heater(s) producing hot water at the time of the inspection.

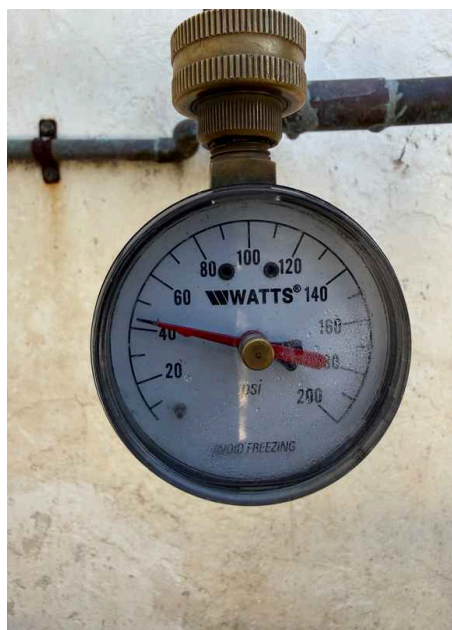
## WATER PRESSURE & REGULATOR: Picture of Water Pressure

Picture of water pressure taken at the time of inspection. Recommend water pressure for residential properties is 40-80 PSI. Water pressure is tested at an exterior hose bib and may not always be reflective of the internal water pressure due to the placement of the water pressure regulator, especially if the home is on a well.

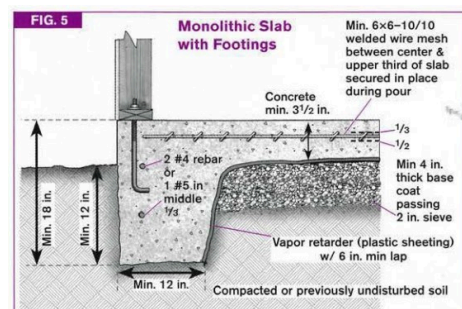
Due to floor coverings, vegetation, siding, or other obstructions, not all areas of the foundation were visible. Our review of the home's foundation is limited. You may wish to have this further explored by a licensed foundation contractor and/or a licensed structural engineer to determine if any latent defects exist.

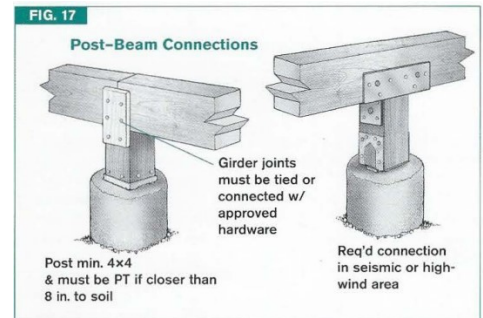
### 10.3.2 POSTS, PIERS AND COLUMNS

#### **PIERS - EXCAVATED SOIL ADJACENT TO PIER**

The soil has been excavated adjacent to, or below, one or more concrete piers. This condition compromises the cone of compression surrounding these piers and can lead to movement in the structure. We recommend further evaluation by a licensed foundation contractor before the removal of contingencies to determine what repairs are needed at this time and to determine if any latent defects exist.

Contact a foundation contractor.

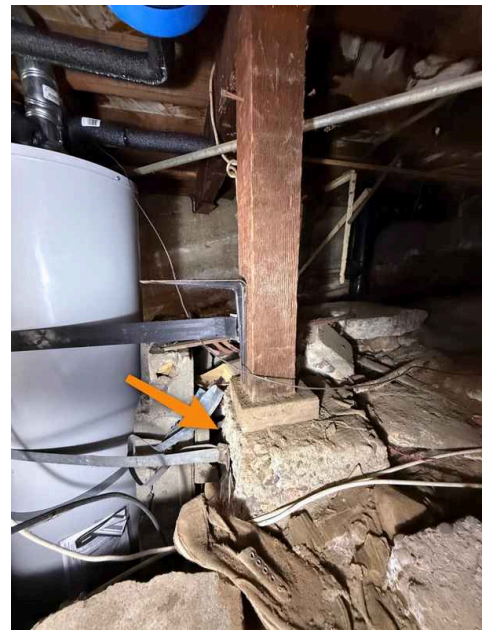
### 10.3.3 POSTS, PIERS AND COLUMNS

#### **PIERS - SPALLING/DETERIORATION**

Spalling and/or deterioration noted at one or more concrete piers in the crawl space. Unable to determine the exact cause or extent of the issue. However, this condition is indicative of moisture intrusion into the crawl space. Moisture intrusion can cause damage to the structure and is conducive to the attraction of wood-destroying organisms and organic growths. We recommend further evaluation by a licensed foundation contractor before the removal of contingencies to determine what repairs are needed at this time and to determine if any latent defects exist.

Contact a foundation contractor.

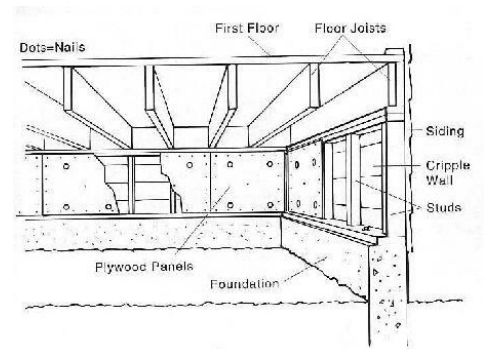
### 10.5.1 WALLS (Structural)

#### **CRIPPLE WALL - NOT BRACED**
