# Premier Home Inspection, Inc.

**Diane Harwell  
155 S. Beth Circle, Anaheim CA**

**Date: 09/10/2026**

**Report # 2260443**

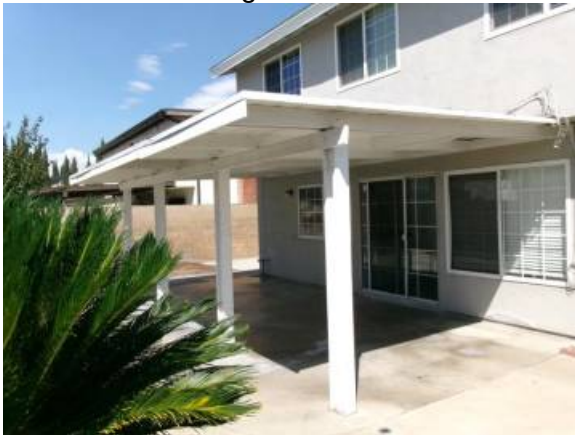
- \* The posts are not properly secured and supported to carry the load of this structure. The posts do not extend down to footings and up to the joists to be properly installed and supported in these areas. Repair and support properly as needed.
- \* Deterioration noted at base of posts. Repair or replace the damaged wood as needed.
- \* There is damaged wood to the beams and posts in several areas. Repair the damaged wood as needed.
- \* Check the termite report for all damaged wood to this structure and repair or replace the damaged wood in these areas as needed.
- \* Patio cover is not stable as it is currently installed. Additional support and repairs needed to the patio cover structure for proper support of structure.
- \* This structure appears to have been an addition done to the property. Check for signed off permits on this addition.

Improper support on posts.

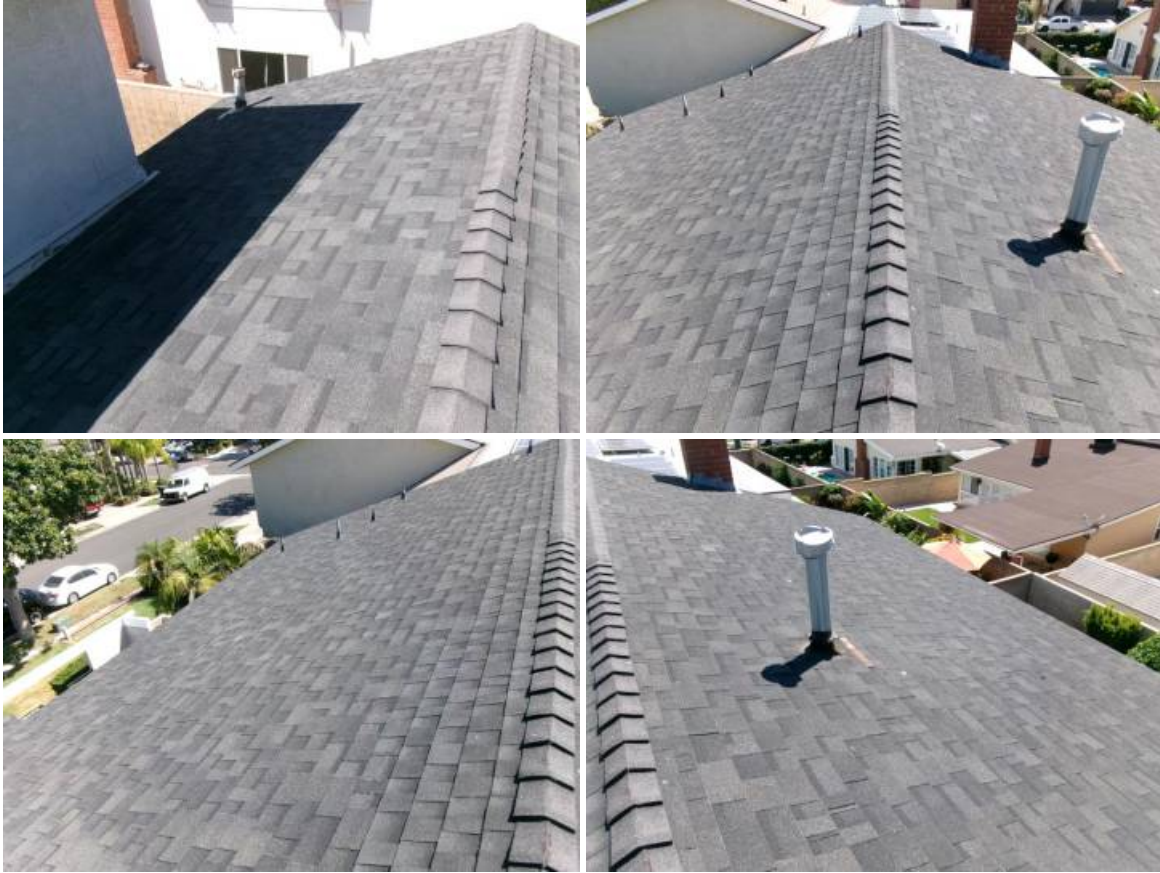
- \* The visible portions of the roof surface are in an acceptable condition for its age, periodic inspection and maintenance is recommended.
- \* The shingles are starting to deteriorate and weather in areas of the roof. There are loose granular material in some areas and some missing shingles in some areas of the roofs surface. There are exposed nails and nail heads on the roof in some areas. There should not be an exposed nails or staples on the roof shingles to be properly installed. The nails can lift or become damaged and leave holes in the roof in these areas. Properly repair and cover the nails or staples in all areas as needed. Repair the damaged areas to add life to the roof.

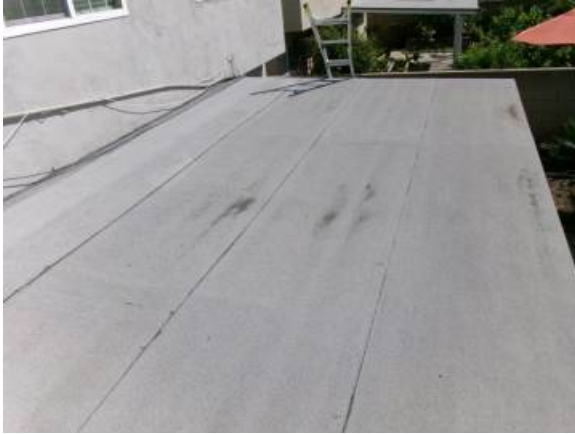
The visible portions of the roof surface are in an acceptable condition for its age, periodic inspection and maintenance is recommended. Evidence of ponding was observed. The presence of shallow ponds of water is not unusual, but regular maintenance of the areas is vital to prevent the build up of rotting vegetation and possible damage to the roof.

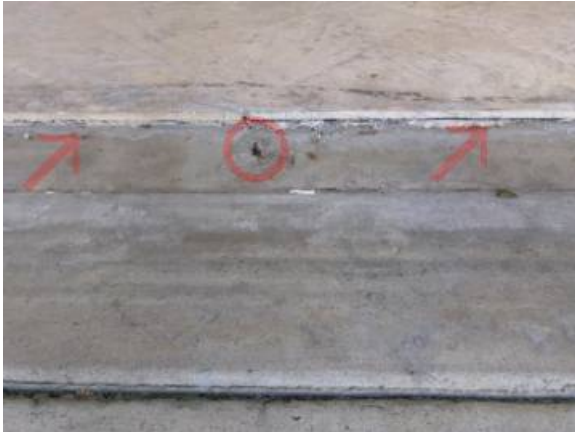
- \* Typical concrete cracks noted.
- \* There are tiles on the floor of the garage in some areas. This is uneven and a trip hazard in these areas.
- \* There is a bolt sticking out of the ground in this area as well. Remove for safety as needed.

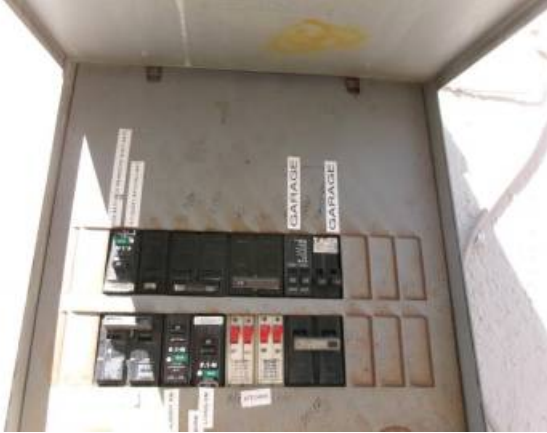
The electrical circuit breakers and wire sizing is correct and properly installed where visible within the panel. The breakers are not all labeled in electrical panel, or the existing labels are no longer legible. They should all be properly labeled for safety.

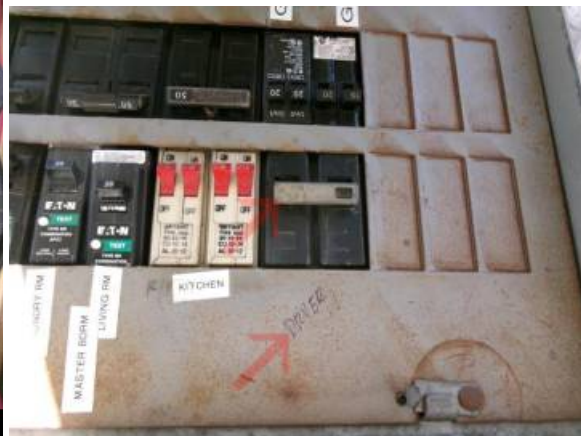
- \* The bottom 30 amp breaker that is labeled dryer is wired up and turned off inside of the panel. Check for its use and function and repair as needed.
- \* The bottom right side middle AFCI breaker does not properly fit in the panel. Some of the breakers are the wrong brand for this circuit breaker panel. This technically voids any warranty and possible replacement should be considered.

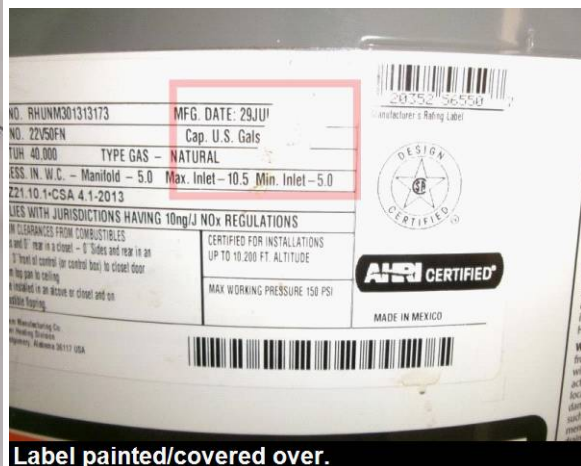
Label painted/covered over.

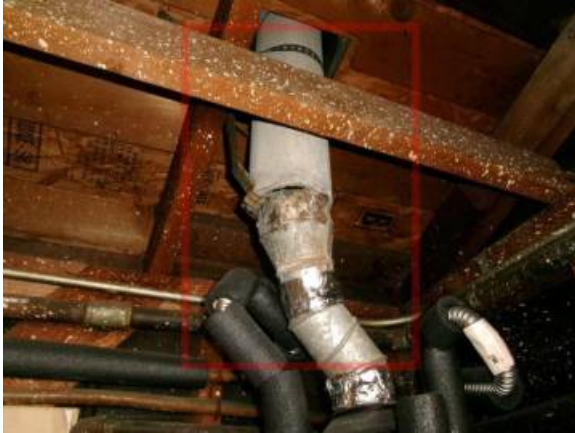
- \* The vent pipe is installed in a substandard manner. The piping is not properly connected and is allowing the products of combustion to spill out. We recommend new piping be installed if necessary and joints be secured with screws as required.
- \* There is Transite vent piping installed above the water heater in some areas. This type of vent piping has materials likely to contain asbestos related materials. Caution is needed when handling this type of vent piping. This section of vent piping should not be cut, damaged, modified or removed without proper care and caution.

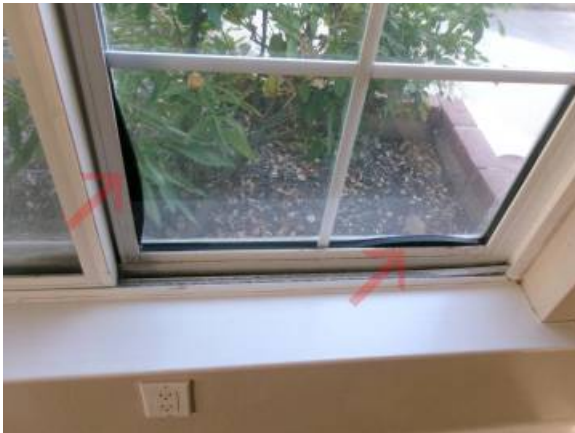
The windows all operated properly when tested. There are damaged seals between the panes of glass on insulated double pane window(s). There is no simple fix for this condition. We recommend all failed insulated glass units be removed and replaced. The seals can not always be properly viewed to determine if the seals are bad. This depends on the time of day and the current weather conditions at time of the inspection.

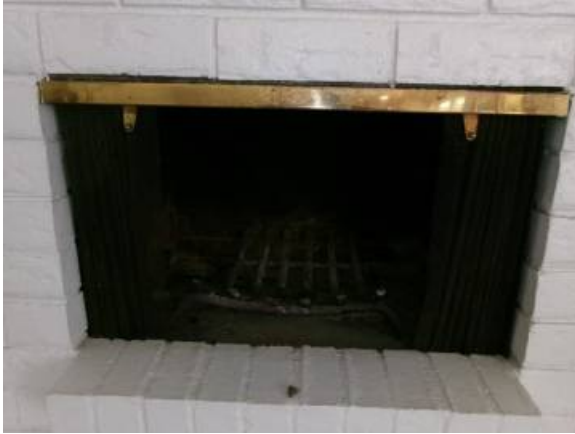
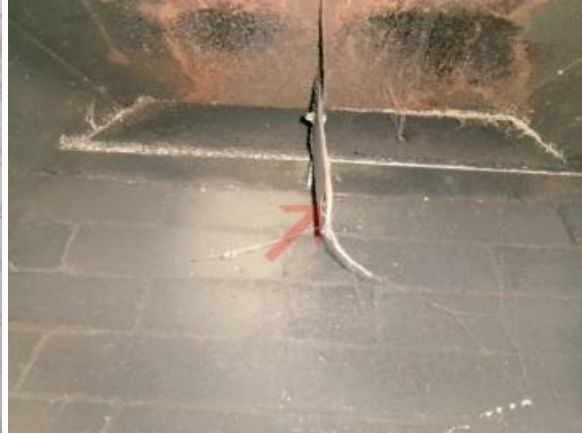
## 938 FIREPLACE - FIREBOX:

Mortar joints are intact. Damper is operational.

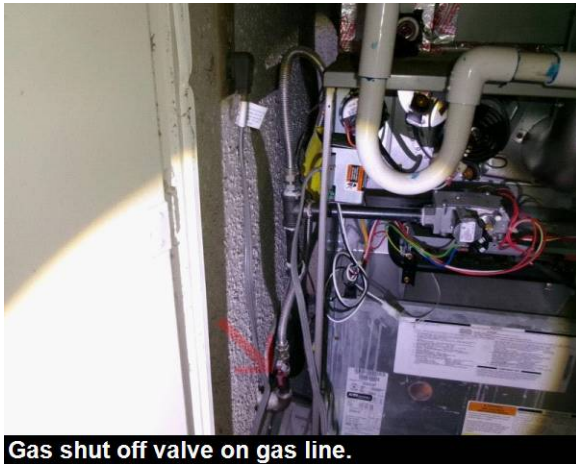
Natural Gas. The gas valve is installed but not tested. An approved flexible gas connected is installed.

Gas shut off valve on gas line.

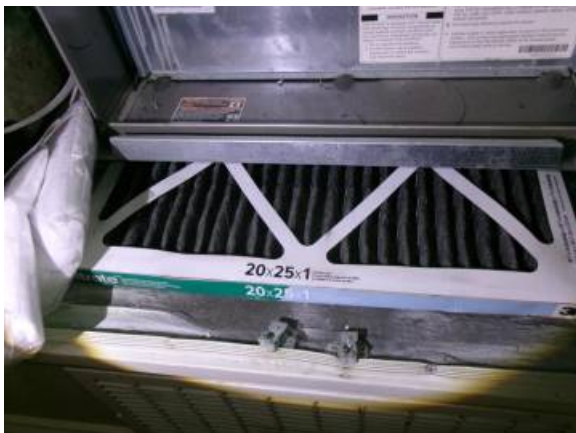
## 1109 BLOWER AND FILTER:

The filter installed is clean at this time. All filters need regular service or replacement at regular intervals.

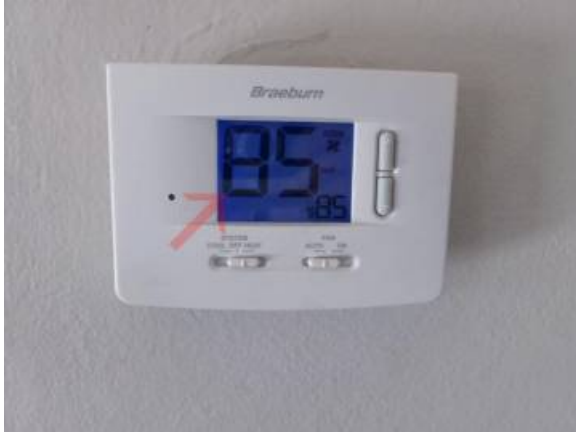
## 1111 THERMOSTAT CONTROLS:

The heater did not turn on as the inside air temperature was 85 degrees at the inspection.

The heating system failed to respond to normal operating controls. We recommend a qualified contractor evaluate and make necessary repairs or recommendations.

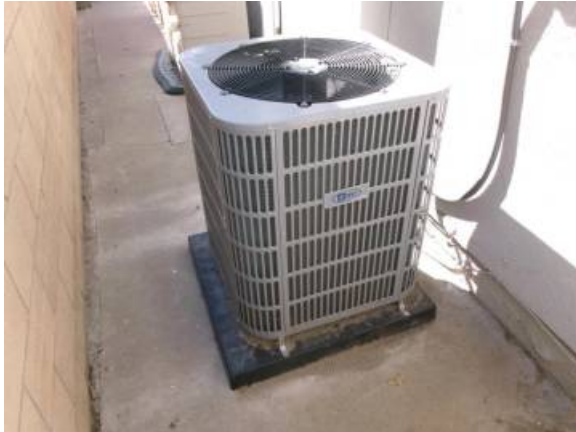
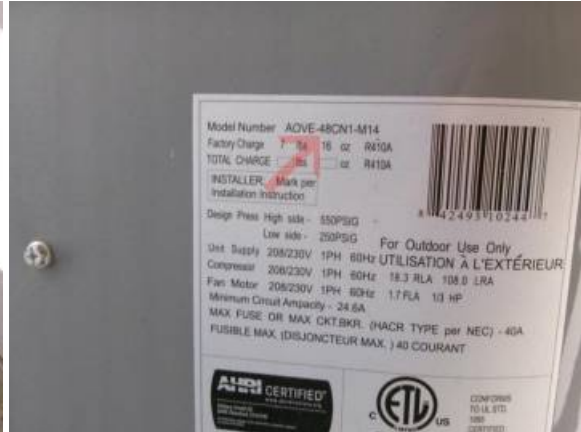
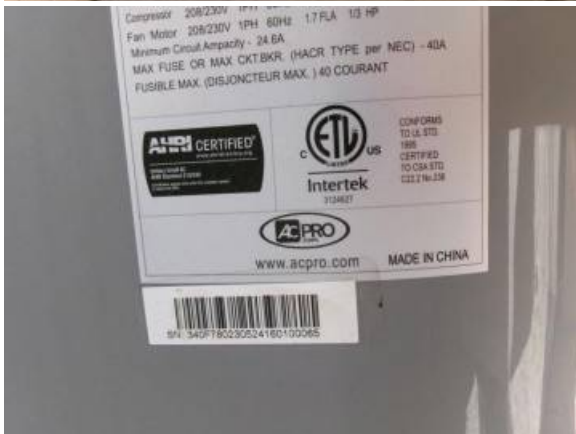
#### 1301 TYPE:

Gas heat with air conditioning combined. This is a 4 ton unit. Could not determine the age of this unit.

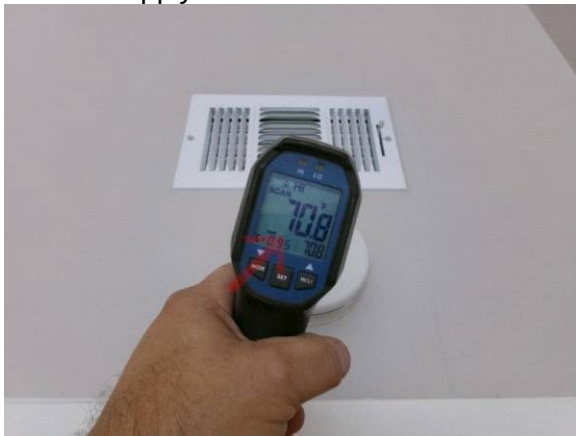
A/C cooling properly.

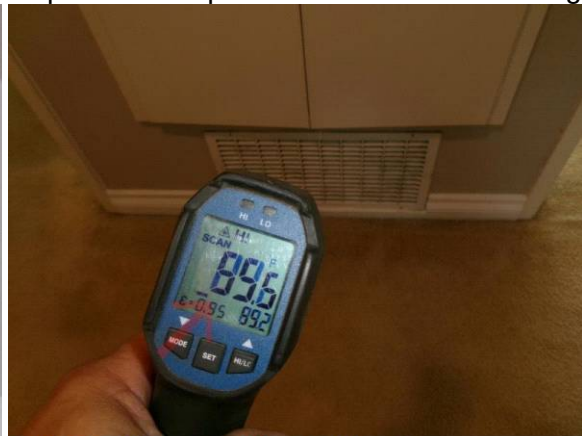
Upstairs air temperature, return air.

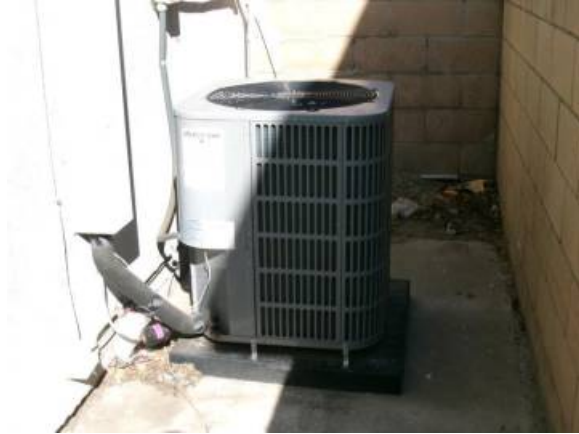
## **1306 CONDENSATE LINE:**

Condensate line installed but is not fully visible.

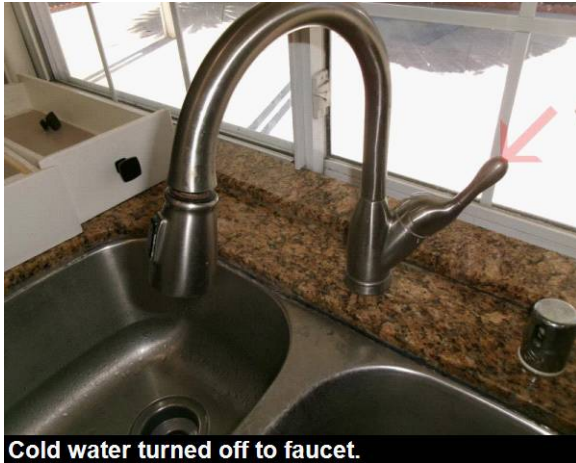
The cold water is turned off to this faucet and it is not in use. Check the water supply and faucet for leaks and proper function and repair as needed.

Cold water turned off to faucet.

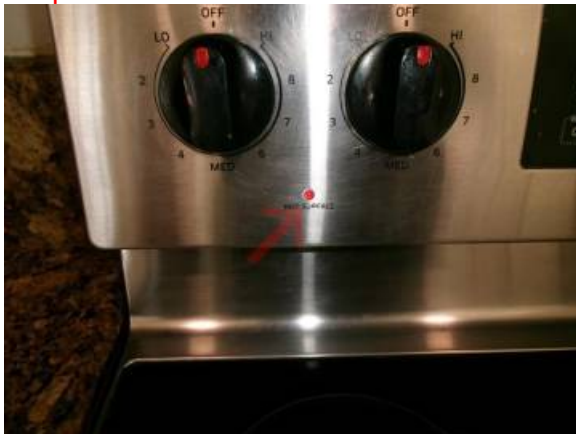
### 1406 TYPE/CONDITION:

- \* Electric. Free-standing unit. The cook top and oven responded to normal operating controls at the time of the inspection and appear serviceable.
- \* The hot surface indicator light was on when the range was off and not hot. Repair as needed.
- \* The unit is not level. Check the legs and adjust as needed.
- \* The range/oven lacks an anti tip device at the rear as required. We recommend it be installed per the manufactures instruction for safety.

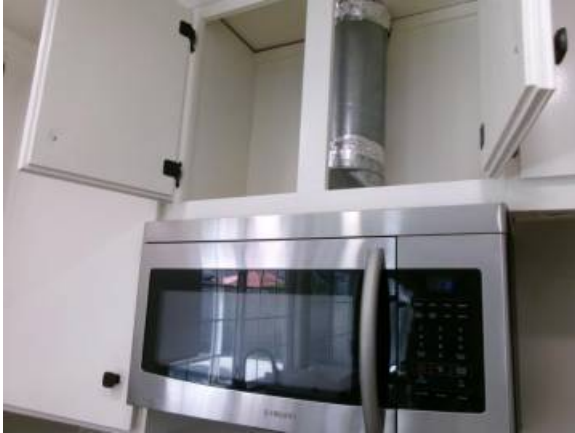
### 1411 TYPE AND CONDITION:

Fan/Hood operational. Could not determine if this vents to the outside of the property and if the venting in the walls is properly installed or not. These areas are not visible to inspector.

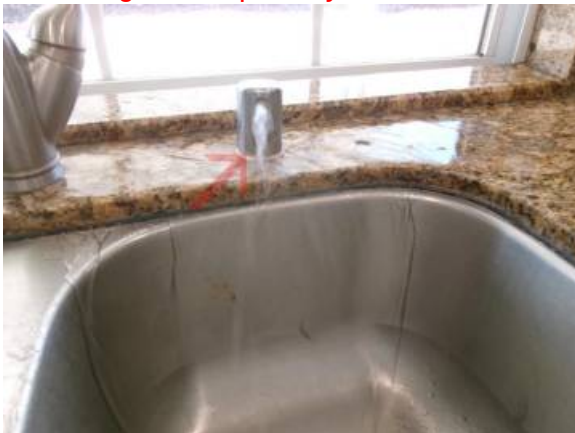
### 1416 CONDITION:

The air gap installed in the dishwasher drain line that is defective or is restricted causing leakage at the sink. Due to the amount of water draining in this area the unit was not run through a complete cycle. We recommend it be cleared or replaced as needed.

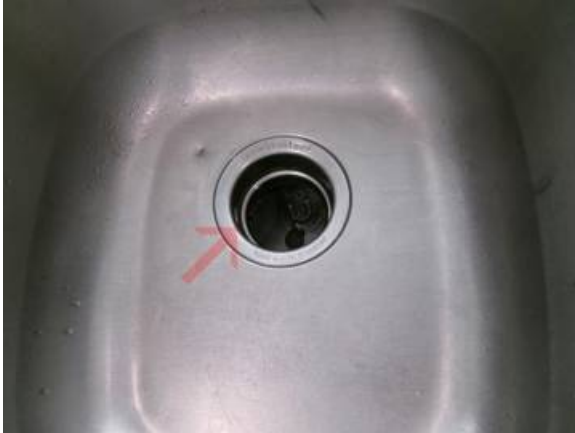
### 1421 CONDITION:

The disposal was turned on and was operating. The inside splash guard cover is missing or damaged on this unit. Repair and add to close off this area properly as needed.

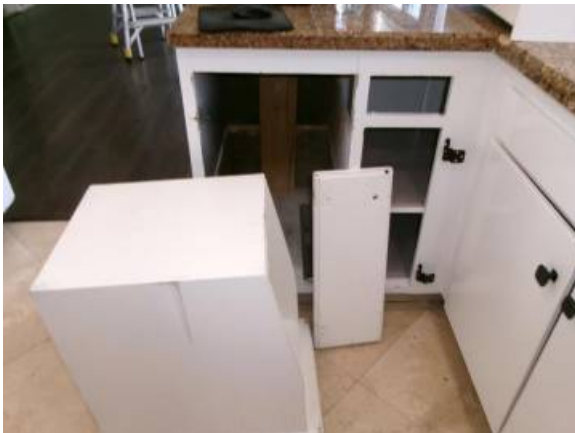
- \* The counter tops are in serviceable condition.
- \* There is some damage to the cabinet doors and drawers in these areas. Repair or replace the damaged areas as needed.
- \* There are water stains and damage to the base cabinet areas under the kitchen sink. Check for the source of these stains and damaged areas and repair as needed. Check for any mold or toxic mold to these areas and remove properly as needed.

Water damage under the sink.

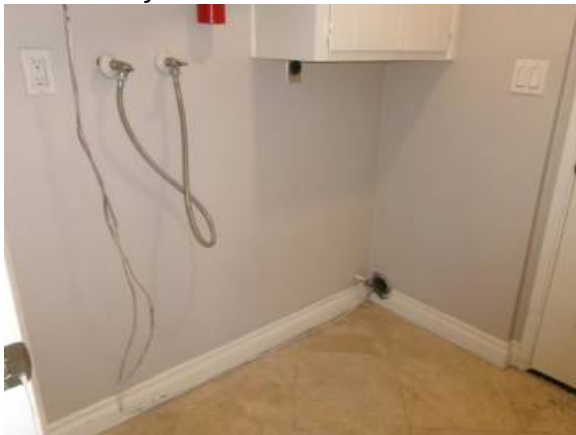
### 1451 LOCATION:

Laundry room.

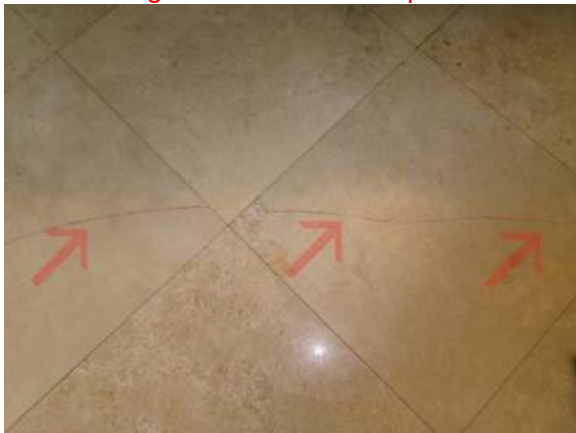
### 1507 BATHROOM WALLS/FLOORS:

There are some cracked floor tiles in this area. Check for a proper installation of the tiled floor covering in this area and repair as needed.
