### *Inspection Report*

Address: 604 Country Club Dr San Luis Obispo, CA 93401

10/07/2026

Inspector: Taylor Vreeken, CCI

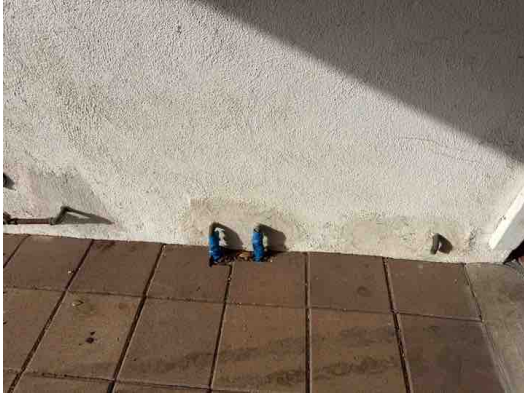
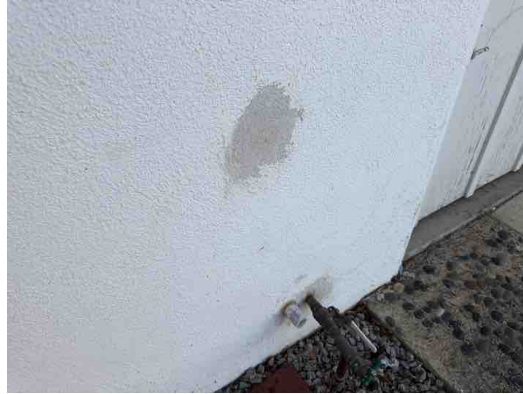
**FI DS 36:** Multiple past stucco repairs noted throughout. Ask seller for details.

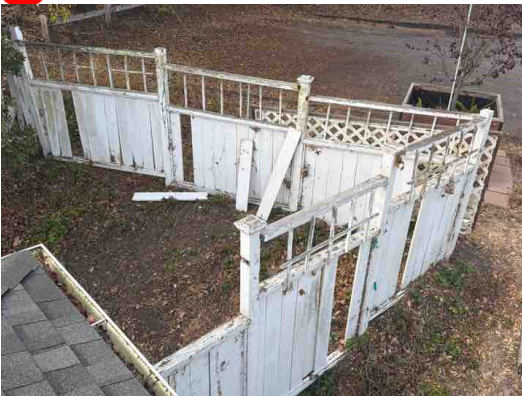
**E&C 42:** Areas of the fencing and gates are in a generally poor condition. Recommend servicing and/or repair.

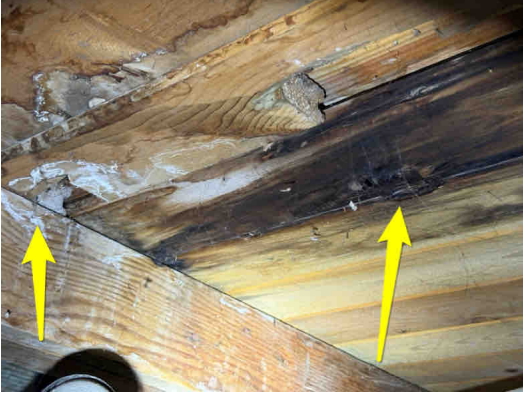
**FI 58:** Moisture and/or bug type deterioration and/or damage found in areas of the crawlspace at wood framing and/or sub-floor. Refer to the current Termite / pest inspection report for additional comments.

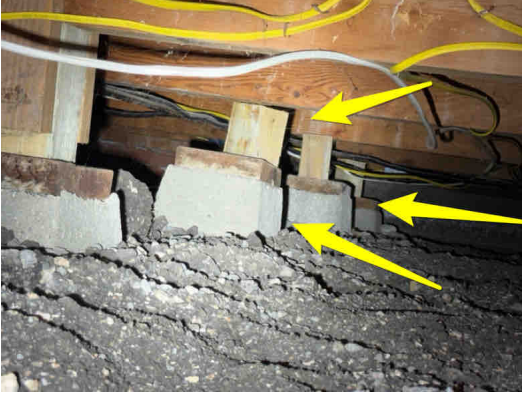
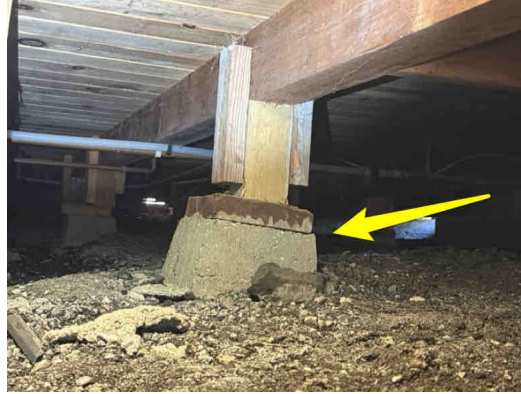
**E&C 61:** Multiple structural support posts in the crawlspace show signs of moderate shifting and settlement with uneven framing and interior floors. Recommend further review and repairs by qualified foundation professional.

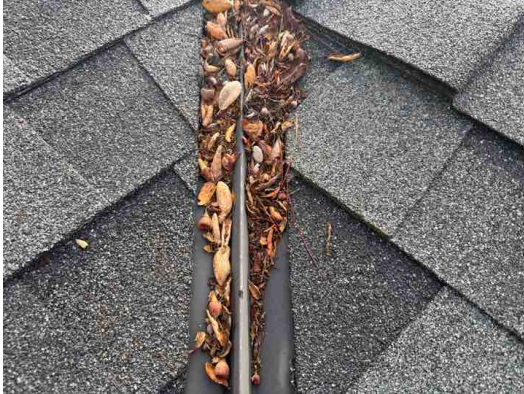
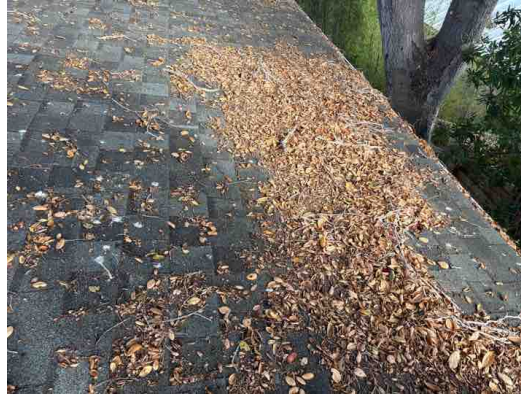
**MR 69:** Debris covers portions of the roof and/or roof flashings. This may cause deterioration and/or a roof leak. Areas of the roof are not fully visible. Clean and inspect regularly.

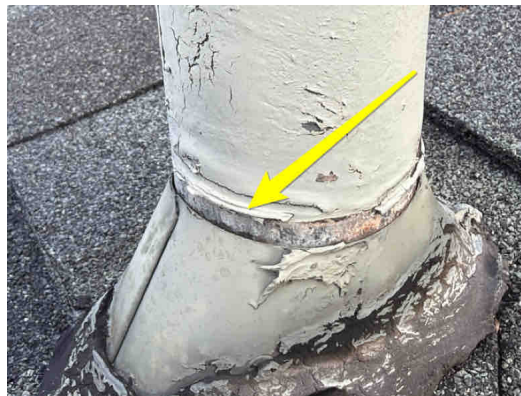
**MR 70:** Missing and/or deteriorated sealant at roof jack flashings.

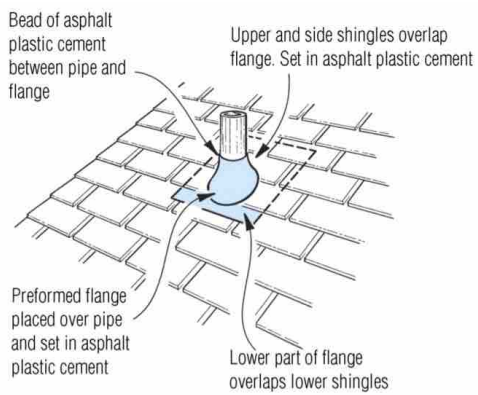
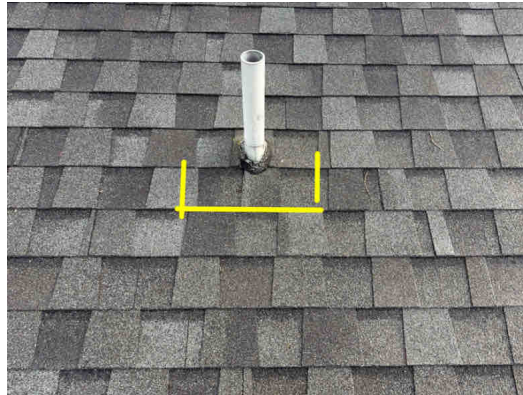
**MR DS 71:** Disclosure: Improper installation of the roof jack flashings where the apron terminates below the roof shingles. This is considered a sub-standard installation for a single layer of roofing and will require continuous maintenance or repairs. Upgrades recommended.

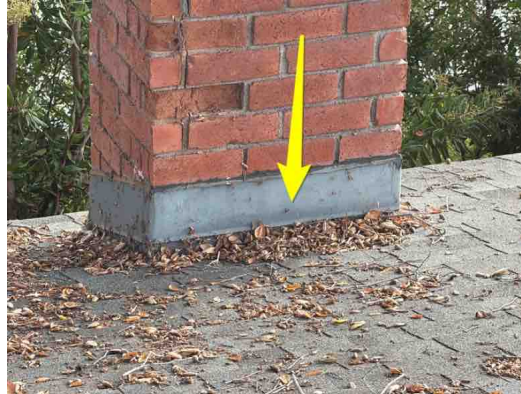
**E&C 72:** Missing / recommend a proper chimney cricket per standards at the LIVING ROOM fireplace chimney chase, to help prevent a buildup of debris and water behind the chimney.

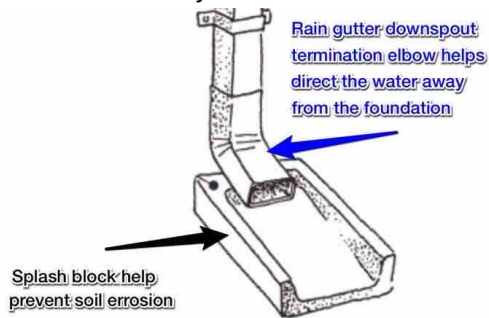
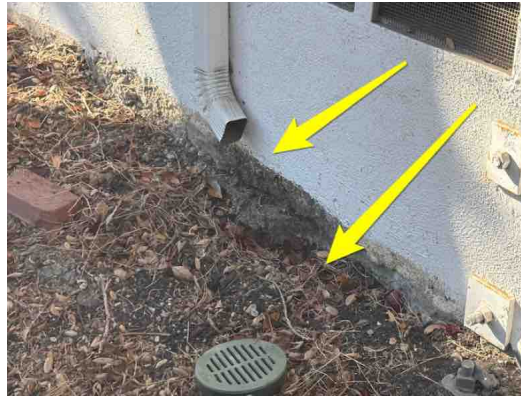
**MR 76:** Recommend splash blocks and diverting the rain gutter downspouts at the bottom to assist in proper flow of roof water away from the house and to help prevent soil erosion where not installed.

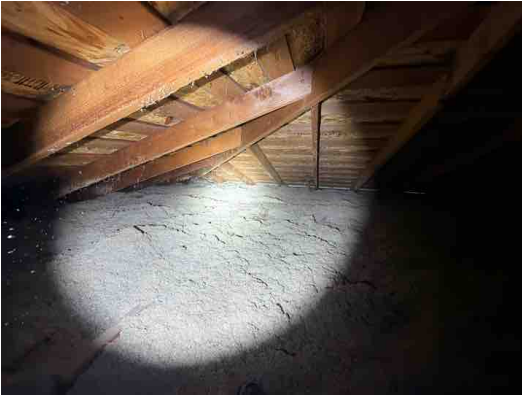
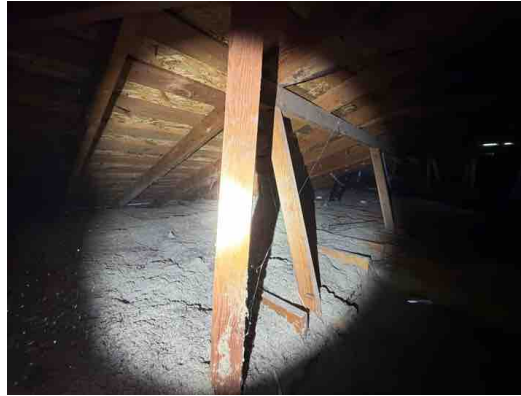
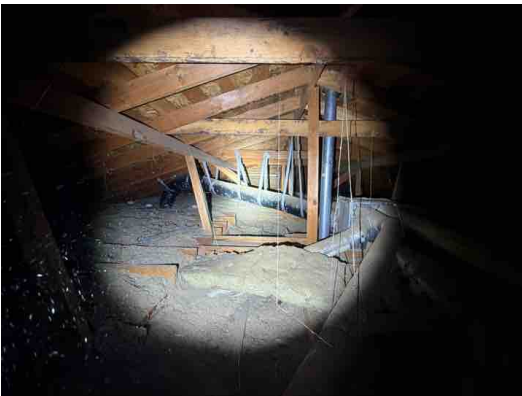
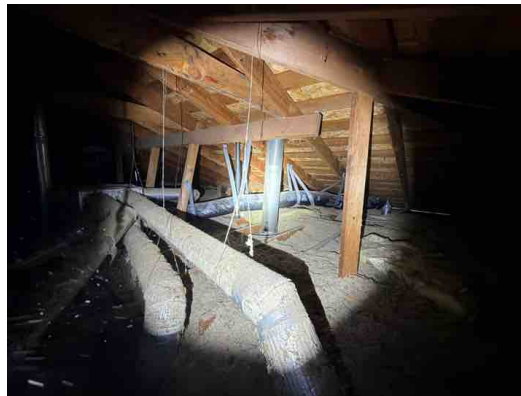
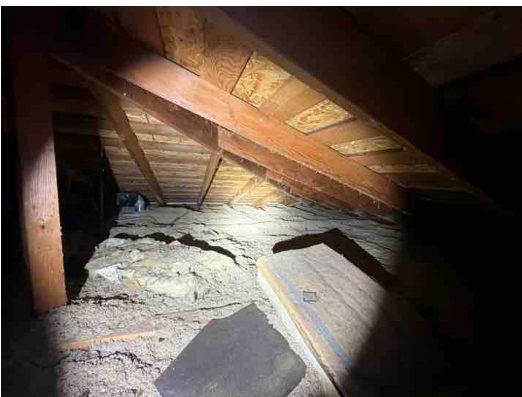
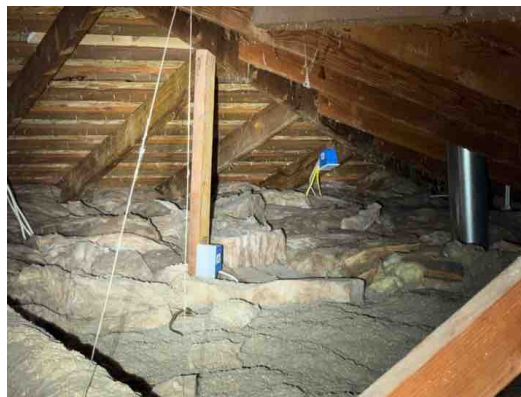
### 83: Attic Photographs

**SU DS 82:** The current attic framing is older and does not meet current structural or seismic standards; however, it appears to be in generally serviceable condition at the time of inspection for its age.

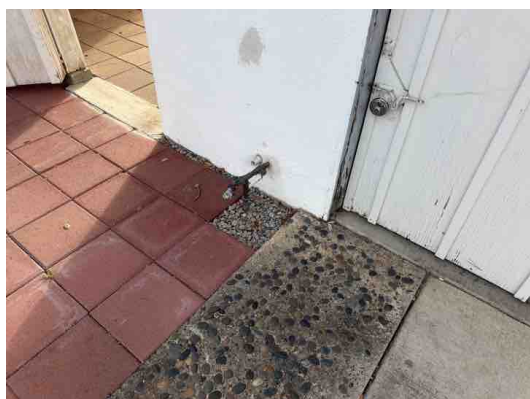
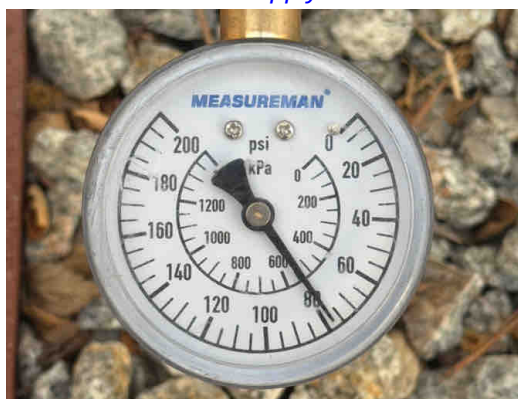
**Water Pressure** - Is At Approx. **77 +/- PSI**. Optimal water pressure is between 40 and 80 PSI.

1. **Pressure Regulator Installed:** NO
2. **An Automatic Leak Detection Device installed on the main water supply:** NO.

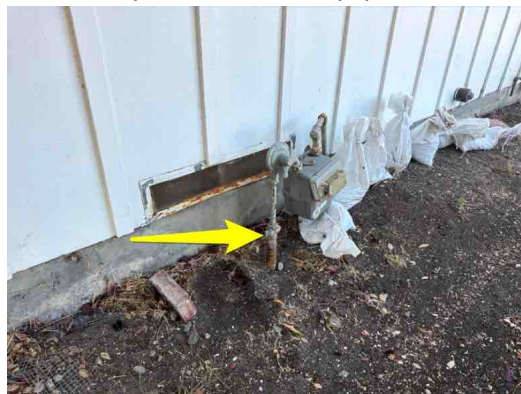
**100: Gas shut-off appears serviceable.**

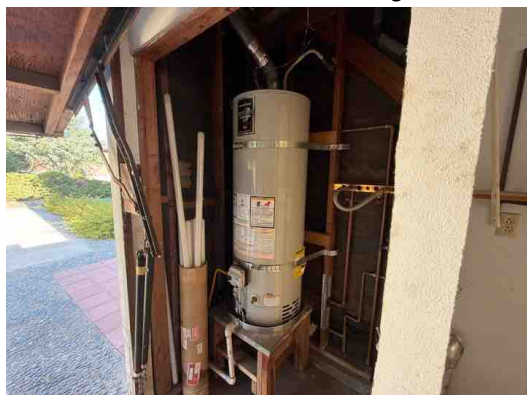
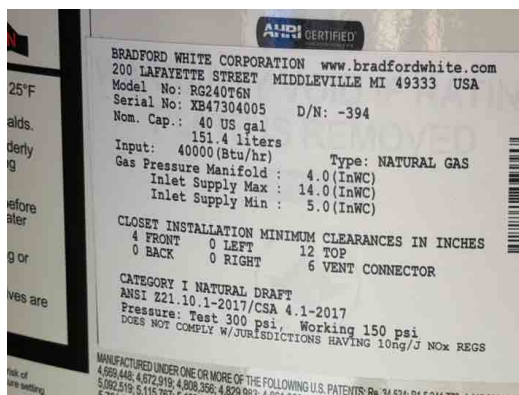
**Date: 2021:** The average lifespan of this type of water heater is approximately 10 years. This water heater is approximately 5 years old. Water heaters can fail without warning and should be monitored and inspected regularly for leaks, corrosion, and other signs of deterioration.

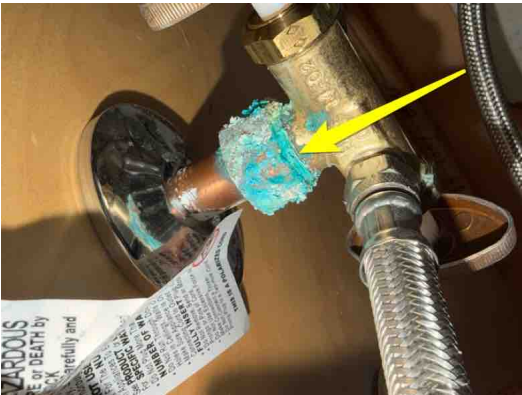
**FI 119:** Some corrosion found at the water supply shutoff valves under the Kitchen sink / evidence of past leaking. Client should investigate further until satisfied as to the cause, condition and potential future issues. Correction Recommended.

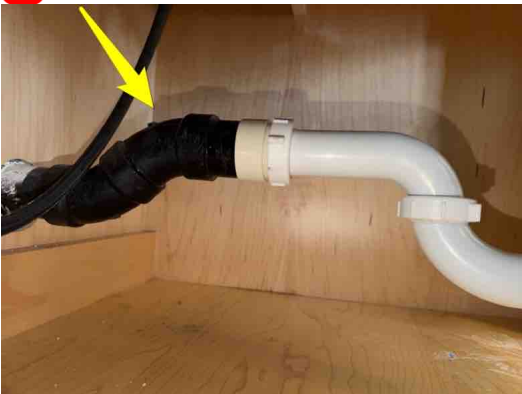
**E&C 120:** Improper waste piping found under Kitchen sink.

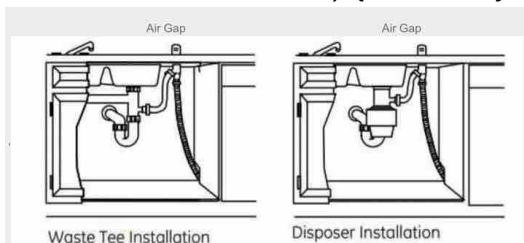
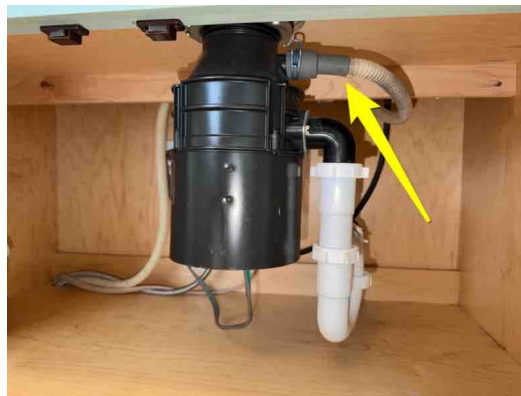
**SU 125:** Improper installation of the dishwasher drain hose directly into the garbage disposal. Missing the Air Gap Device at the dishwasher drain per minimum codes and standards (California does not allow for high-loop methods or direct waste connections). {CPC 801.2}

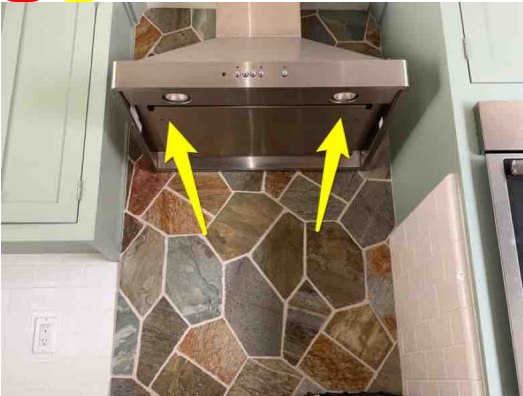
**E&C** **MR** 129: Kitchen cook top exhaust hood light non-operational.

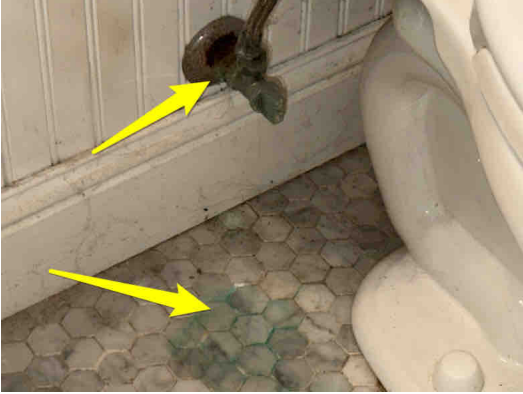
**E&C 142:** Corrosion on the cold supply line at the toilet water supply / evidence of past leakage: HALLWAY BATHROOM

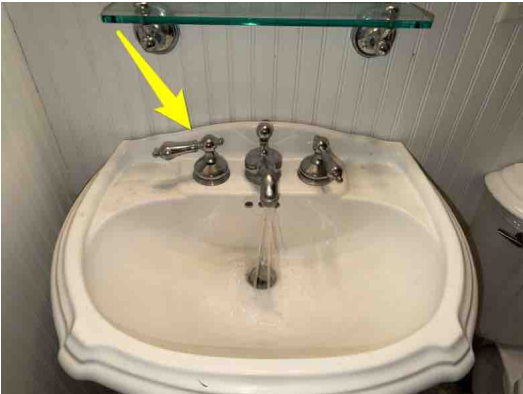
**146:** Hot water supply valve found non-operational at the: HALLWAY BATHROOM

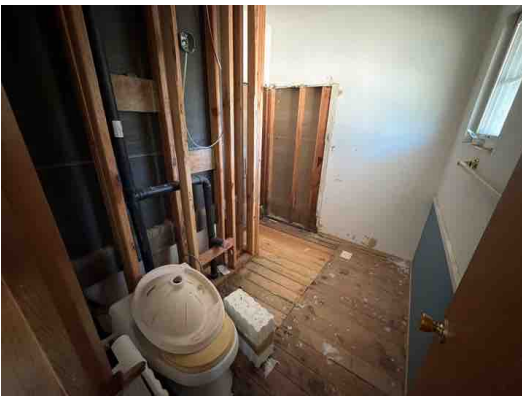
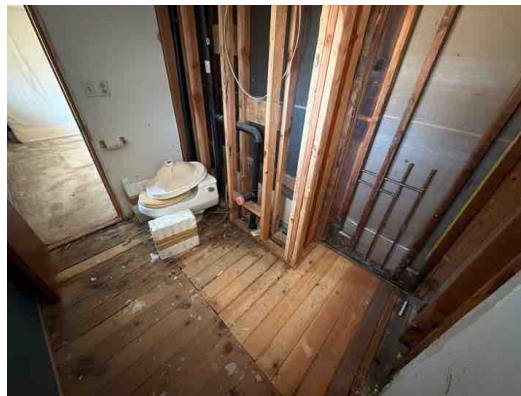
**E&C 152:** The PRIMARY BEDROOM BATHROOM has been deconstructed and not rebuilt. This bathroom is incomplete and not inspected. Recommend completion by licensed contractor.

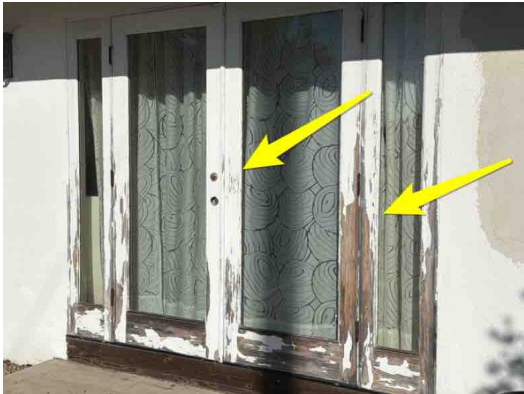
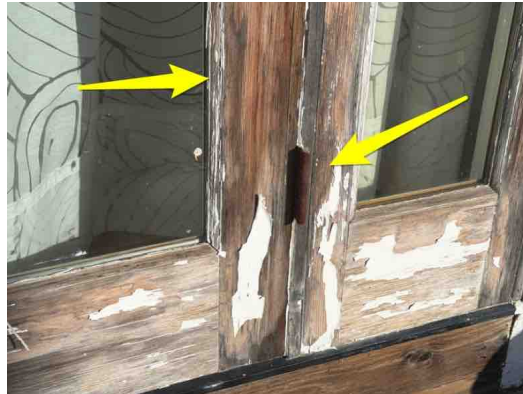
**E&C 155:** Multiple exterior doors were observed with significant deterioration and/or deferred maintenance. Conditions noted include deteriorated or damaged door materials and finishes, damaged or missing weatherstripping, missing or damaged hardware/door knobs, and other installation or maintenance-related defects. Due to the number of doors and conditions present, individual defects are not separately listed. Recommend evaluation of all exterior doors and repair or replacement as needed by a qualified contractor to provide proper operation, weather resistance, security, and protection from further deterioration.

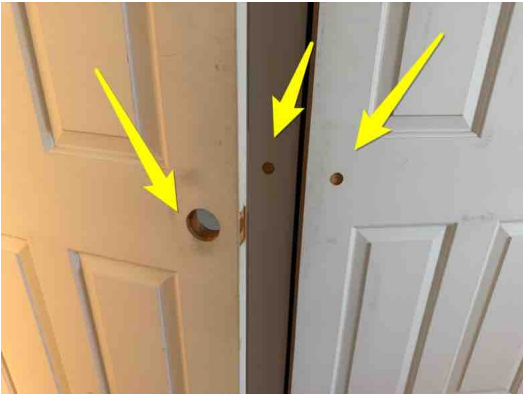
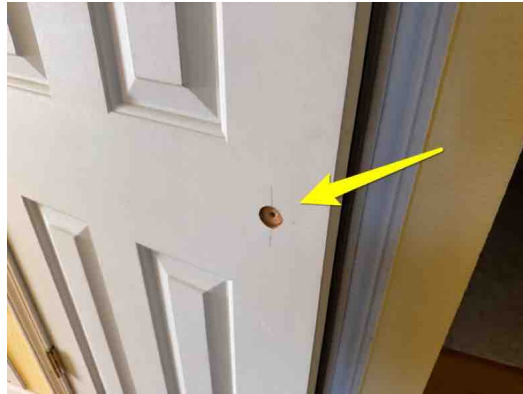
**156:** Multiple interior doors throughout the home were observed to be unfinished and/or incomplete, with various defects including missing door hardware, missing or incomplete strike plates, doors rubbing or binding at the flooring or frames, unfinished surfaces, and other installation deficiencies. Due to the number and variety of conditions present, individual defects and locations are not specifically listed. Recommend evaluation of all interior doors and completion, adjustment, and repair as needed by a qualified contractor.

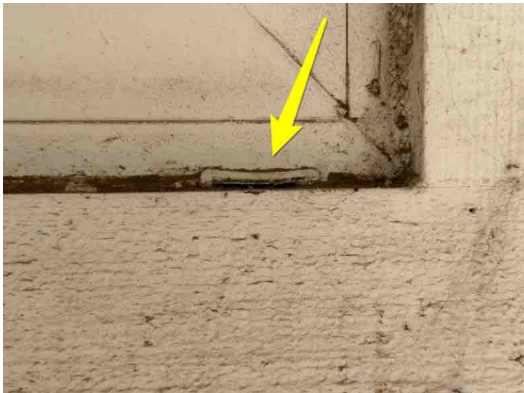
**E&C 161:** The window weep holes are covered or blocked and in need of maintenance or repair at multiple locations. These weep openings on the exterior of the window allow the water to drain from the window tracks helping the window stay watertight. The lack of properly functioning Window weep holes can allow water to accumulate and leak inside the envelope of the building.

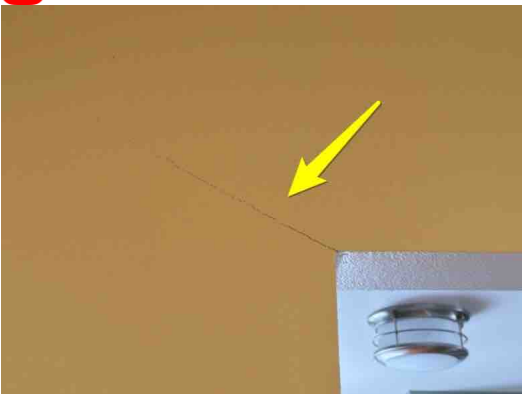
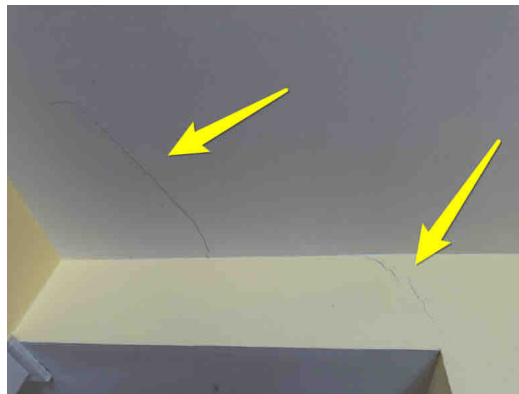
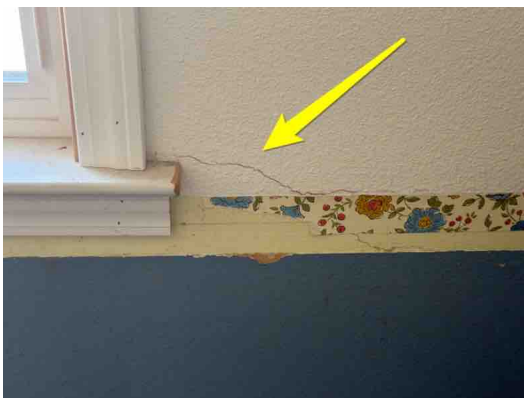
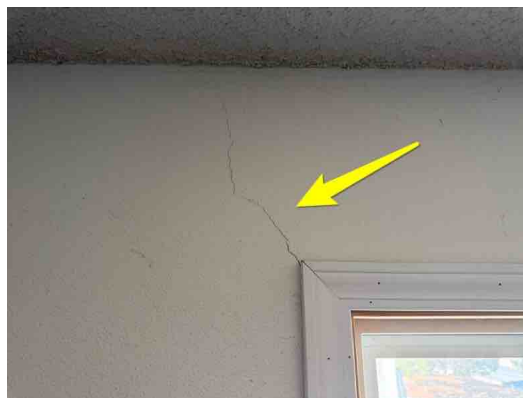
**E&C 178:** Several cracks noted throughout interior drywall indicative of moderate and minor structural movement.

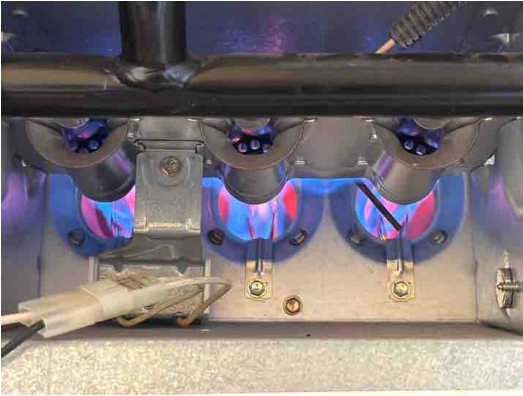
**182: HEATING SYSTEM CONDITION:** The heating system operated when tested.

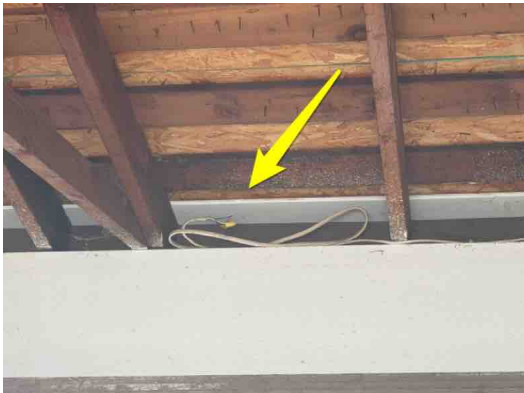
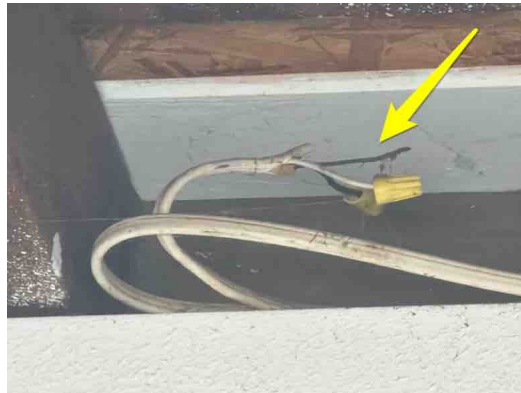
**SC 198:** Improper electrical wiring. Exposed electrical wires and/or splices not protected in a box with a cover:  
GARAGE ABOVE VEHICLE DOOR

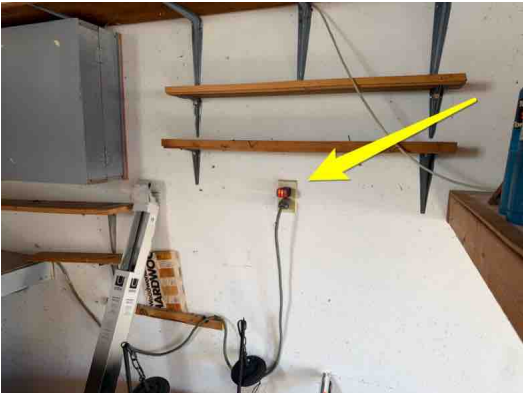
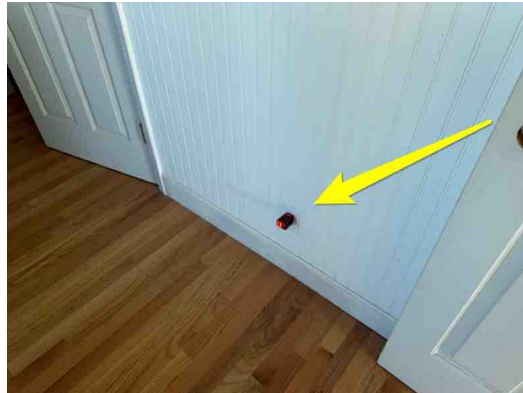
**SC 200:** Miswired electrical outlet (Reverse polarity) found at: MULTIPLE IN THE GARAGE and BEDROOM-2 EAST WALL. Have electrician check all outlets and correct as needed.

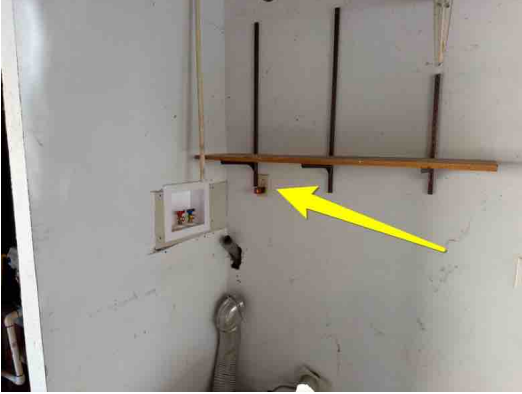
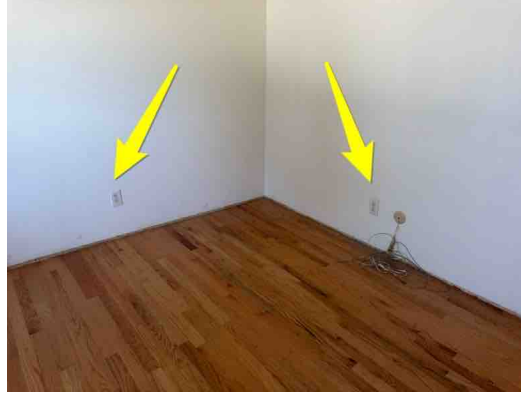
**SC 201:** Three-prong electrical outlets did not test properly grounded: GARAGE NORTHWEST ABOVE LAUNDRY and 2 IN BEDROOM-1. Contact a licensed electrical contractor for evaluation and repairs.

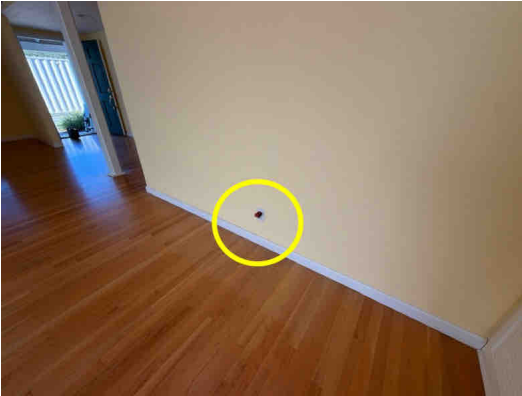
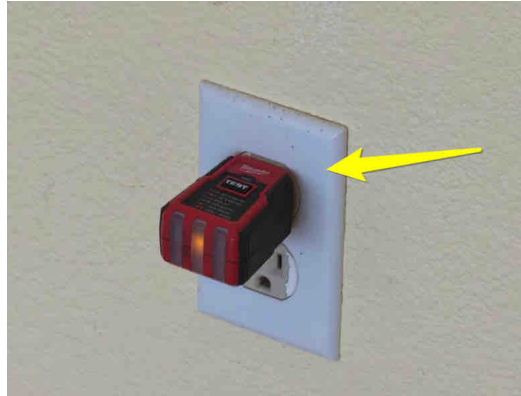
**SC 202:** Three-prong electrical outlets did not test properly grounded: LIVING ROOM WEST WALL and PRIMARY BEDROOM SOUTH WALL. Have electrician check all outlets for proper grounding.

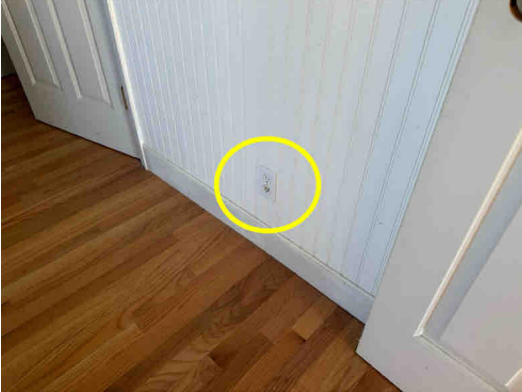
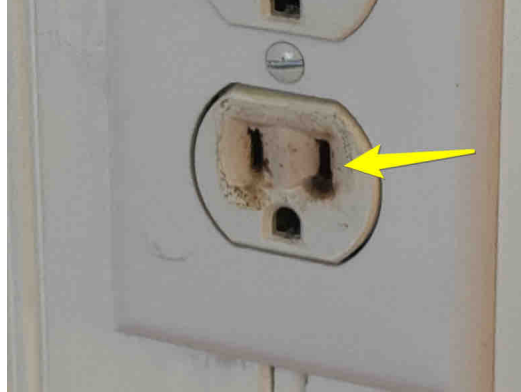
**SC FI 203:** A Burnt and Damaged electrical outlet found: BEDROOM-2 EAST WALL. Additional review to determine the cause and replacement of the damaged outlet is needed by an electrician.

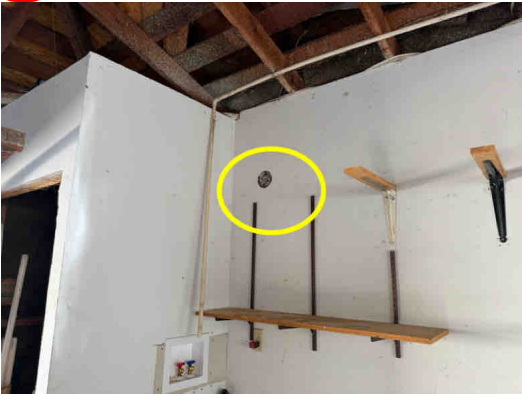
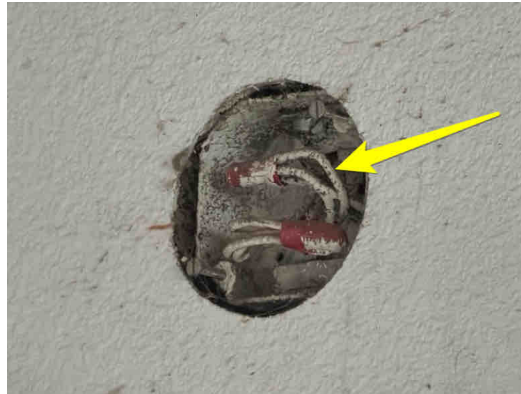
**SC 204:** Light fixture is missing with exposed wires: GARAGE AT LAUNDRY

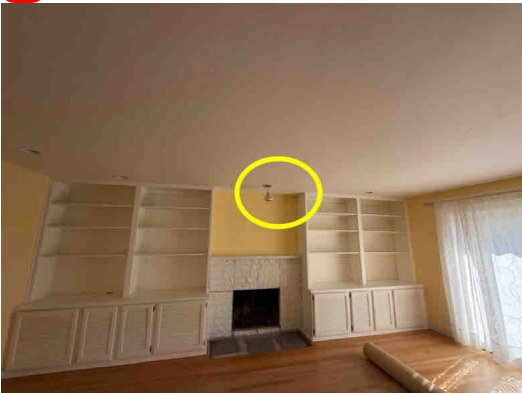
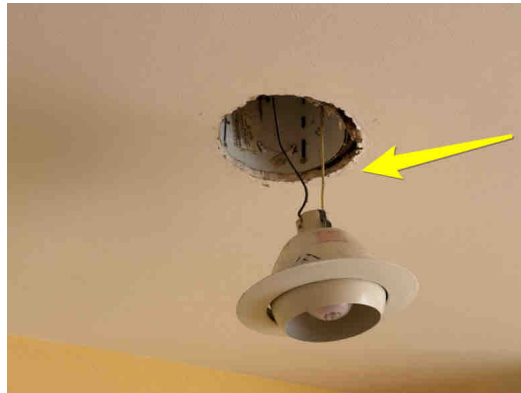
**SC 205:** Light fixture is hanging loose with exposed wiring: LIVING ROOM

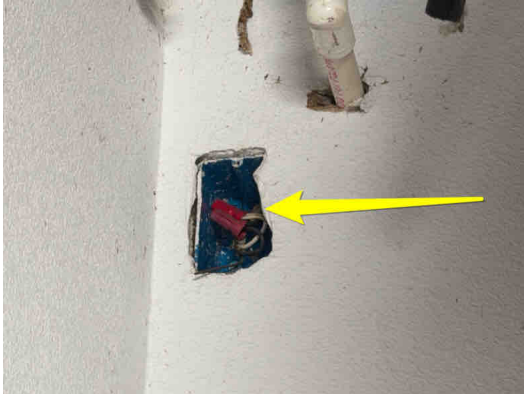
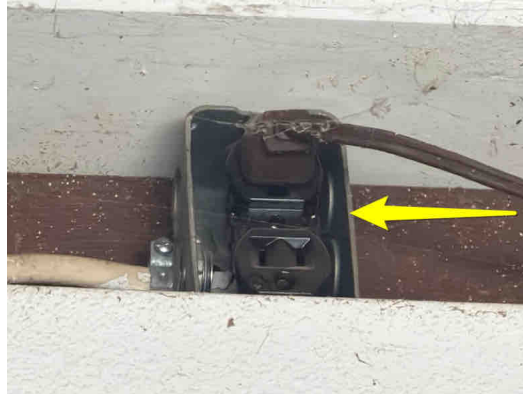
**SC 206:** Missing electrical cover plate: MULTIPLE IN THE GARAGE/ PRIMARY BEDROOM and PRIMARY BEDROOM BATHROOM

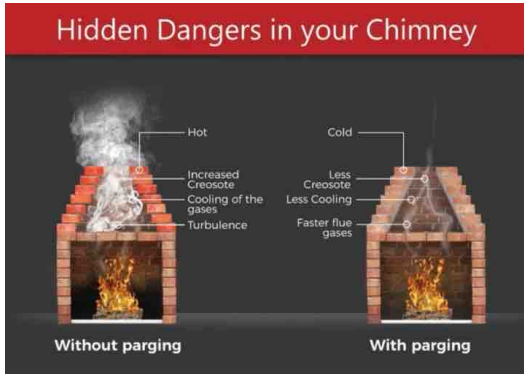
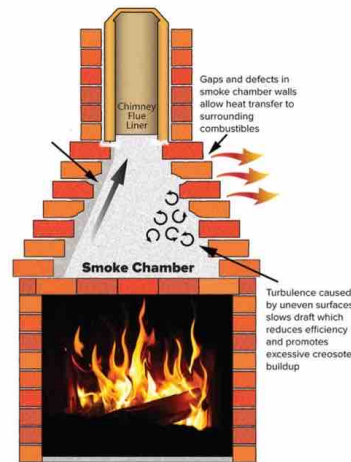
**E&C SU 232:** The LIVING ROOM fireplace throat above the damper was observed to be unfinished and not properly parged, with exposed masonry and visible separations between the flue liners and chimney structure. The throat is required to be constructed with smooth parging to provide a continuous, smoke-tight pathway directing combustion gases into the flue liner system (IRC R1003; NFPA 211). The absence of proper parging may allow superheated gases to escape into concealed portions of the chimney and/or wood framing of the building, increasing the risk of thermal damage, cracking, and fire hazards. Recommend repair by a qualified chimney professional to restore proper function and safety.

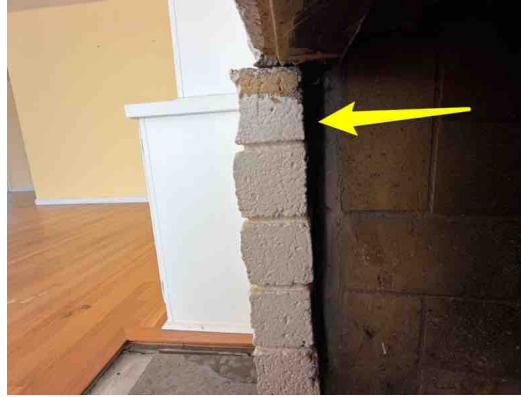
**E&C 235:** The masonry veneer at the front of the fireplace was loose and could be moved by hand. Loose masonry may continue to deteriorate or detach and may indicate inadequate bonding or attachment to the underlying fireplace assembly. Recommend repair by a qualified masonry contractor to properly secure/reconstruct the affected veneer and evaluate the surrounding masonry for similar conditions.

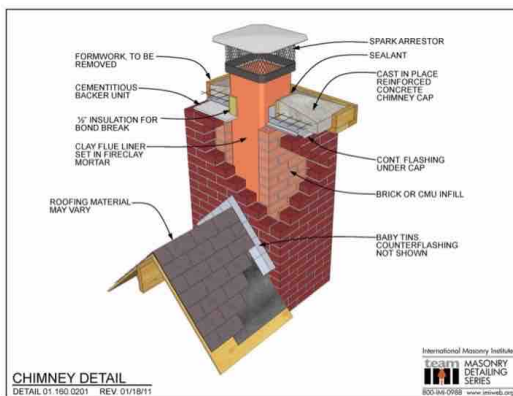
**SC 237:** An improper and unsafe use of a flat spark screen atop the LIVING ROOM masonry fireplace chimney. Recommend the proper installation of an appropriate screen and cap for fire safety per standards. Contact a qualified professional.

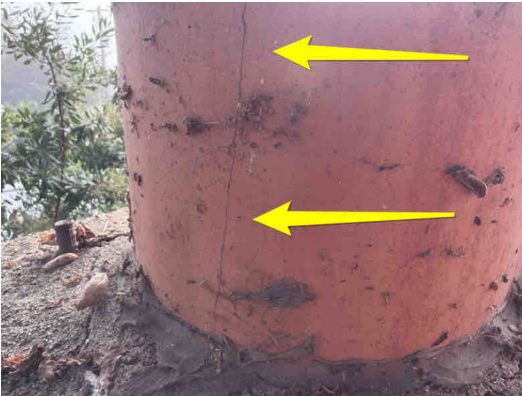
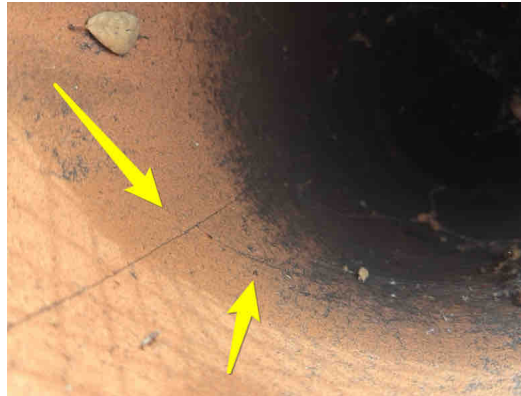
**SC 239:** Some visible cracking noted at areas of the LIVING ROOM chimney flue liners. This can allow for the super heated fireplace exhaust to escape through the cracks into confined areas of the chimney and make contact with wood framing. Potential Fire hazard.

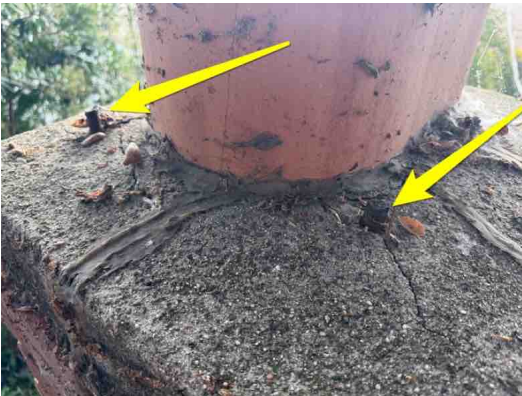
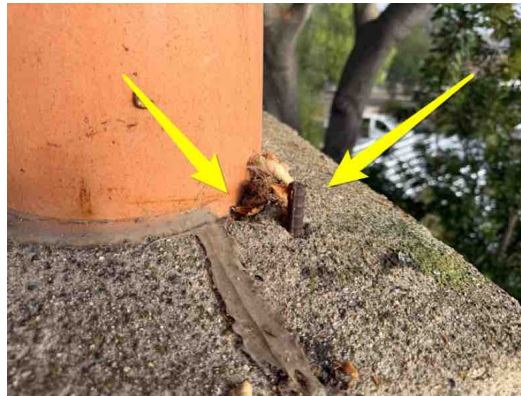
**E&C 240:** The mortar/concrete chimney crown is heavily deteriorated, with significant cracking, material loss, and exposed reinforcing steel/rebar observed. These conditions can allow continued moisture intrusion and corrosion of the reinforcement, resulting in progressive deterioration of the crown and potentially the surrounding masonry. Recommend evaluation and proper repair or replacement of the chimney crown by a qualified masonry/chimney contractor.

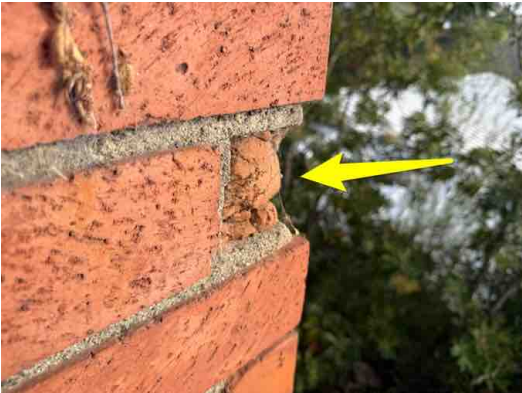
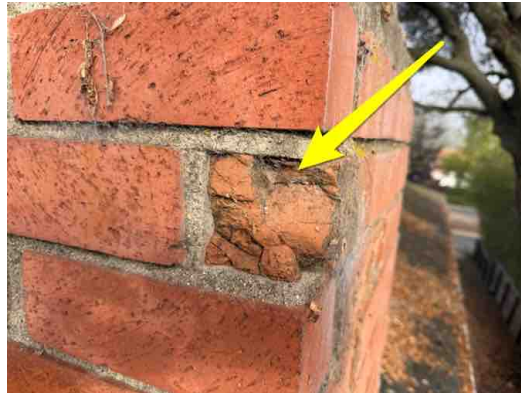
**E&C 241:** Several bricks at the chimney are heavily deteriorated, spalled, and/or crumbling, with significant loss of the brick material noted in multiple areas. Continued deterioration can allow increased moisture intrusion and further damage to the masonry. Recommend evaluation and repair/replacement of the dete

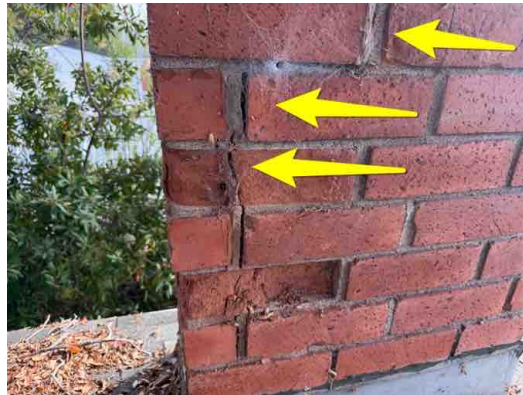
**242:** Visible cracking and separation were noted at portions of the chimney masonry, including separation through brick and mortar joints. The cause and extent of the movement cannot be determined during a visual, non-invasive inspection and may be related to movement or other underlying conditions. Recommend further evaluation by a qualified masonry contractor and repair as necessary; structural evaluation should be performed if significant movement or instability is identified.
