HEDDERMAN SERVICES

## FOUNDATION INSPECTION

8139 Silent Deep Dr  
Rosenberg, TX 77469

05/28/2026

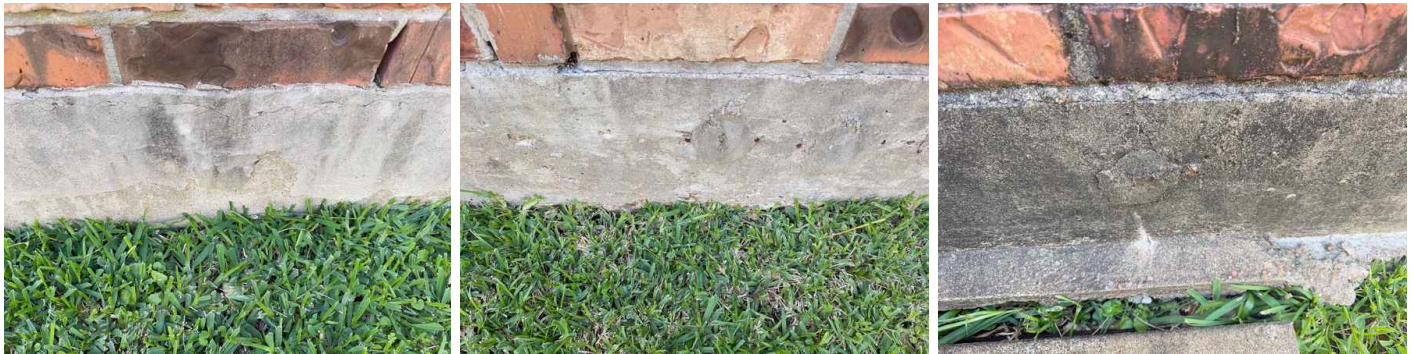
The foundation was a concrete slab on grade, and was reinforced with post tensioned cables.

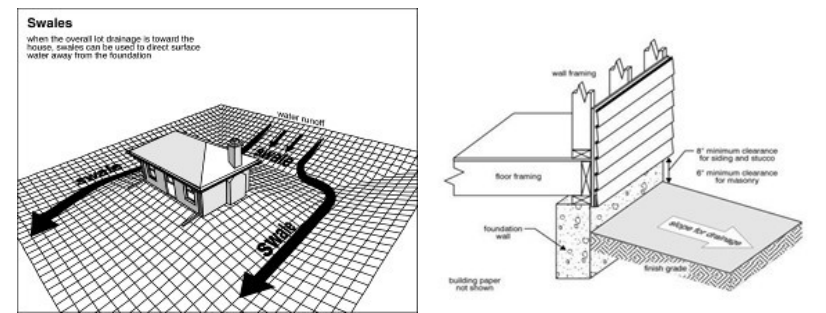
Water was observed to be ponding at some locations on the property due to the recent rains. Have a service company specializing in drainage solutions provide a solution and cost estimate to eliminate the poor drainage conditions, as poor drainage can contribute to foundation movement.

Recommendation  
Contact a qualified professional.

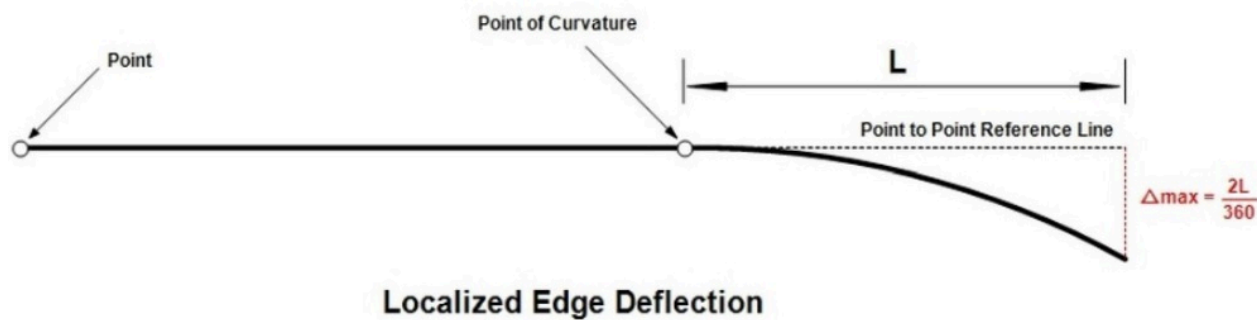
According to the ASCE Guidelines, the evaluation of localized **localized edge-condition deflections** shall be evaluated as a cantilevered member (allowable deflection = one inch deflection in a 15-foot horizontal distance ( $2L/\Delta = 360$  per the building code)).

From the point of curvature located at the west bedroom to the south bedroom ( $L = 30$  feet), the maximum allowable deflection is 2.00 inches. We calculated a deflection of 2.23 inches at the time of inspection across this span, which is **greater than the maximum allowable deflection**. This observation can be observed along the **Red Line** in the sketch below.

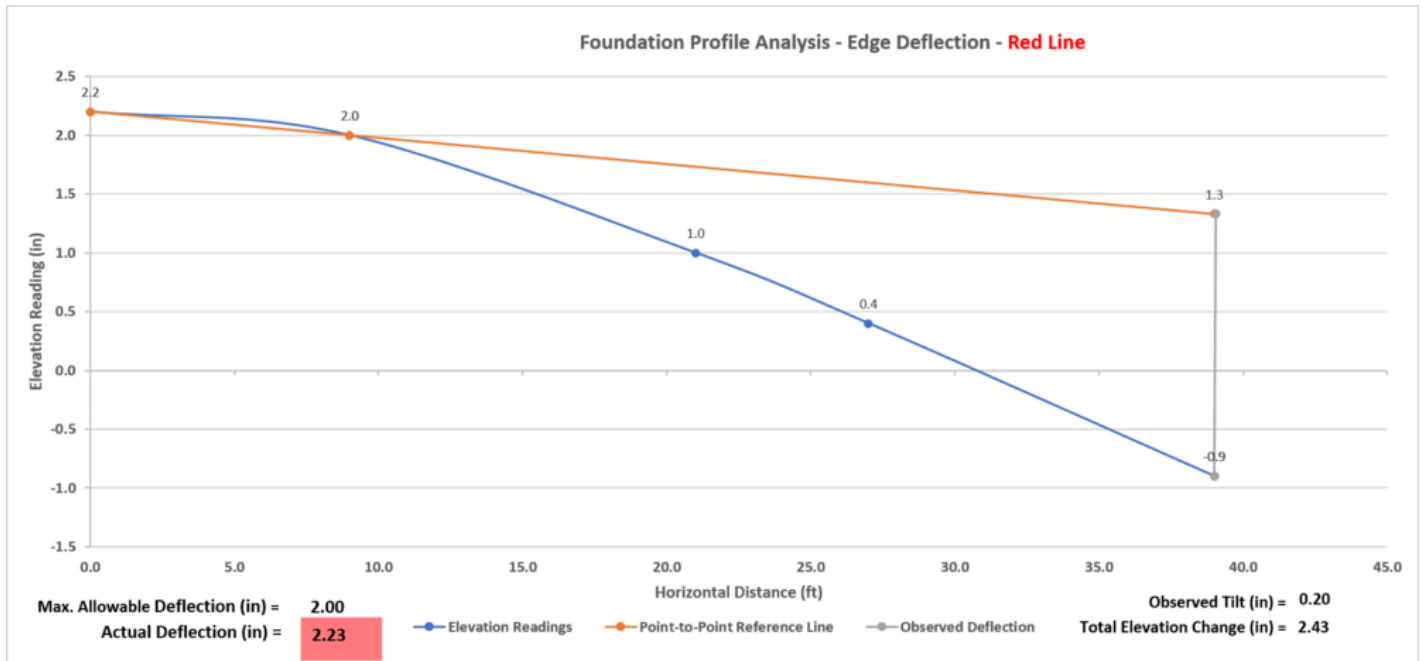
**Elevation Readings**  
**8139 Silent Deep Drive**  
**(Not to Scale)**

Most of the structures previously inspected by this firm have experienced some degree of differential foundation movement, and this structure was no exception. After careful examination, the engineering analysis above showed that the degree of the foundation movement is more than what is acceptable by the standards set forth by the American Society of Civil Engineers. The most significant movement was located at the south.
