## PROPERTY INSPECTION REPORT FORM

| 4102 Avenue M 1/2 , Galveston, TX 77550 | |

DATE OF INSPECTION: 01/19/2023

Inspection No. 521350-1345

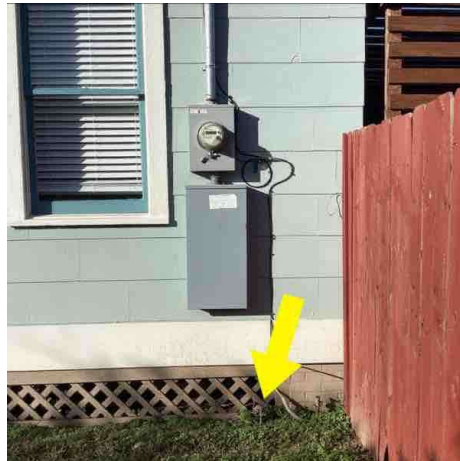
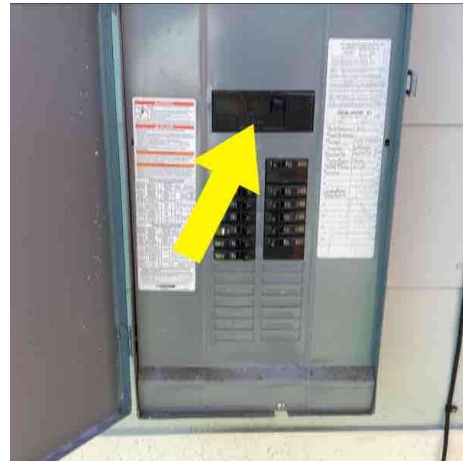
- 120/240 volt, 150 amp service.
- Grounding is through grounding rod to earth.
- Main disconnect is located in service panel on the right exterior of the home.
- No deficiencies were noted at time of inspection.
