**May 15, 2026**

# PROPERTY INSPECTION REPORT FORM

| 12704 Rio Nueces Ln, Rosharon, TX 77583<br><i>Address of Inspected Property</i> | |

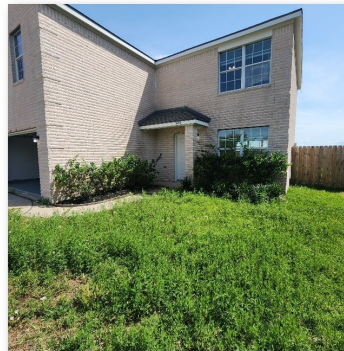
- The soil line was observed to be marginally high on the north side of the structure. Under current building standards there should be at least 4-inches of foundation visible below masonry veneer and 6-inches of foundation visible below wood type veneer.

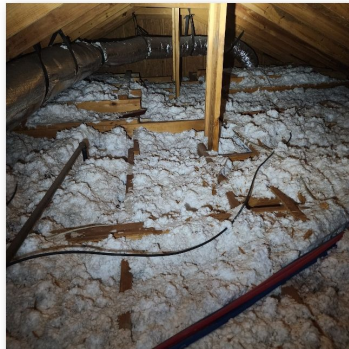
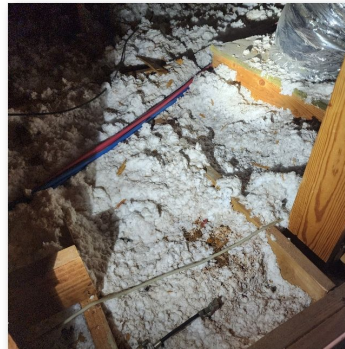
- The attic floor insulation should be redistributed in one or more locations.

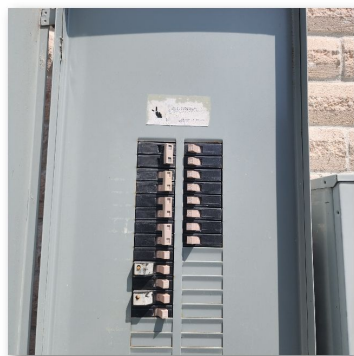
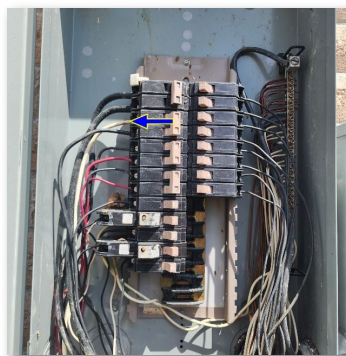
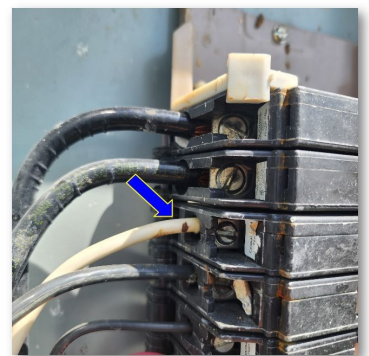
- An unmarked white wire was found connected to a hot breaker in the panel. While white wires are sometimes used as 'hot' conductors for 240-volt circuits, they must be permanently re-identified with black or red tape/marker at all terminations to identify them as energized. This creates a potential safety hazard for technicians assuming it is a neutral wire. **Recommendation: Have a licensed electrician properly identify the wire.**

- None of the required dwelling unit devices, receptacle and lighting outlets (switches, receptacles and fixtures) are connected to an arc-fault circuit-interrupter (AFCI) circuit device. AFCI devices were first required under the 1999 National Electrical Code and under the 2014 NEC, all living space, kitchen and laundry room devices, receptacle and lighting outlets (switches, receptacles and fixtures) should be connected to an arc-fault circuit interrupter (AFCI) device.

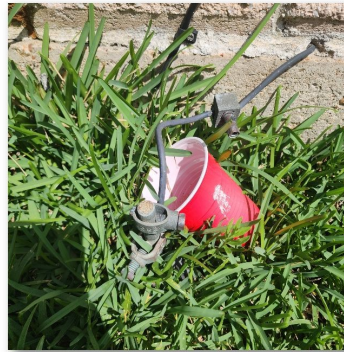
- One or more of the receptacles are inoperative. This receptacle(s) and circuit should be investigated and corrected as necessary. Receptacle(s) were located in the front porch.
- The garage area, laundry area, north exterior wall, west exterior wall receptacles are not connected to a ground fault circuit interrupter (GFCI) device. Under current electrical standards, these receptacles should have GFCI protection.

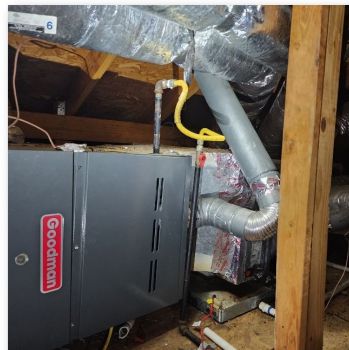
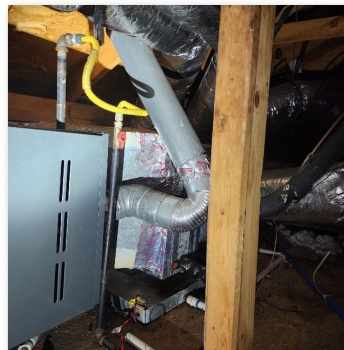
- The roof level flue storm collar should be properly sealed to help prevent water intrusion into the structure.
- The heater gas supply line is not equipped with a sediment trap just before the gas appliance connector. This condition does not meet current installation requirements and should be corrected.

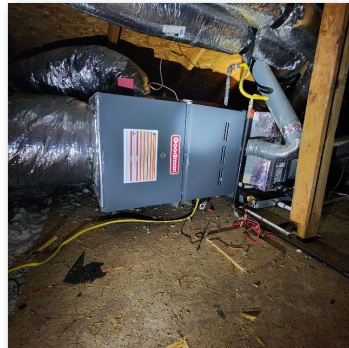
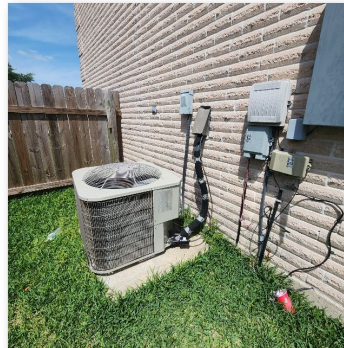
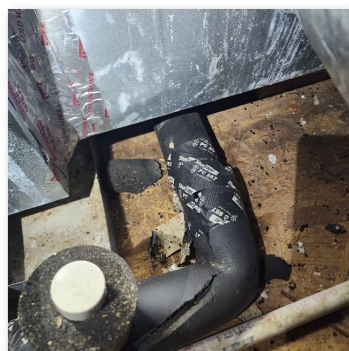
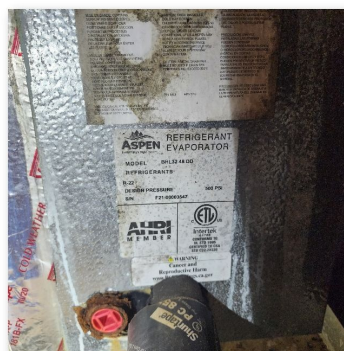
- The air conditioning system was inoperative at the time of the inspection.
- Damaged, deteriorated and/or missing insulation on the refrigerant lines should be repaired or replaced at the outside condenser.

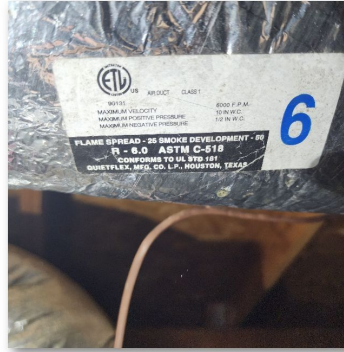
- The duct work in the attic area is not properly separated to help prevent condensation from developing. It is recommended to separate the duct work with a minimum intervals of 1.5-inches.
- The duct system was observed to be dirty and should be cleaned for air quality purposes.
- The supply ductwork in the attic has an R6, Which is less than the current recommended R8 for this climate zone. This can lead to reduced energy efficiency and potential condensation issues. Recommend evaluation and sealing/upgrading of insulation by a qualified HVAC Contractor.

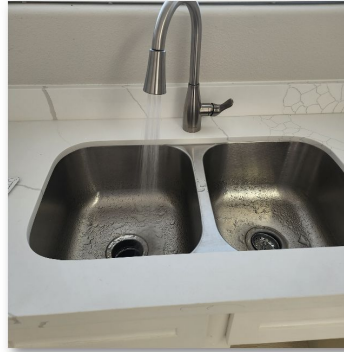
- The stopper does not function properly.
- The stopper is missing.
- The sink has some surface damage.
- The drain leaks water into the cabinet.

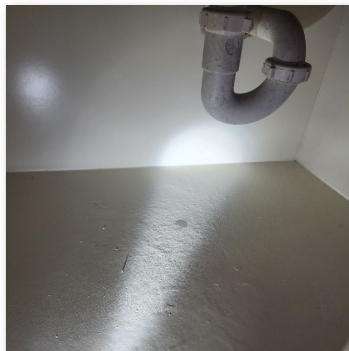
- The stopper does not function properly.
- The stopper is missing.

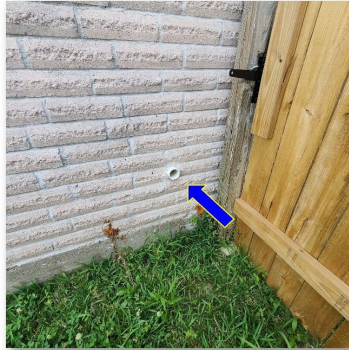
- The exterior wall cleanout cover is missing on the east side of the structure.

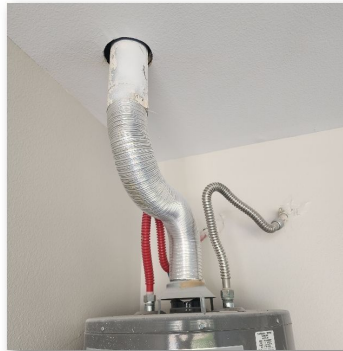
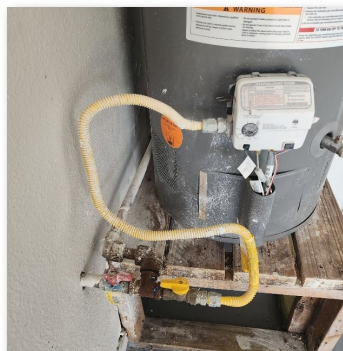
- The water heater gas supply line is not equipped with a sediment trap just before the gas appliance connector. This condition does not meet current installation requirements and should be corrected.

- The water heater flue (vent pipe) has inadequate clearance from combustible materials. Double walled vent pipes should have at least 1-inch of clearance and single walled vent pipes should have at least 6-inches of clearance from combustible material.
- The water heater flue was observed to be an older single wall type. Under current mechanical standards, the exhaust flue should be a Type-B double wall flue.
- There is no pan installed under the water heater.

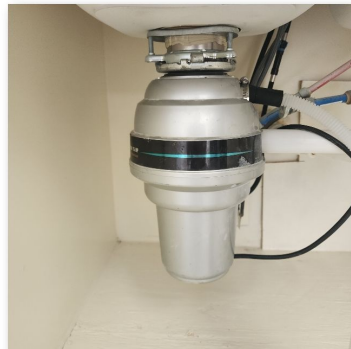
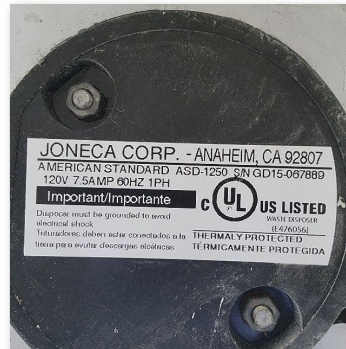
- The food waste disposer is leaking water into the cabinet area. This condition should be further evaluated and corrected as necessary.

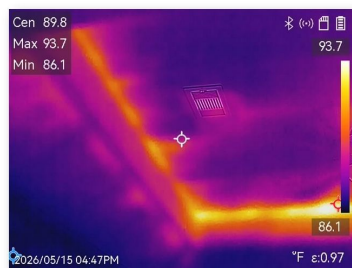
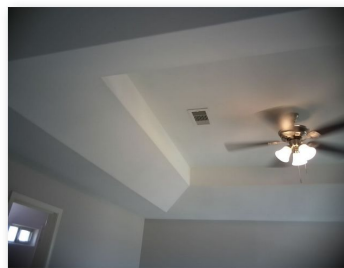
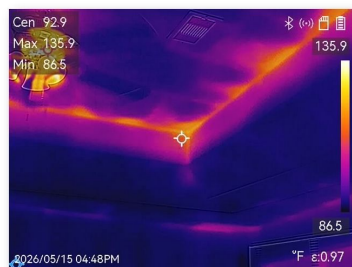
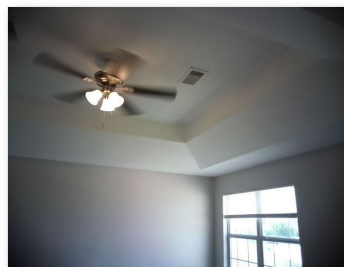
#### Thermal Imaging / Infrared

- Missing insulation was observed within the wall cavity in the several locations throughout the house.
- Missing insulation was observed at the ceiling in the several locations throughout the house.
