# Inspection Report

4425 Fuqua St  
Houston TX 77048

# PROPERTY INSPECTION REPORT FORM

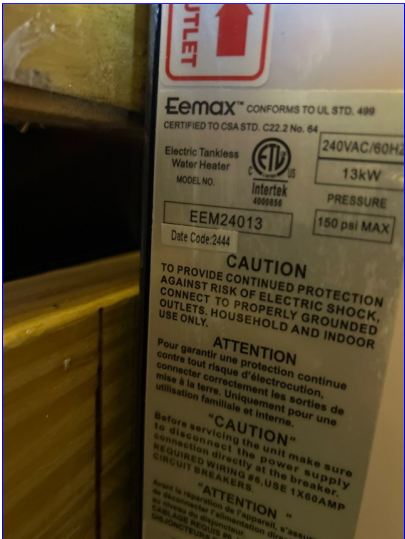
(2) There is no drain pan underneath the water heater at the attic. Recommend correction.
