# Inspection Report

**Property Address:**  
5443 Queensloch Dr  
Houston TX 77096

# PROPERTY INSPECTION REPORT FORM

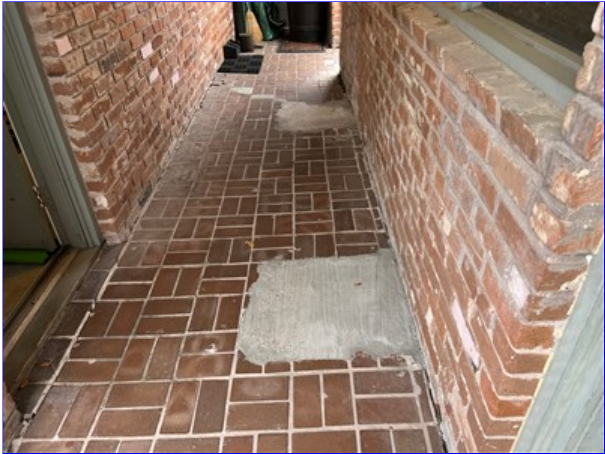
(1) The main structure foundation appears to have been previously repaired, as suggested by concrete patches near the foundation. I recommend that you consult with the seller to determine the company that performed the repairs to obtain information on the repairs, any transferrable warranty associated with the repairs and complete the warranty transfer requirements.

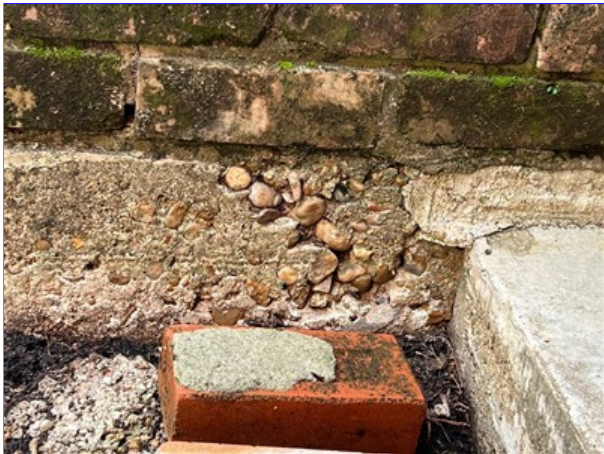
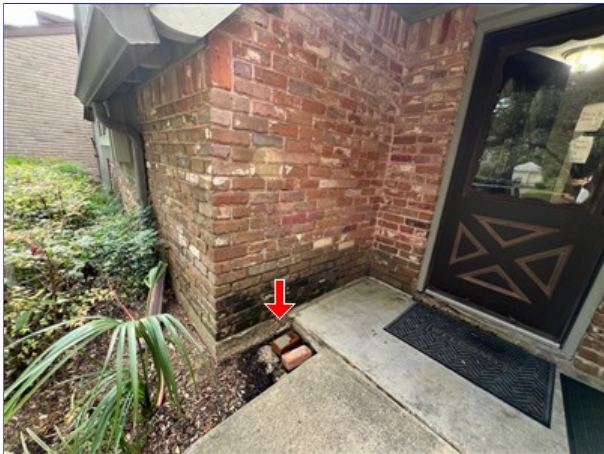
Front entrance

(3) Instances of "honeycombing" observed on the slab edges. I recommend that all voids and "honeycombing" be sealed with an approved cementitious epoxy.

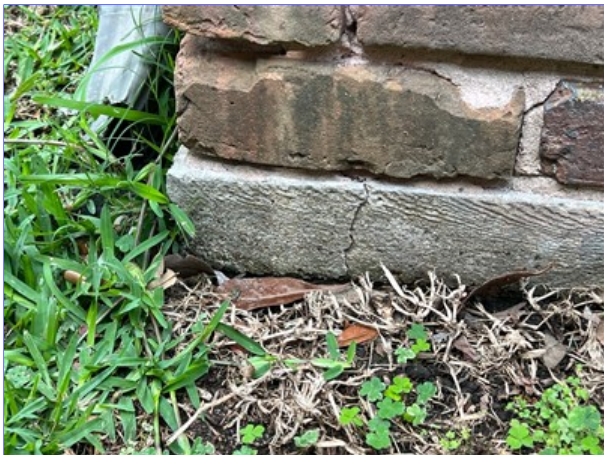
Left back

(4) Typical corner "pops" observed at foundation corners. This condition is cosmetic in nature and not structurally significant.

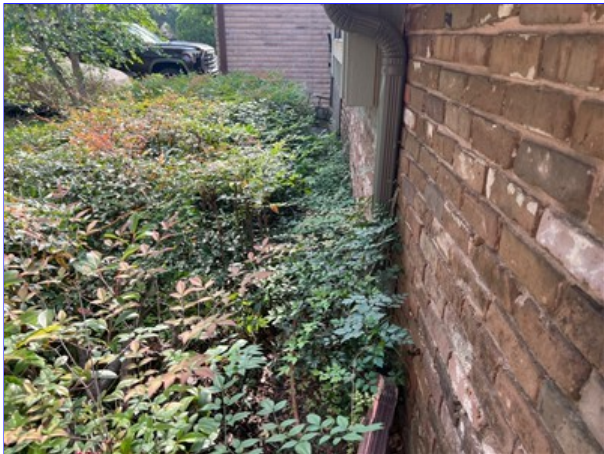
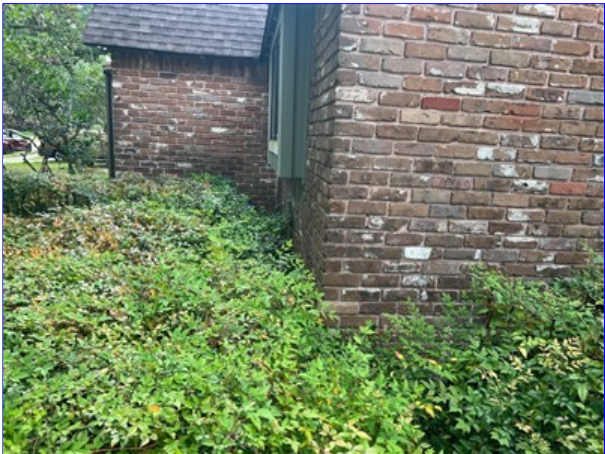
Front left

(1) Vegetation was in contact with the exterior wall. Recommend cutting back.

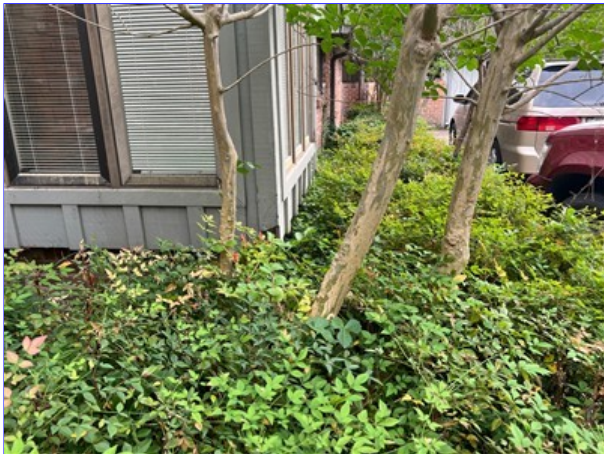
(2) No gutters observed at some slopping sides of the roof. Gutters are recommended at all appropriate roof slopes to channel and direct rain water away from the structure and to promote foundation health.

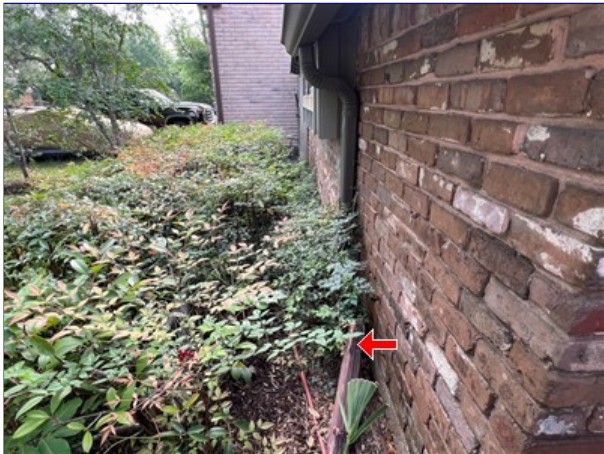
(3) The gutter discharges into the the flower bed, or an area that the gutter will not properly drain. I recommend adding landscape piping to the gutter to help discharge water out of the bed or further away from the house.

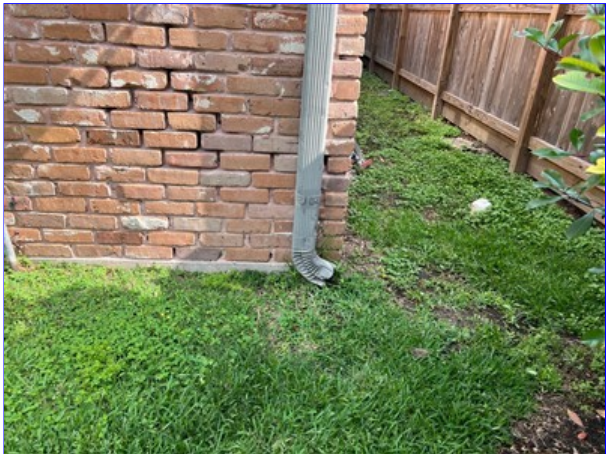
(6) Concrete splash blocks or downspout extensions, are absent at some gutter downspouts. Gutter downspouts should discharge a minimum of 18" away from the foundation.

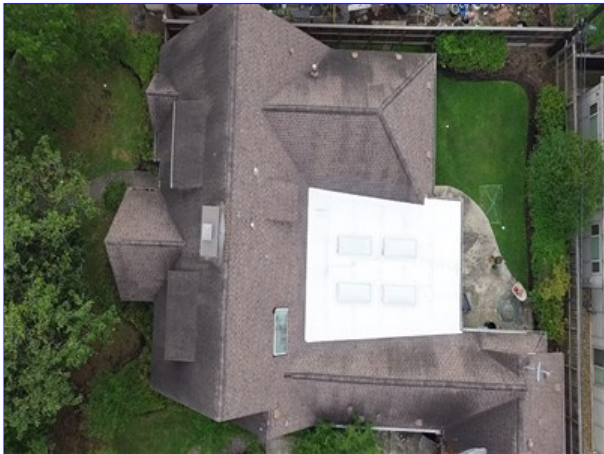
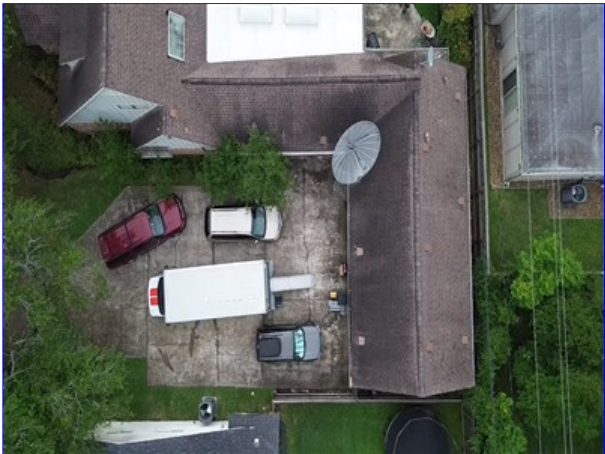
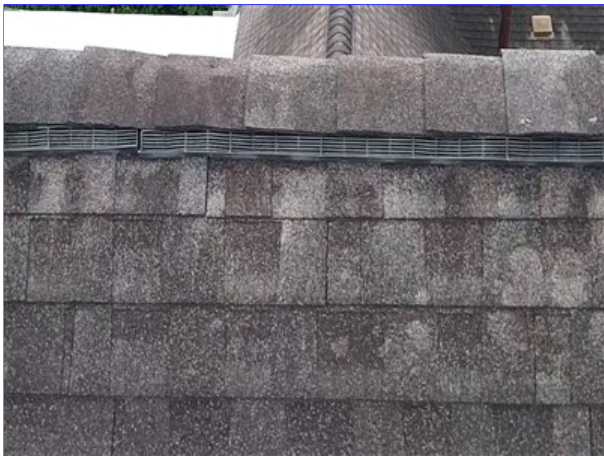
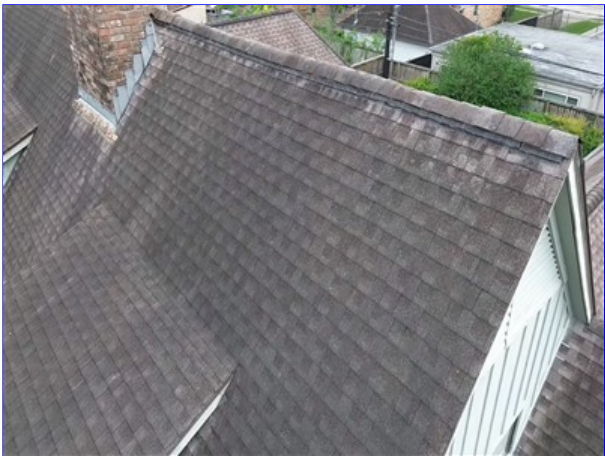
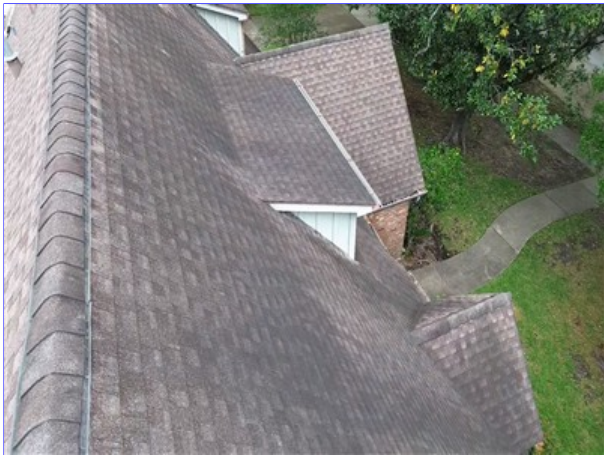
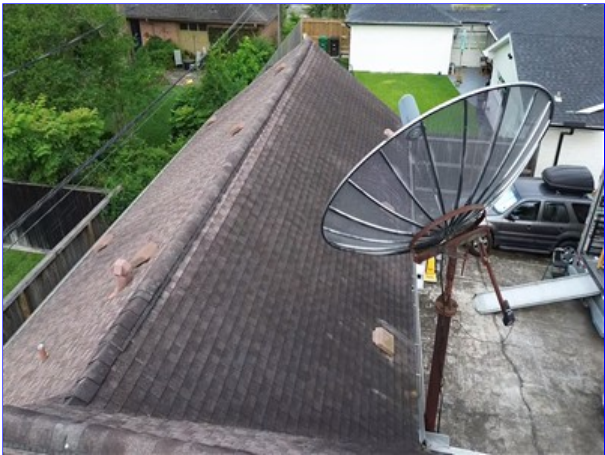
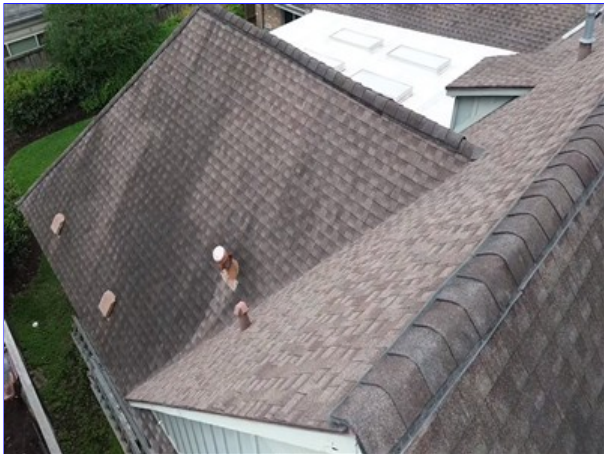
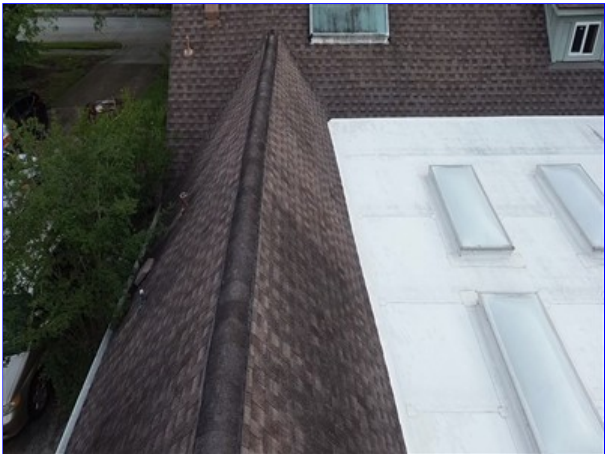
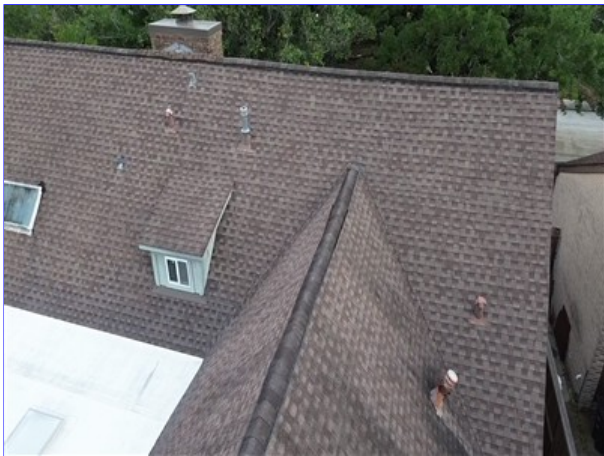
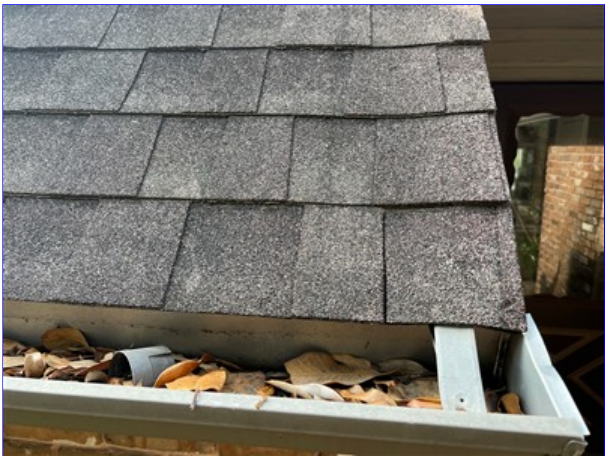
(1) The overall condition of the roof covering appears to be weathered. This type of architectural style composition shingles typically lasts about 20 years in this climate. I recommend, you consult with a competent and qualified roofing contractor to evaluate further.

A general seal up of roof penetrations, exposed nail heads and flashings is recommended as routine maintenance.

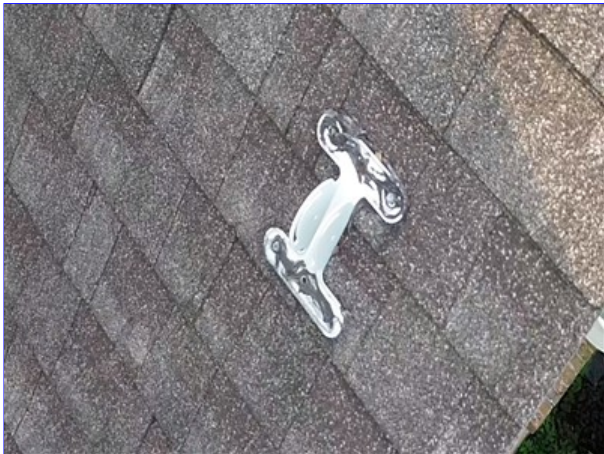
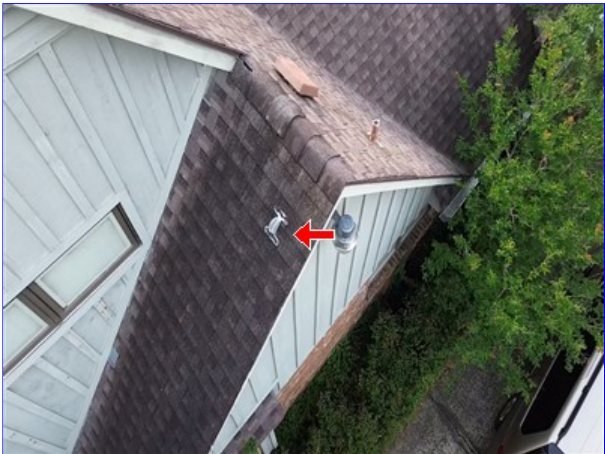
(2) The satellite dish and mounting bracket was observed mounted on the roof covering. The securing screws penetrate the roof covering, underlayment and sheathing. Over time, this installation will most likely leak water into the structure causing water damage. A better installation might be to bolt the dish to a vertical structural element and seal the bolts/screws to insure that water does not penetrate the building envelope. If you choose to remove the dish from its current location, immediate repair to the roof covering is recommended.

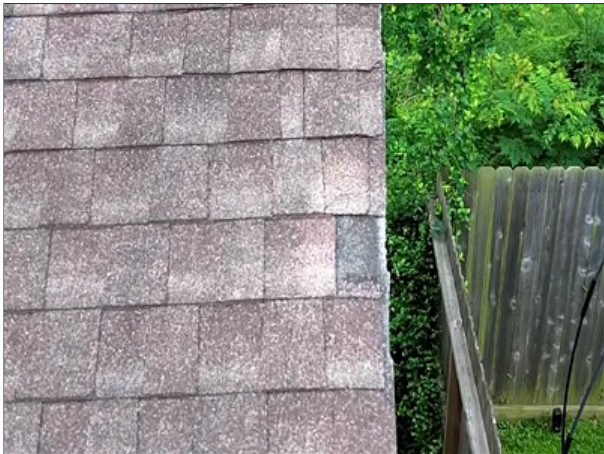
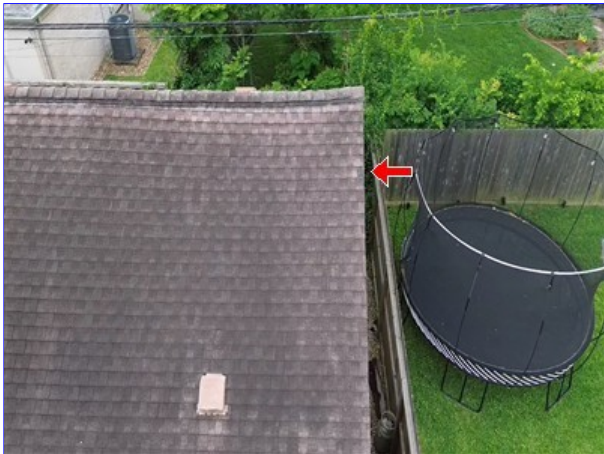
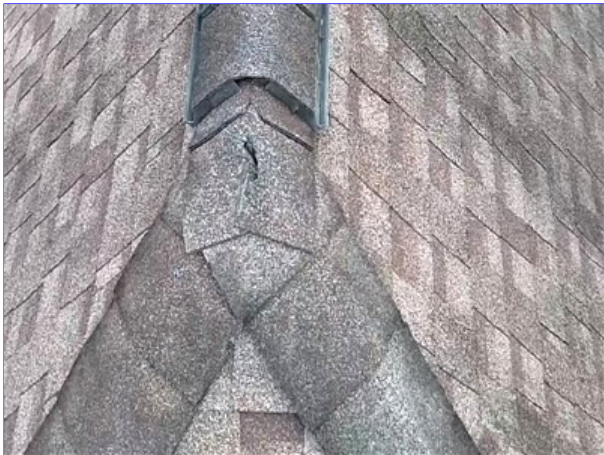
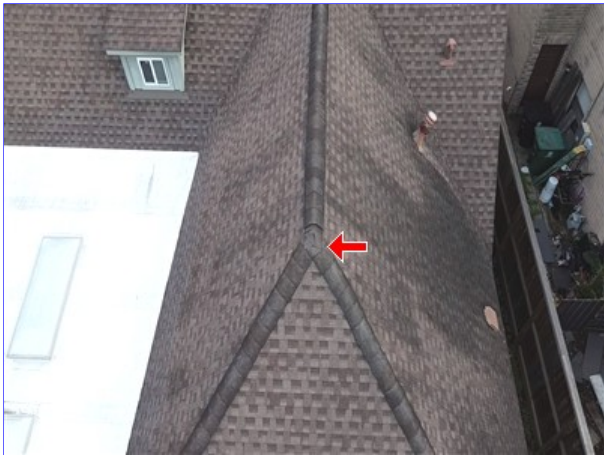
(3) Damaged and/or missing shingles were observed on the roof surface. Recommend correction

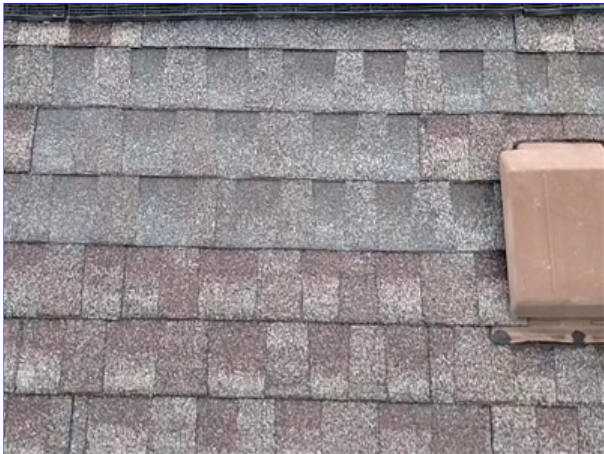
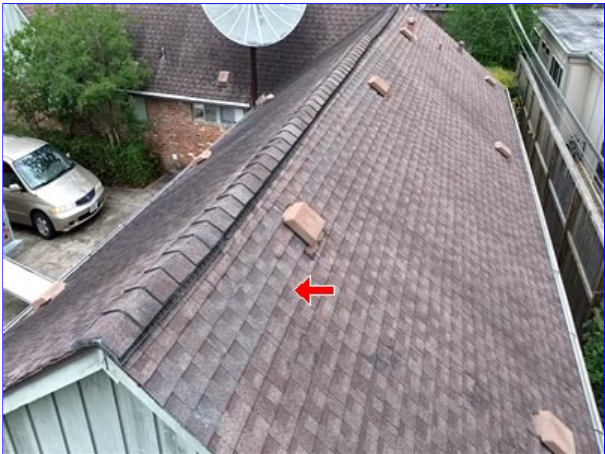
(4) Previous roof repairs were observed.

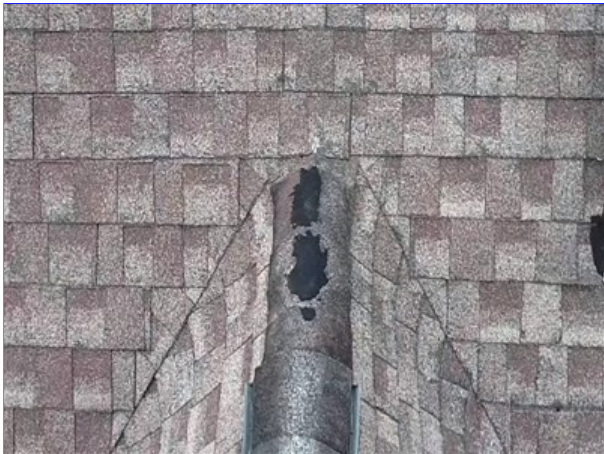
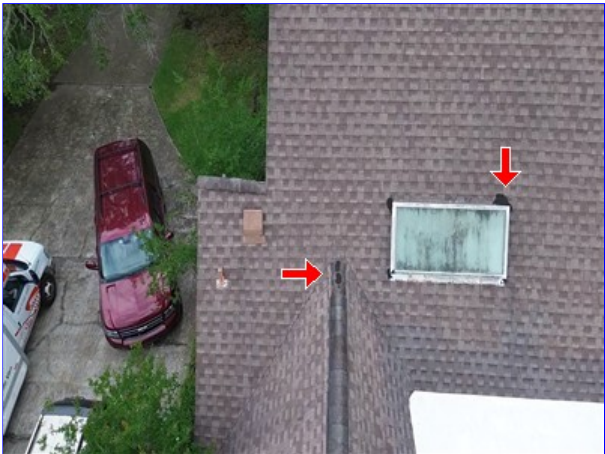
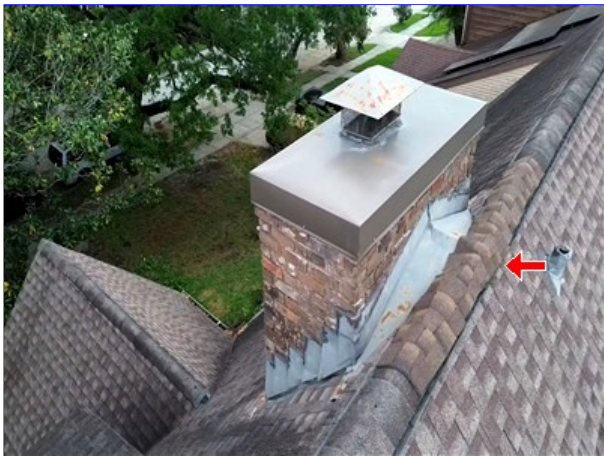
(5) Some shingles are not sealed down at the edge. I recommend that the shingles be sealed down at the edge to prevent uplift and tear off during periods of high wind. Recommend correction.

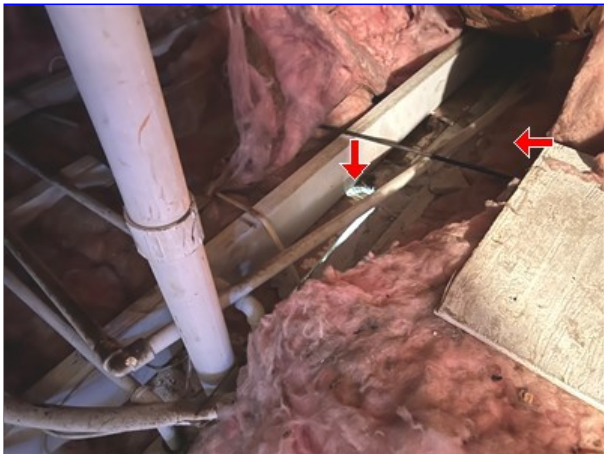
(2) From the attic space above the garage apartment. Visible light was seen through the attic floor. Missing or displaced insulation was observed in the attic. Recommend correction.

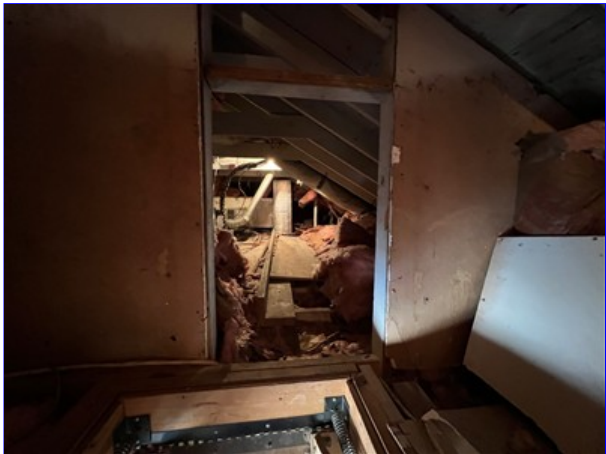
(3) At the garage apartment, the attic space does not have a fire stop. I recommend that a one hour fire wall separation be installed between the garage and the garage apartment attic.

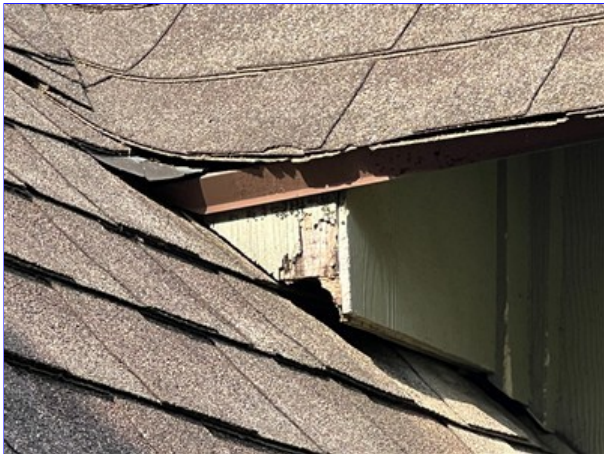
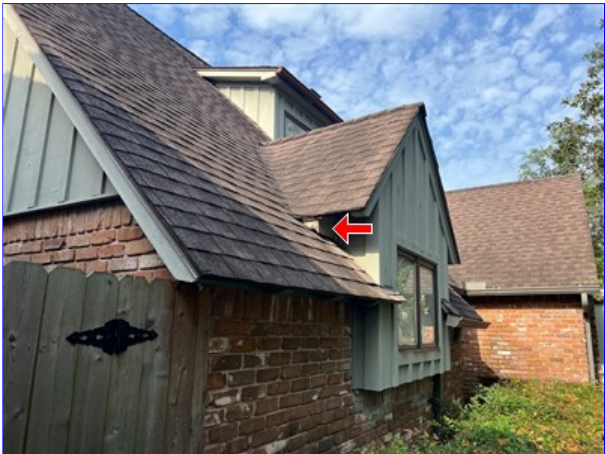
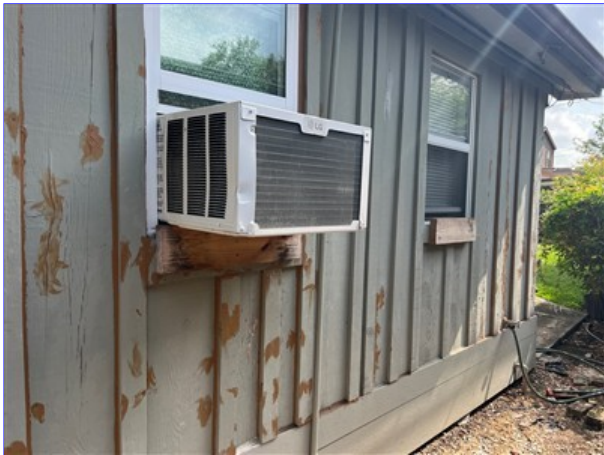
Garage apartment back

(1) Paint was weathered or missing on some areas of the exterior wall. Recommend correction.

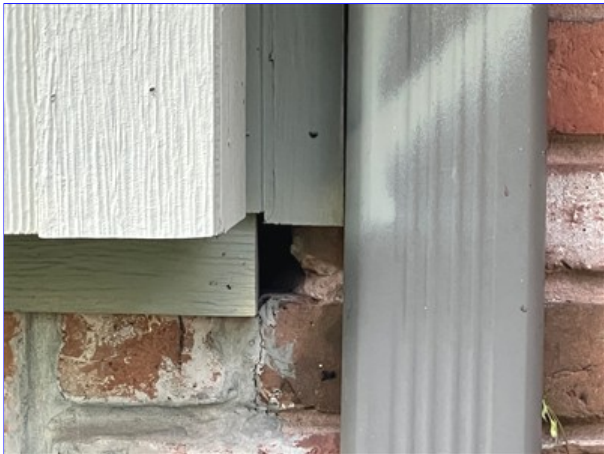
Front left

(2) Missing mortar was observed at some areas of the exterior brick wall. Recommend correction.

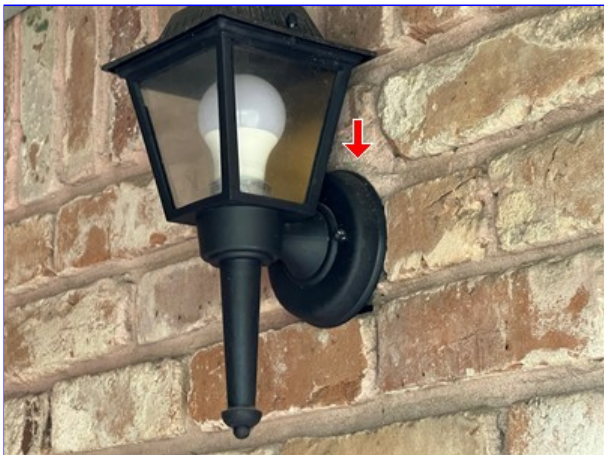
(3) All penetrations of the exterior wall, electrical or otherwise, should be sealed at the wall. Recommend caulking.

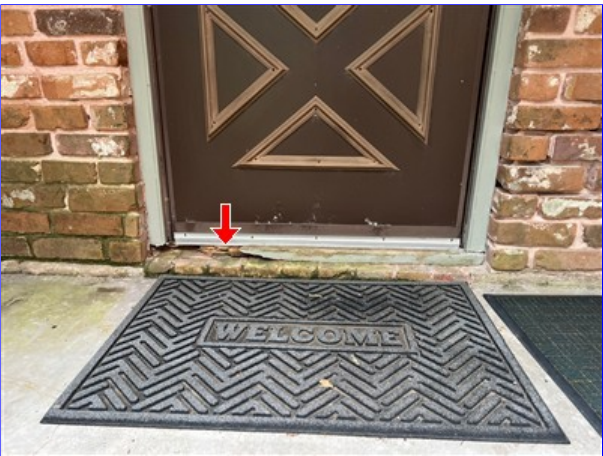
Front door

(5) Wood rot was observed on some areas of the exterior wall and/or trim. Recommend correction to all damaged materials.

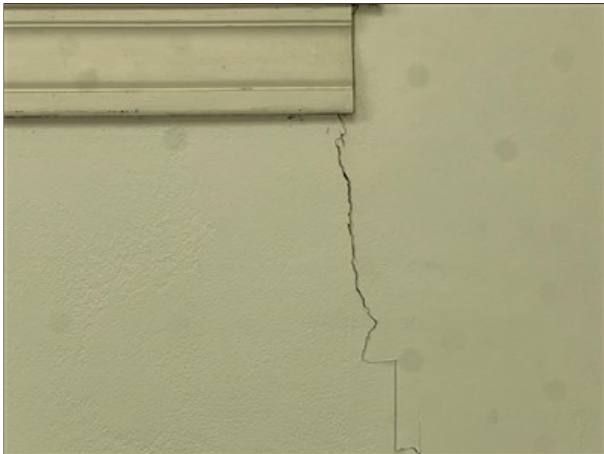
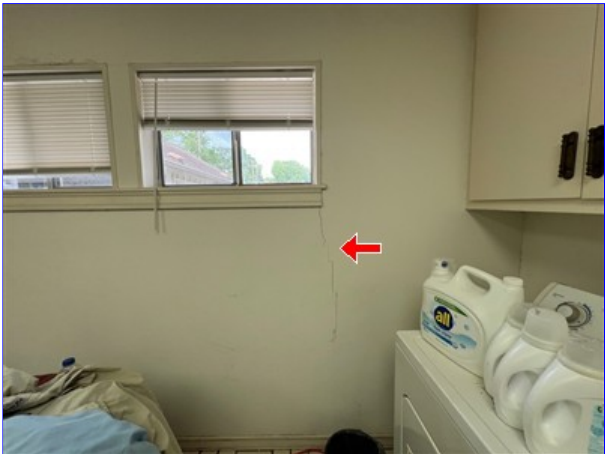
(7) Drywall stress cracks observed in the home. Some locations observed:.. Laundry room.

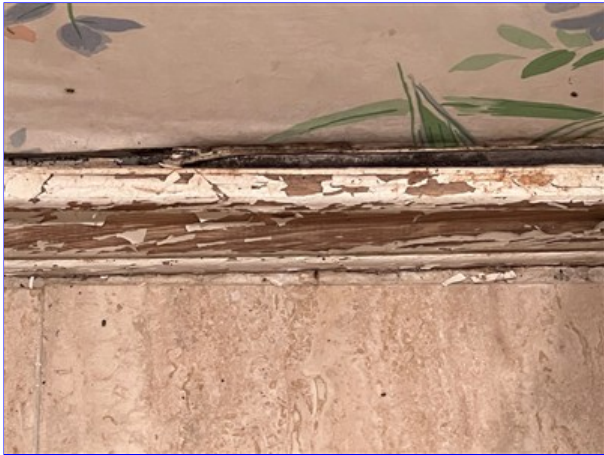
Primary bathroom

(8) At the primary bedroom half bathroom, moisture damage was observed at the baseboards of the exterior facing wall. The exterior side of the wall was missing mortar between a section of bricks and may be a possible source of moisture intrusion. Recommend correction to all damaged materials and consulting, a professional contractor to evaluate further.

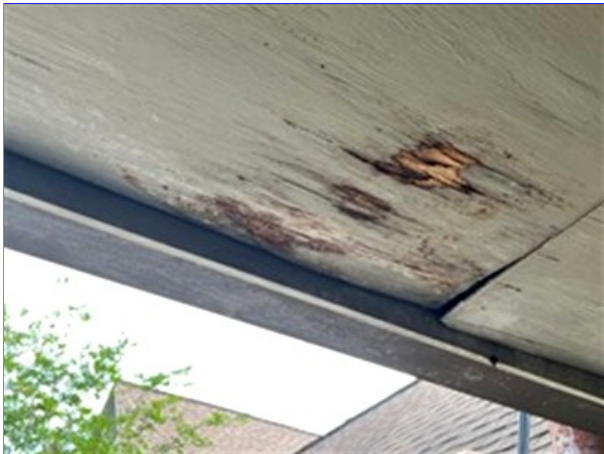
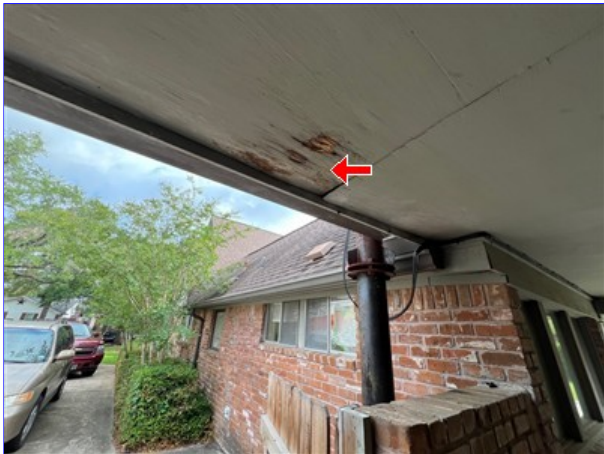
(1) Loose and/ or damaged materials were observed at some areas of the exterior soffit/ ceiling wood panel. Recommend correction.

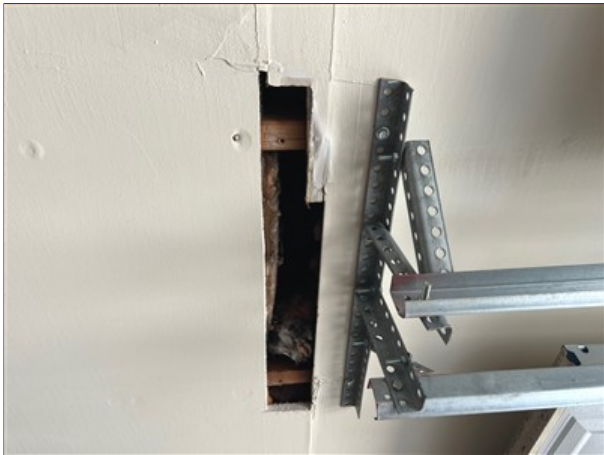
Garage

(2) Drywall damage/unfinished repairs were observed. Recommend correction.

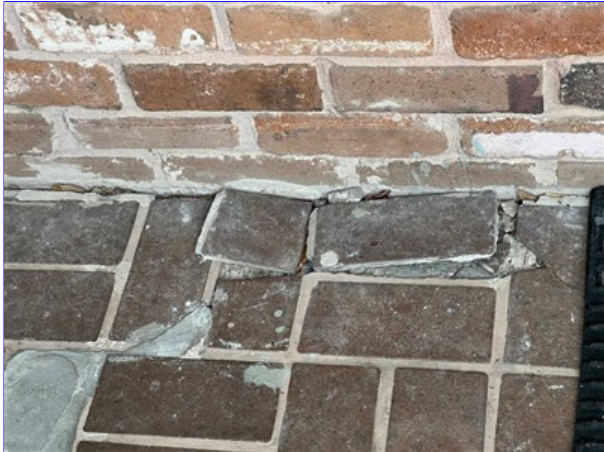
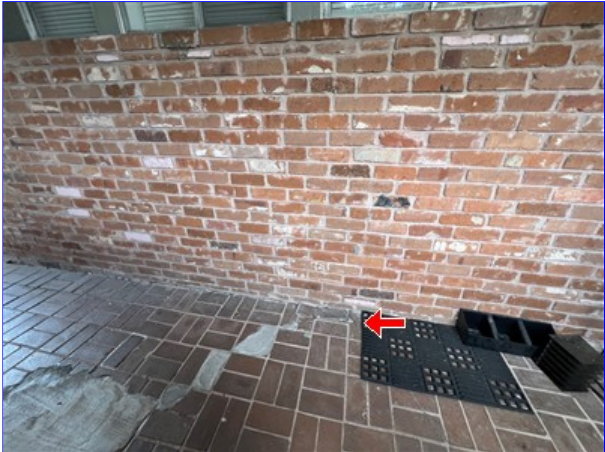
(3) Broken floor tiles at the exterior walk way. Recommend correction.

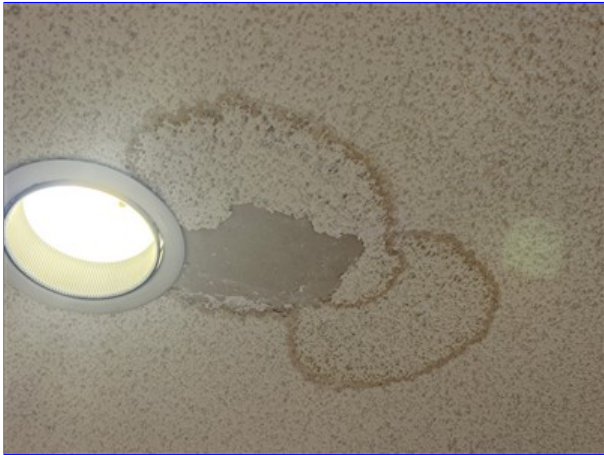
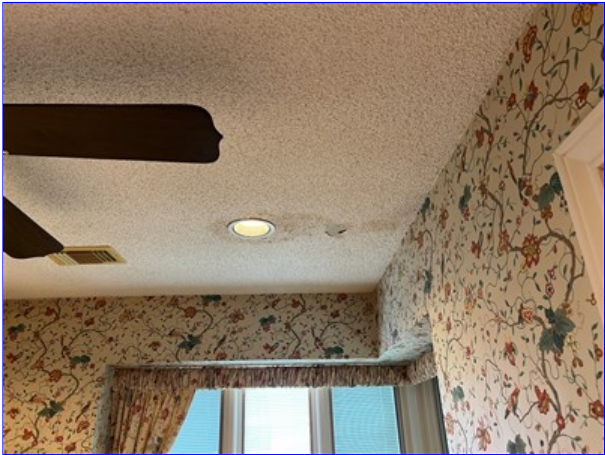
(4) At the kitchen, moisture stains were observed at the ceiling. The area was tested with a moisture meter and there were no high moisture readings detected during testing. Recommend correction to all damaged materials and consulting a professional contractor to evaluate further.

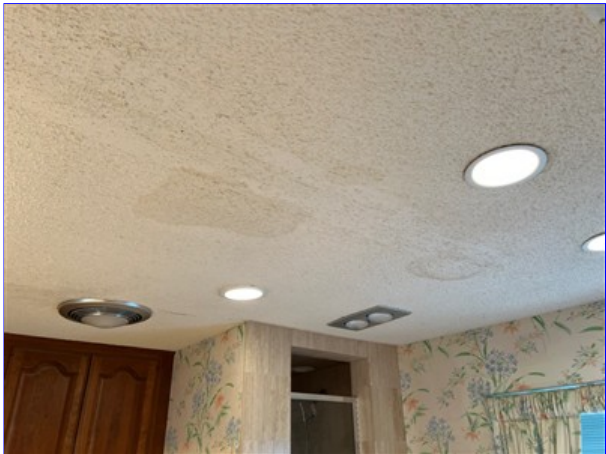
(10) At the primary bathroom, moisture stains were observed at the ceiling. The area was tested with a moisture meter, and there were no high moisture readings detected during testing. Recommend correction to all damaged materials and consulting a professional contractor to evaluate further.

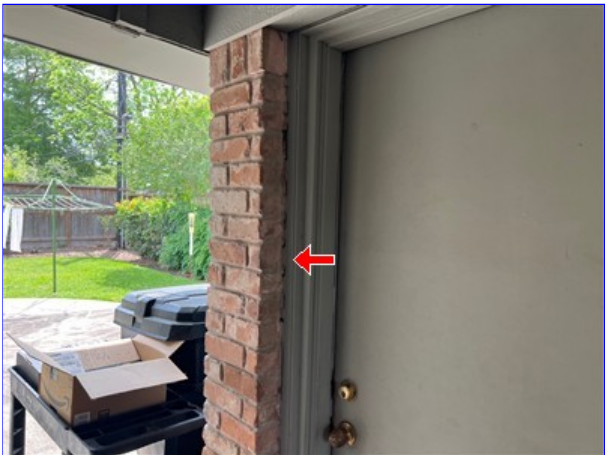
Garage apartment

(2) The perimeter sealant around door frames has deteriorated or was missing. Recommend correction.

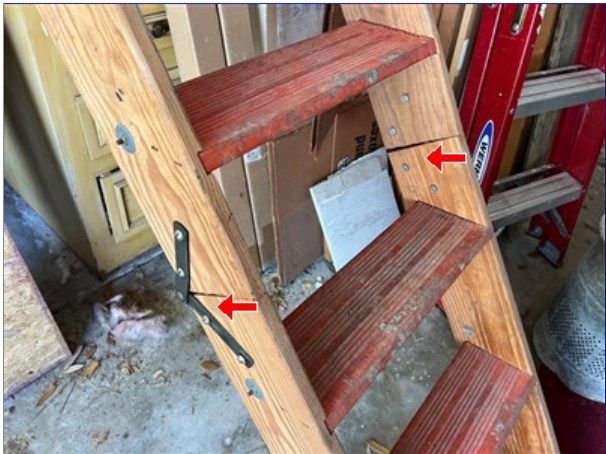
Garage

(5) The attic access door ladder fastener hardware was loose. Recommend tightening all fasteners.

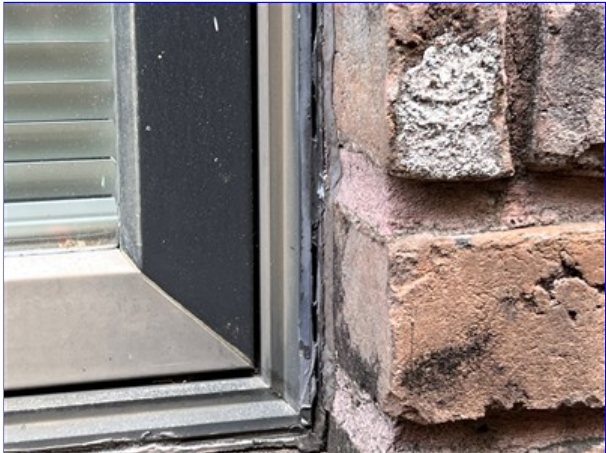
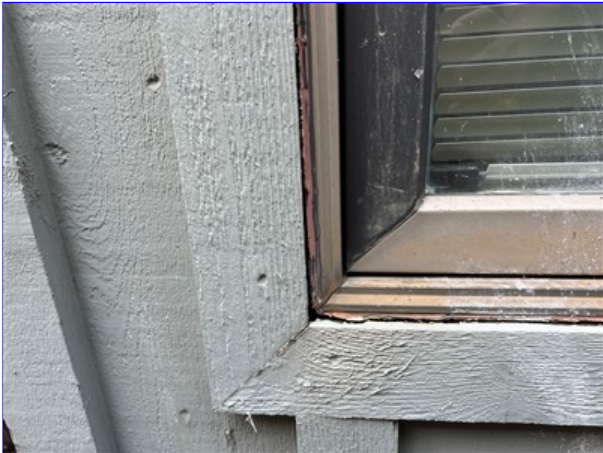
(1) Exterior perimeter sealant has deteriorated or was missing at some windows. Recommend correction.

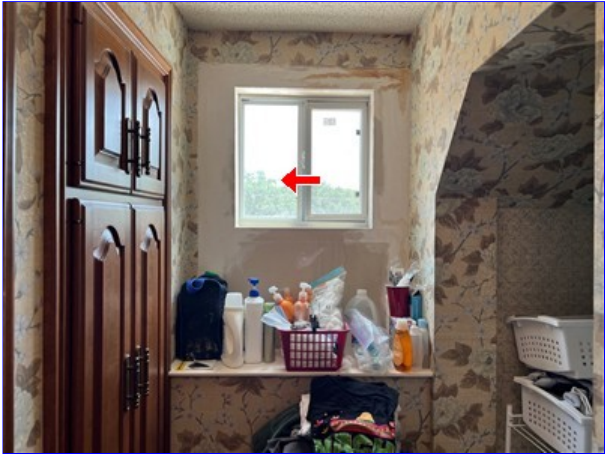
(3) At the upstairs hallway, bathroom, the window glass was broken. Recommend correction.

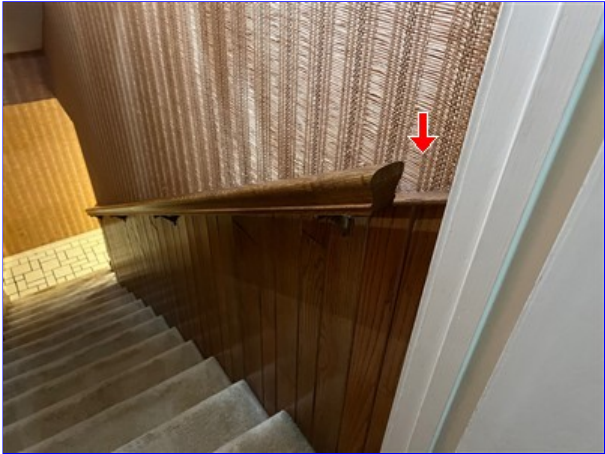
The handrail ends do not return to the walls. Open handrail ends can catch on clothes causing safety concerns on stairs.

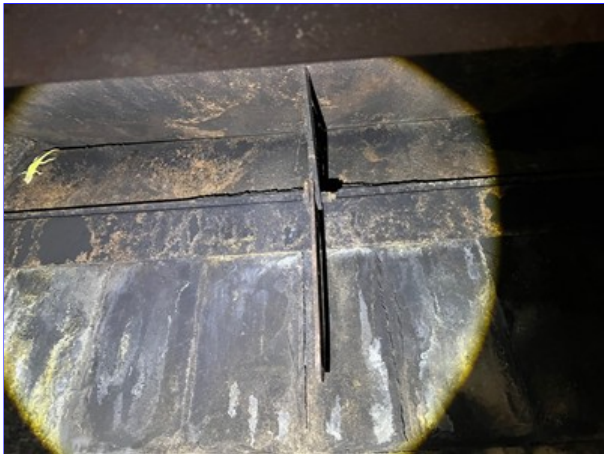
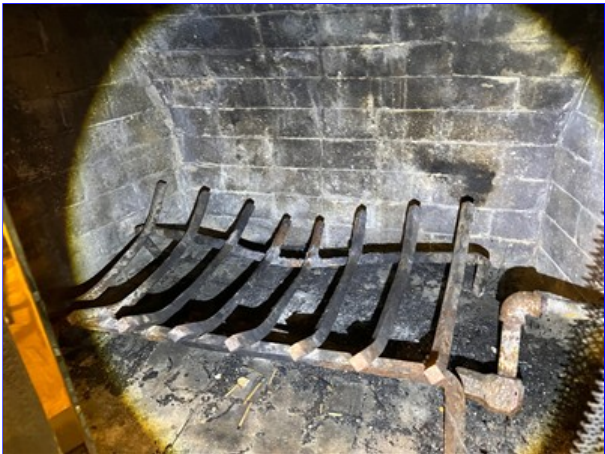
(1) The fireplace flue door was seized shut. Recommend correction before next use.

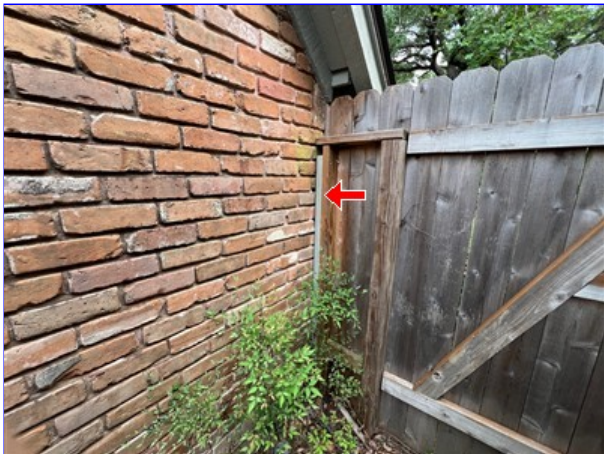
(2) At the left side of the home, the fence post against the exterior wall can be considered a conducive condition for wood destroying insects. Recommend correction.

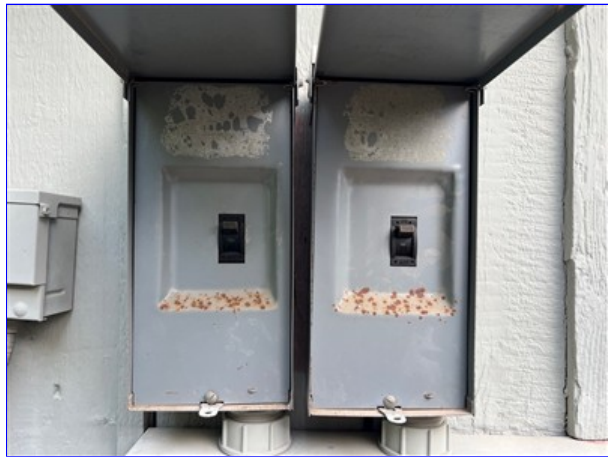
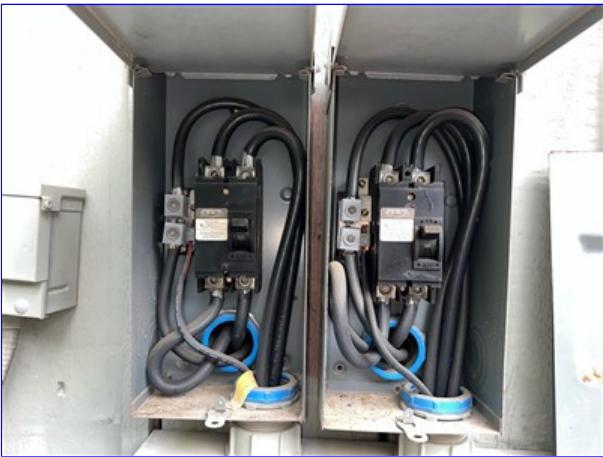
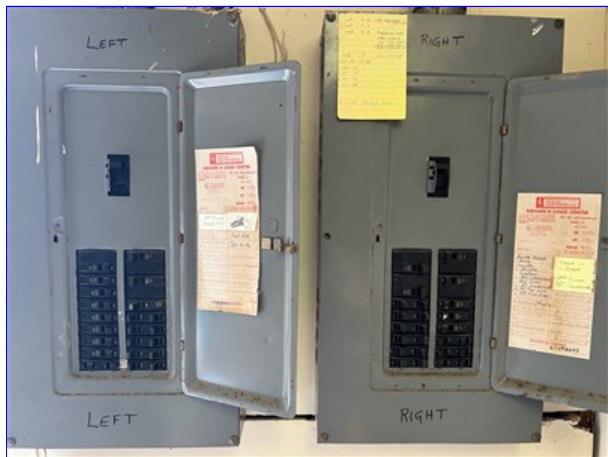
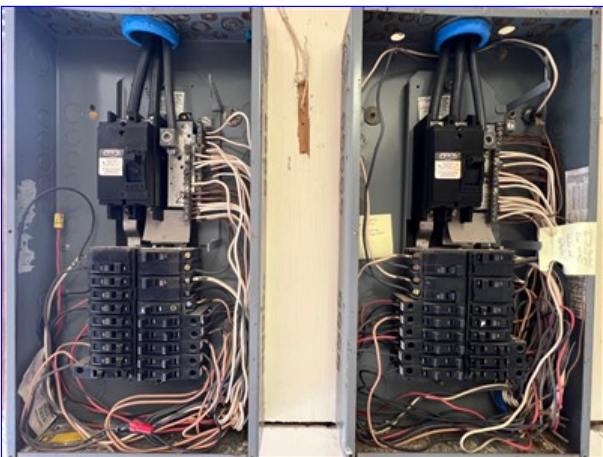
(1) The main disconnect and electrical service panels shown with dead front cover removed for inspection purposes.

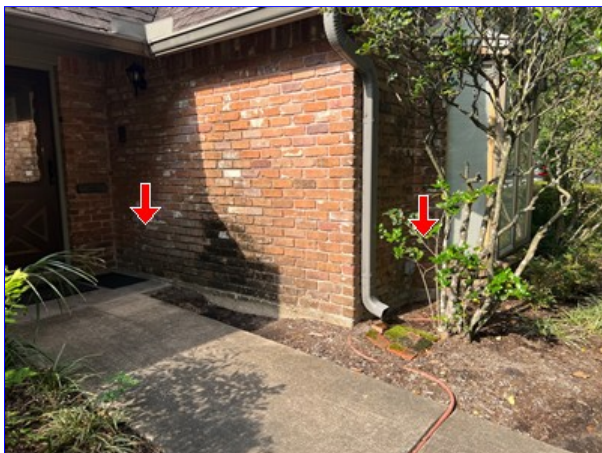
(2) Ground Fault Circuit Interrupters (GFCI's), were not observed to be installed in all required wet locations. GFCI's are intended to protect persons from accidental electrocution in locations susceptible to moisture. I recommend that you consult with their licensed electrician and consider upgrading all applicable locations to GFCI protection for current construction standards and personal safety reasons. Some locations observed: Exterior front door. Garage. Downstairs half bathroom. Upstairs hallway bathroom.

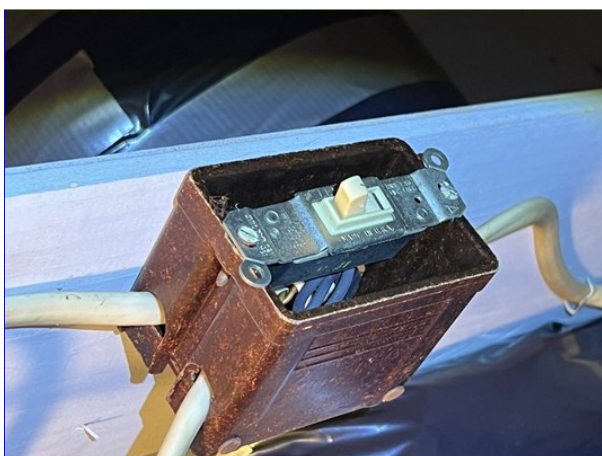
Garage attic

(3) There are damaged/missing receptacle/switch, cover plates. These plates should be replaced for safety reasons.

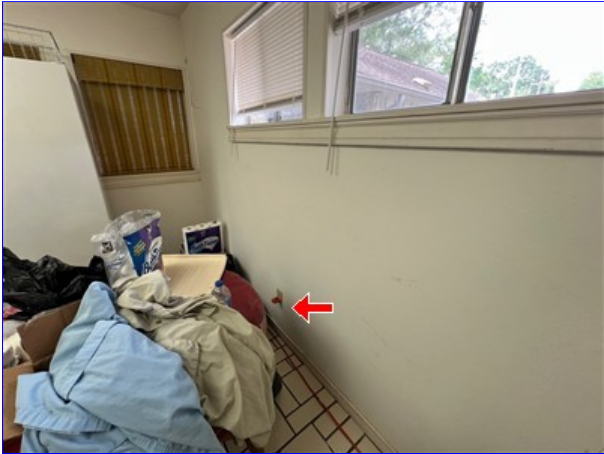
(6) Some outlets tested with no power. Recommend correction and further evaluation by a licensed electrician. Some locations observed:.. Laundry room.

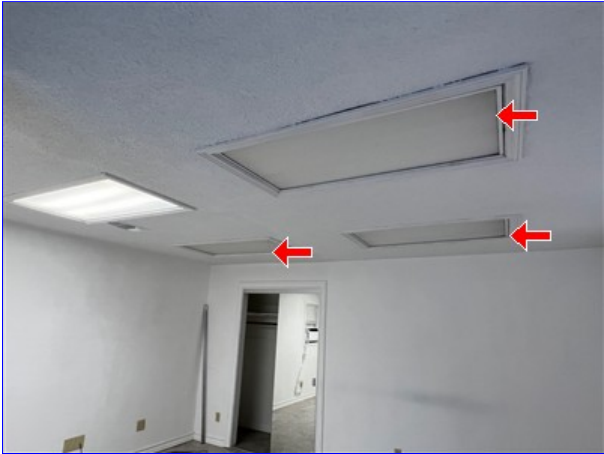
Garage apartment

(9) There are fixtures, that did not illuminate. This could simply be burned out lamps, or could indicate fixture or wiring problems.

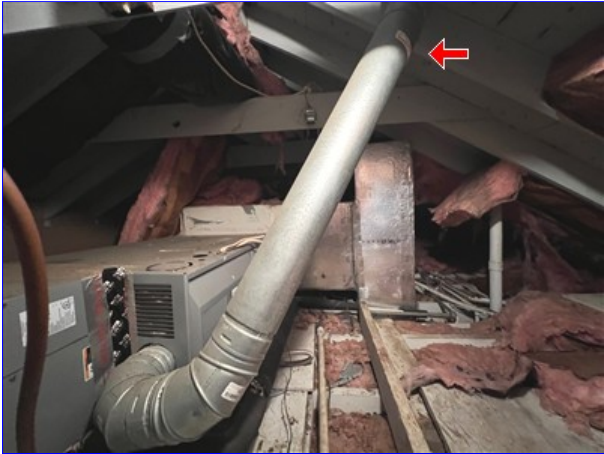
- (3) At the garage apartment, the furnace unit was turned off and return air plenum blocked intentionally. Per the owner, the unit is operational and can be made active. It is controlled by two thermostats for the same zone (Garage apartment, Sunroom living area)
- (4) At the gas line for the garage apartment furnace, a drip leg sediment trap was not observed. Recommend correction.
- (5) The furnace vent pipe was unsupported at the adjacent framing. Recommend correction.

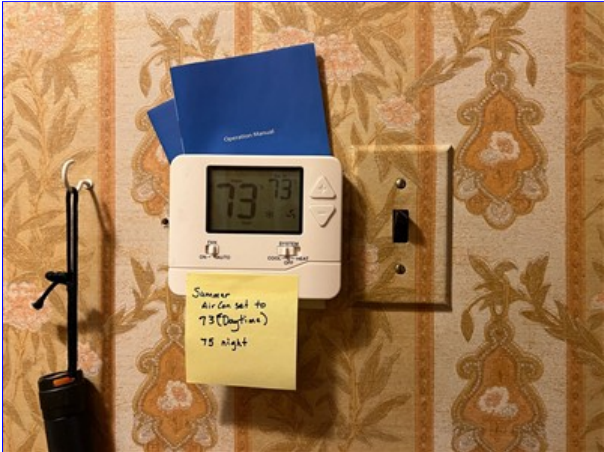
Hallway

- (4) An emergency cut off (float) switch, was not observed on the A/C auxiliary pans viewed from the attic space. An emergency cut off switch is recommend to prevent interior water damage in the event of an emergency condition involving the A/C condensate drains.
- (5) They two downstairs thermostat controllers work in tandem to operate the downstairs unit. It is a dual control single zone system. The wall switches next to the thermostat controllers open and close dampers to the bedroom spaces and the living spaces.

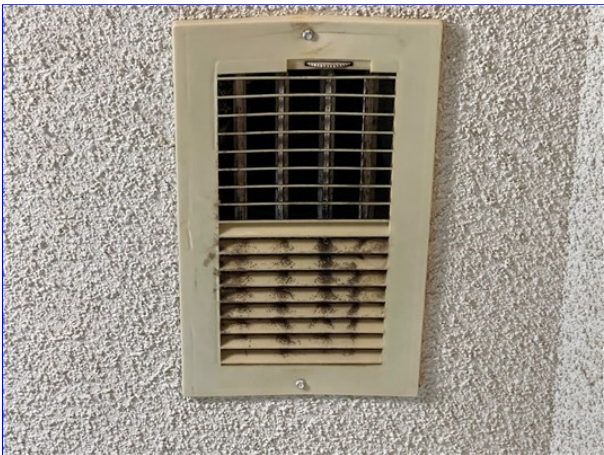
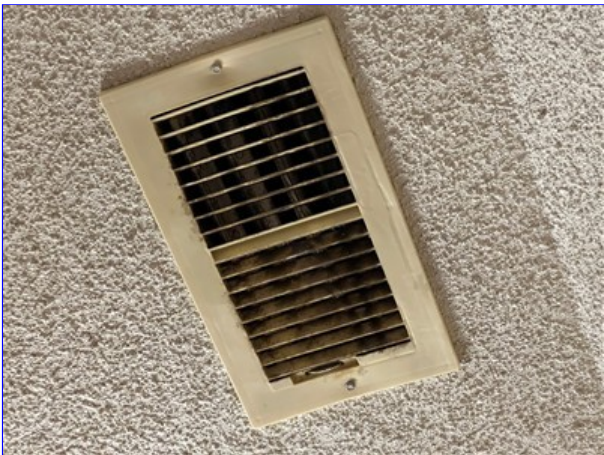
(1) Dirty supply vent registers were observed. Recommend correction and consulting a licensed HVAC contractor to evaluate further.

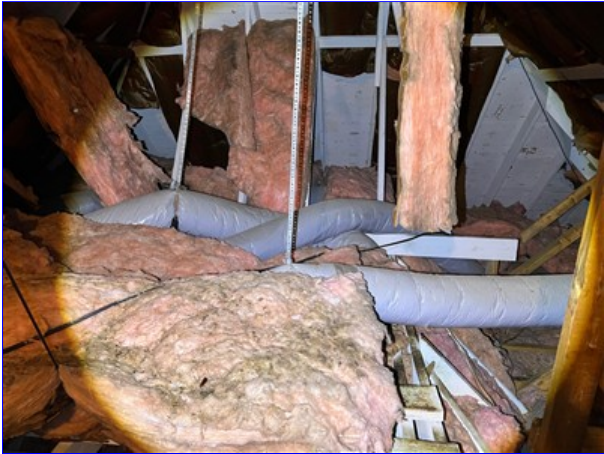
(2) Ductwork is not properly strapped and suspended above the attic floor.

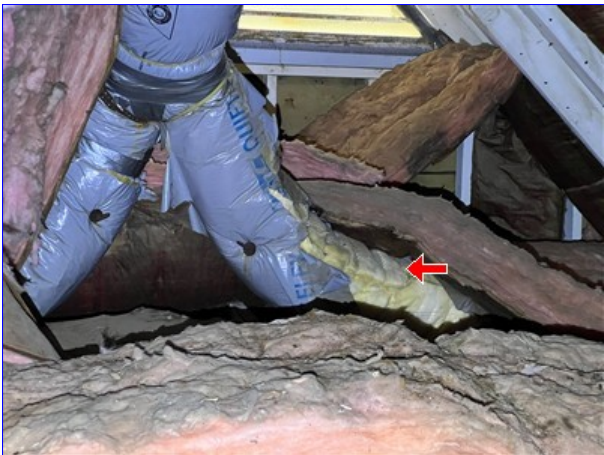
(3) Some air ducts were damaged and insulation exposed. Recommend correction.

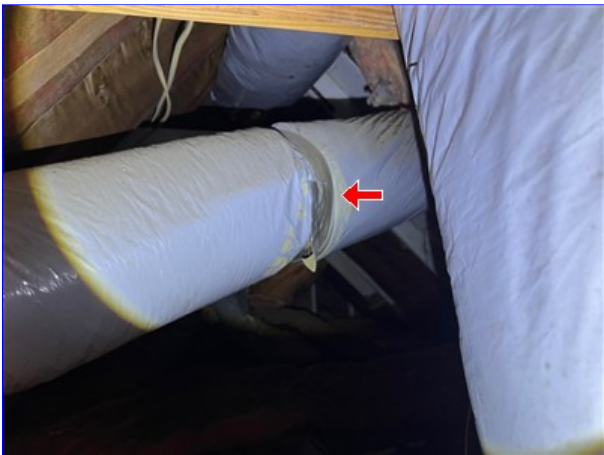
(4) Duct tape was observed used on the air ducts. This is an improper material for this type of installation. Recommend correction.

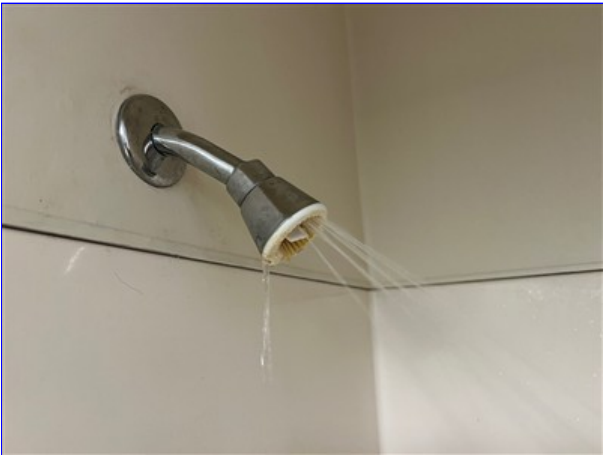
An indication of internal corrosion is reduced flow at plumbing fixtures. Today, most fixtures had functional flow.  
(2) Some drain stoppers were missing or not operable at some sinks/ tubs. Recommend correction.  
(3) At the garage apartment, the showerhead fixture water flow was partially blocked. Recommend repair or replacement.

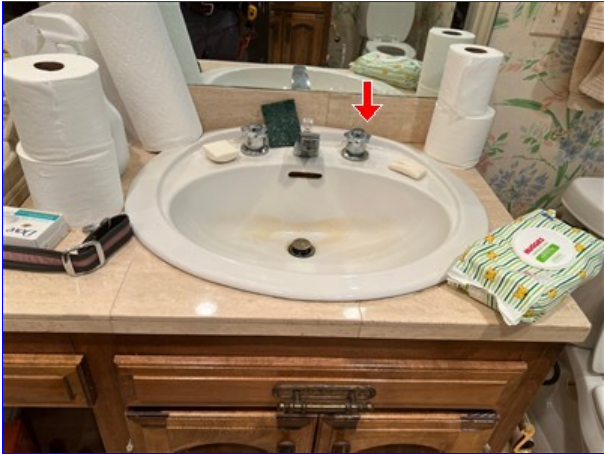
(4) At the primary bedroom half bathroom, there was no water flowing at the cold water valve. Recommend correction.
