# Inspection Report

**Property Address:**  
5443 Queensloch Dr  
Houston TX 77096

# PROPERTY INSPECTION REPORT FORM

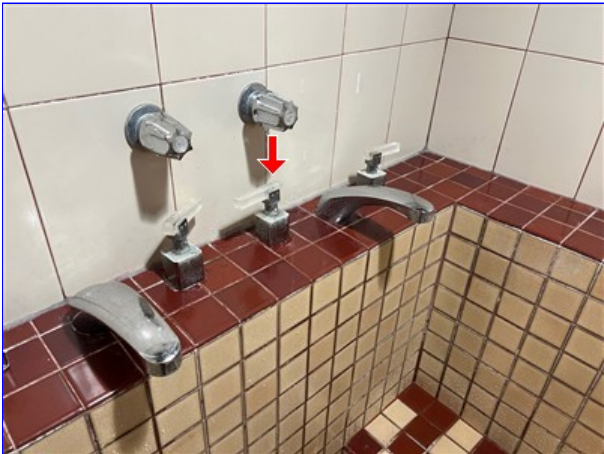
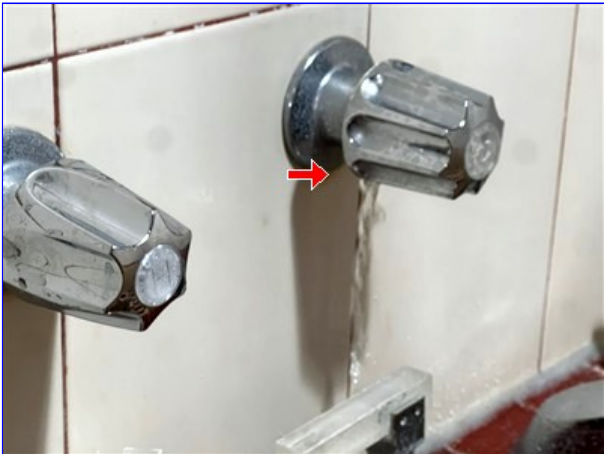
- (5) At the primary bathroom, the toilet was not sealed at the floor. Recommend correction.  
(6) At the hallway bathroom shower tub, the right side, hot water control valve had no water flow.

The cold water showerhead control valve was leaking water at the handle. Recommend correction.

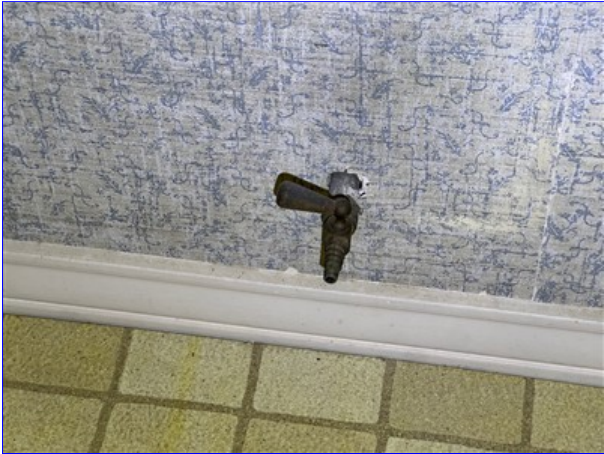
- (7) At the upstairs hallway bathroom, there was low pressure observed at the sink fixture. Recommend correction.  
(8) At the upstairs hallway bathroom, laundry area, the gas valve intended for a dryer was not capped. Recommend capping for safety purposes until installed at its intended appliance.

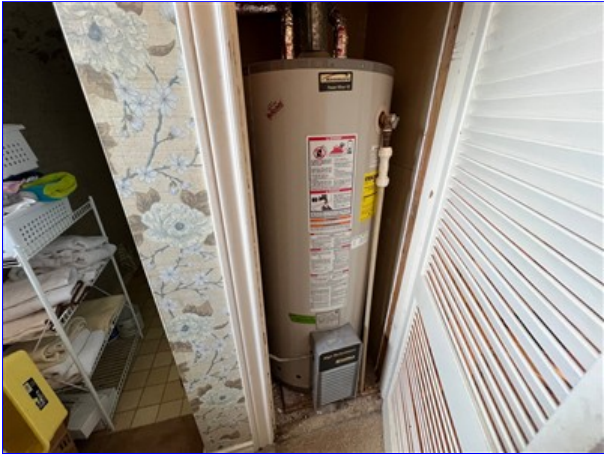
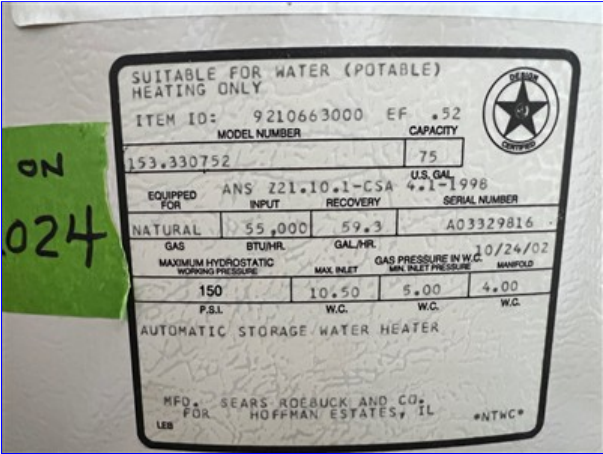
(2) The gas line to the water heater was missing a drip leg sediment trap. Recommend correction.

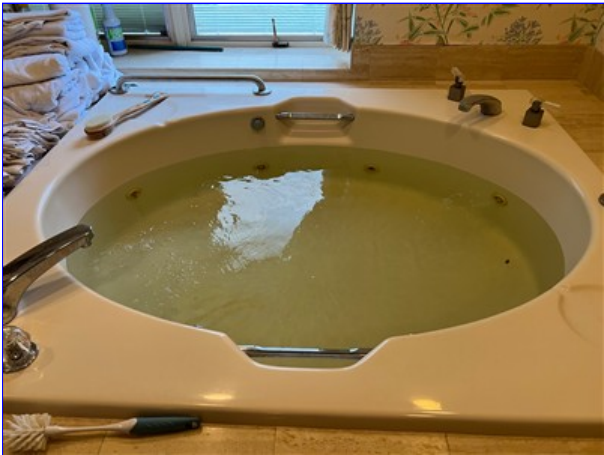
(1) The jetted tub turned on with normal controls. The jet pressure was low. Recommend consulting with a licensed electrician to evaluate further.

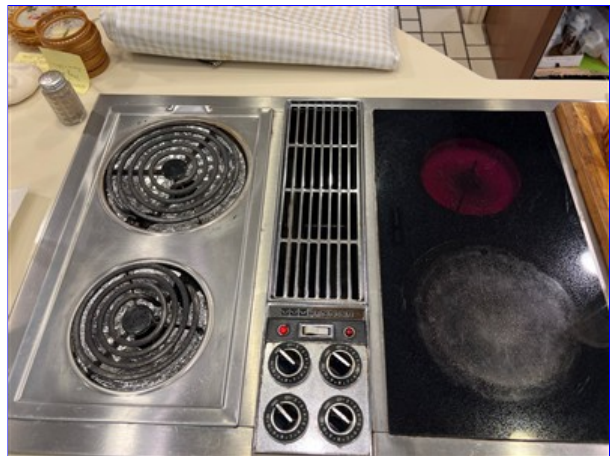
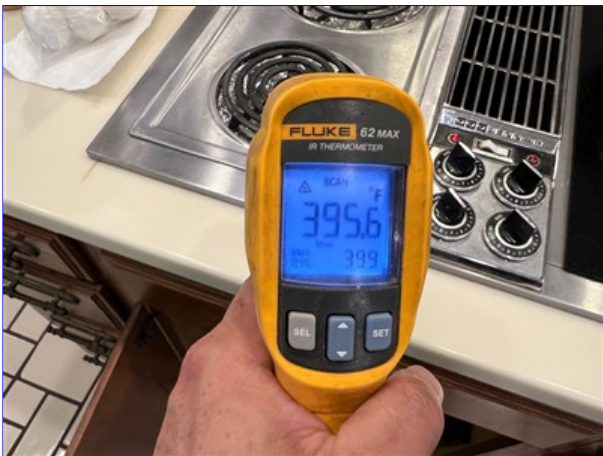
The burners appeared to operate normally.

The oven heated to normal temperature range when set to 350, the normal variance is +/- 25 degrees.

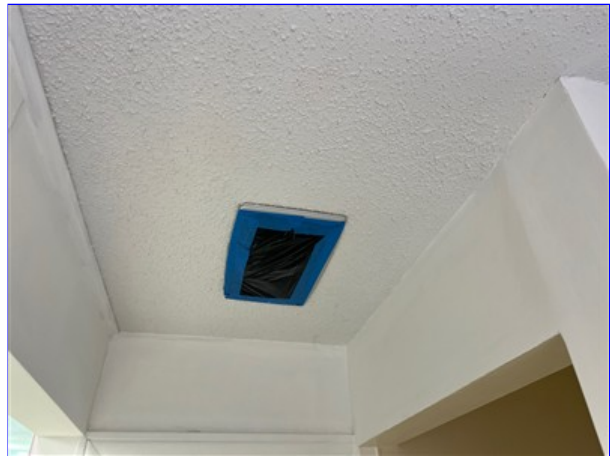
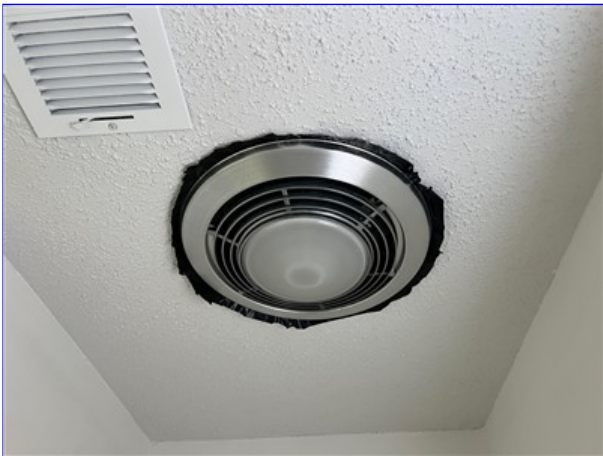
At the garage apartment, the exhaust fan vents were sealed with plastic. The units were quickly tested with the wall controls and did have power.
