# Inspection Report

**Property Address:**  
24902 Pavonia Lake Lane  
Tomball TX 77375

**House To Home Inspection**

# PROPERTY INSPECTION REPORT FORM

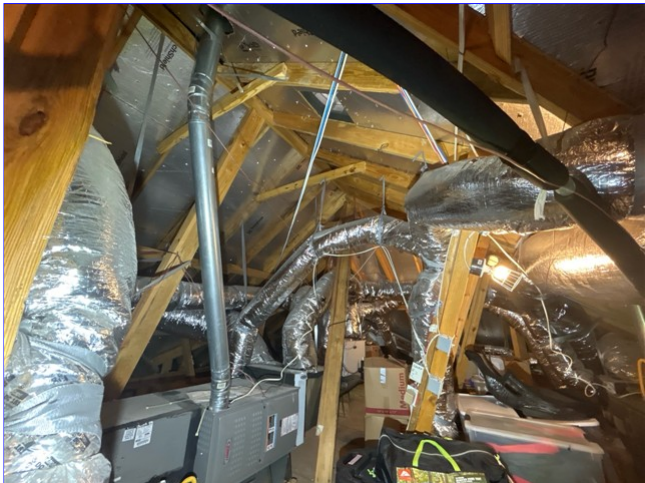
There were no deficiencies detected concerning the roof structure at the time of the Inspection. All visible and accessible roof structure appeared to be the correct size and placed properly in the attic space.

C. Item 1 (Picture) View of roof structure from attic space

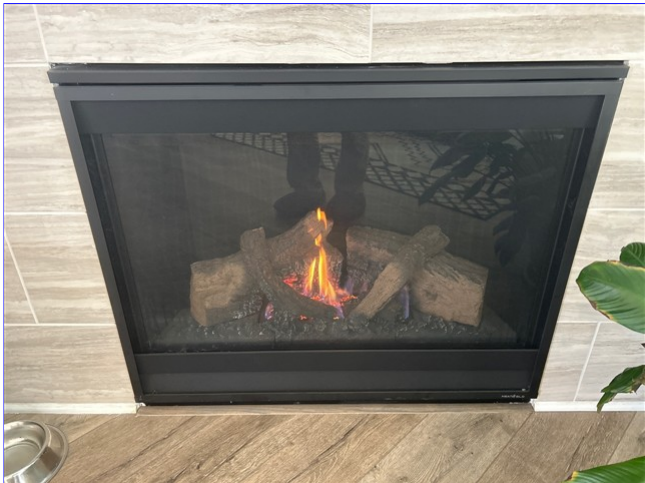
No deficiencies detected at the time of the inspection. The fireplace was lit to inspect for function. The fireplace damper was opened and closed to inspect for function as well as inspect for proper safety such as a damper stop.

J. Item 1 (Picture) View of the fireplace lit for inspection

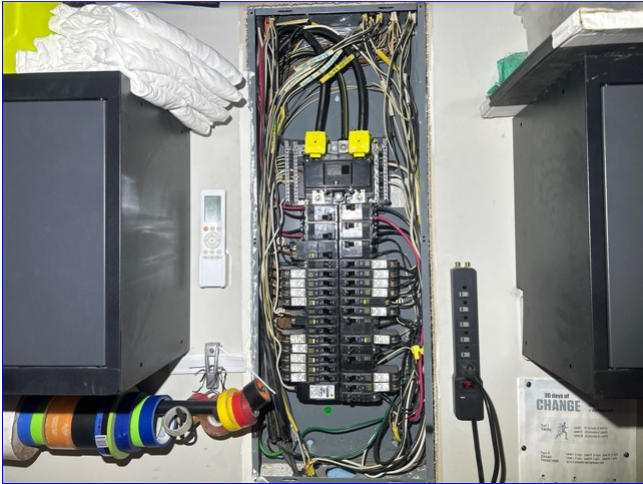
A. Item 4 (Picture) View of breaker panel open for inspection

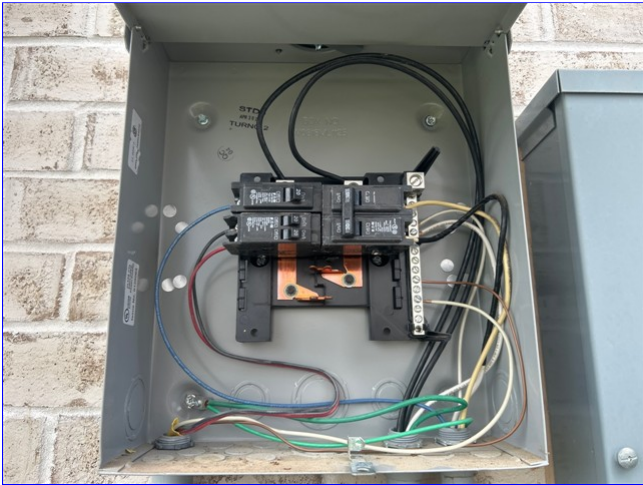
A. Item 5 (Picture) View of pool equipment sub panel open for inspection

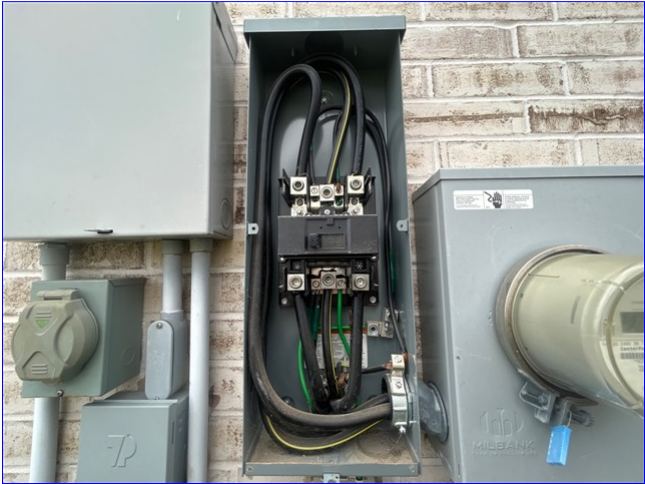
A. Item 6 (Picture) View of service disconnect open for inspection

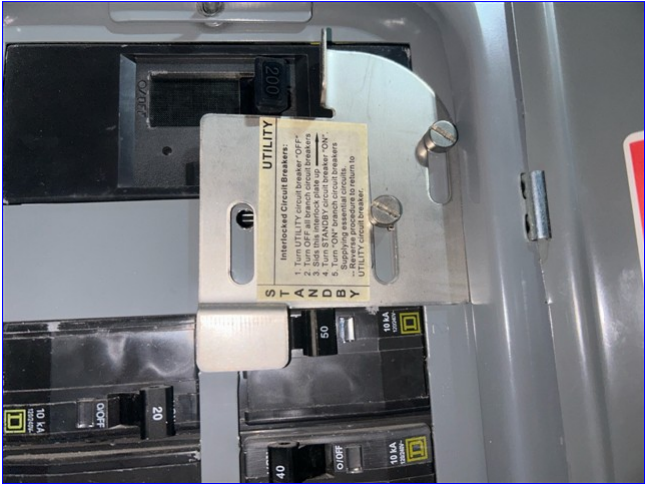
Comments:  
The home has a generator interlock kit installed which is used to connect a portable generator to the homes electrical distribution system. This system and its associated components are considered outside of the scope of the home inspection and were not inspected. For a more thorough inspection of this system I recommend consulting with a licensed electrician as needed.

C. Item 1 (Picture) View of 50 amp generator interlock kit installed in breaker panel

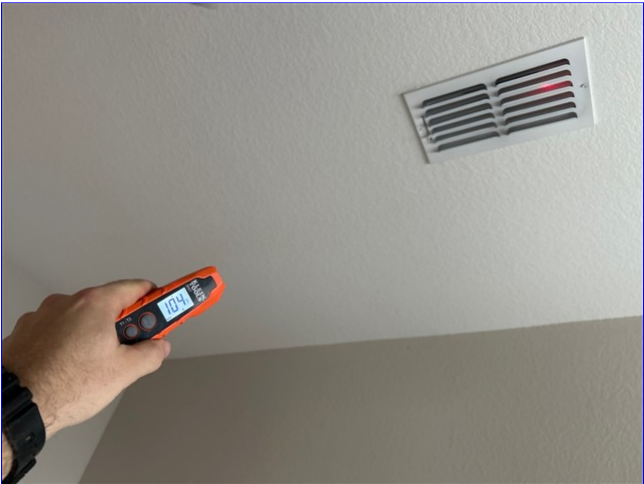
(1) There were no deficiencies detected at the time of the inspection concerning the function of the heating systems. The heating system produced warm air as intended. Heating systems do have limited visibility to the heating elements/heat exchangers and as a result the heat element/ heat exchangers could not be 100% checked for defects. For a more detailed inspection of the heating system, I recommend contacting a licensed HVAC technician.

A. Item 1 (Picture) View of the measured supply air temperature from heating system 2 at the 2nd floor supply register

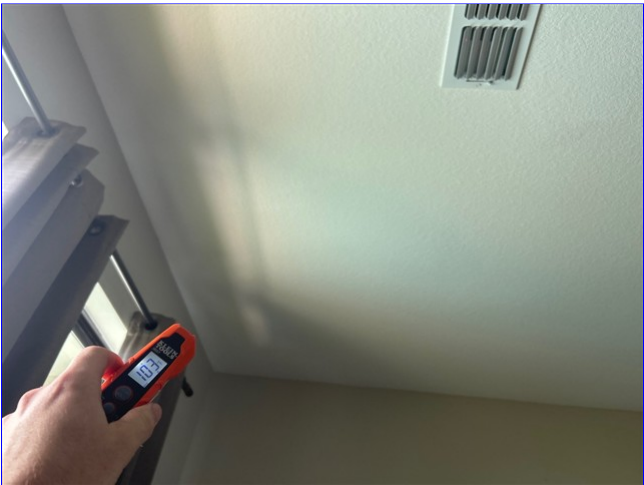
A. Item 2 (Picture) View of the measured supply air temperature from heating system 1 at the 1st floor supply register

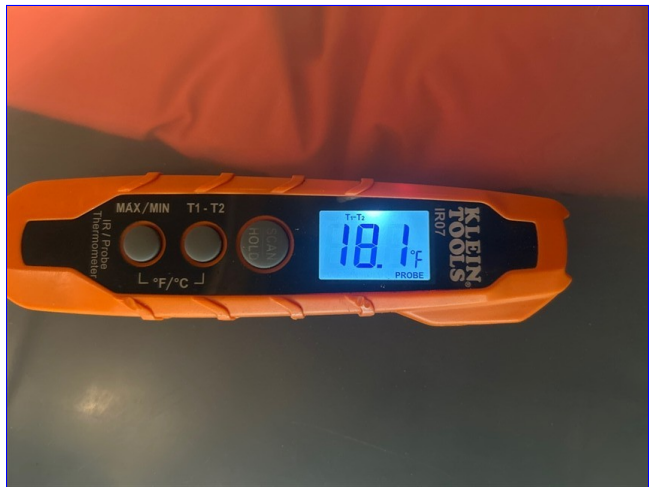
Delta on a correctly functioning cooling system should approximately be between 15 and 22 Degrees F depending on humidity and other factors.

B. Item 3 (Picture) View of the measured delta T across the indoor component of cooling system 1

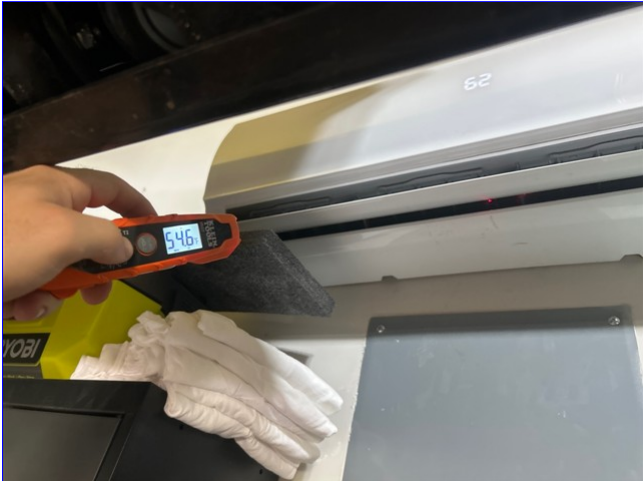
(5) The home has a mini split air condition system installed in the attached garage. A limited inspection of this system was performed and the system appears to be working. I recommend consulting with a licensed HVAC technician for a more thorough inspection as needed.

B. Item 4 (Picture) View of the measured temperature of the cooled air produced by the mini split

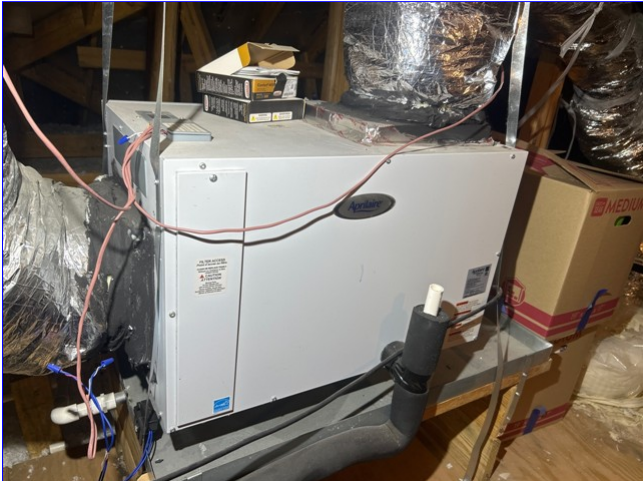
(2) The HVAC system appears to have a whole home dehumidifier installed. This system is considered out of the scope of this inspection. I recommend consulting with a licensed and qualified HVAC technician as needed for a more thorough evaluation of the system.

D. Item 2 (Picture) View of whole home dehumidifier installed in attic space

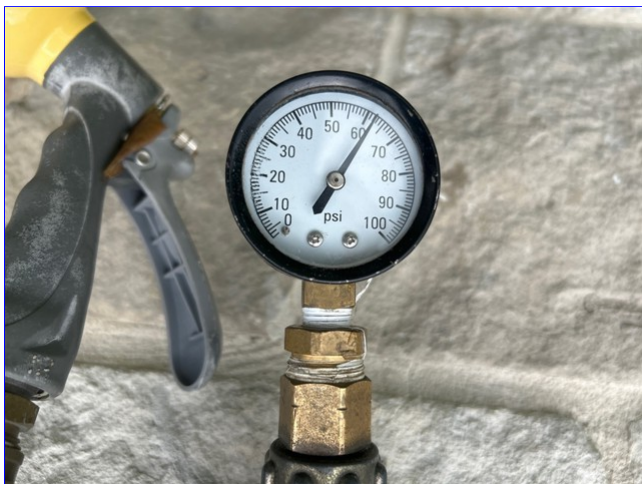
(3) The water pressure to a home should be between 40 PSI and 80 PSI. The water pressure to this home was measured at 62 PSI and this water pressure is within the acceptable pressure range.

A. Item 3 (Picture) View of the measured water pressure

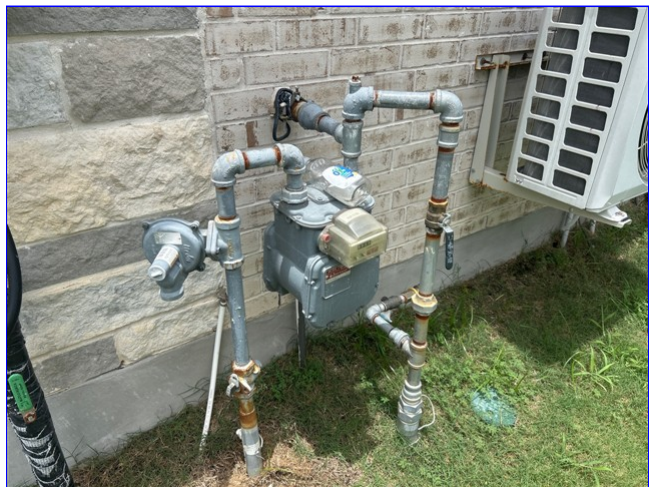
There were no deficiencies observed in the gas distribution systems throughout the home. A bonding wire was observed and appeared to be properly installed. A tracer wire was present at the gas meter. All visible gas distribution piping throughout the home appeared to be properly supported, secured and in fair condition.

E. Item 1 (Picture) View of the gas meter at the right side of the home

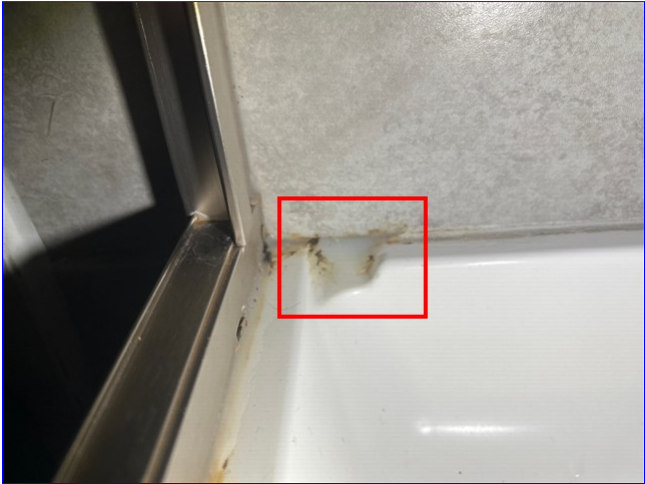
(1) The weep holes were blocked in the shower enclosures of in two or more of the bathrooms around the home. The weep holes provide a pathway for water that gets behind the shower enclosure to drain out. This prevents moisture damage from occurring to the wall behind the shower enclosure. While no moisture damage was detected during the inspection, I recommend further evaluation and repair by a qualified contractor.

F. Item 1 (Picture) View of block weep holes in the second floor jack and jill bathroom shower enclosure

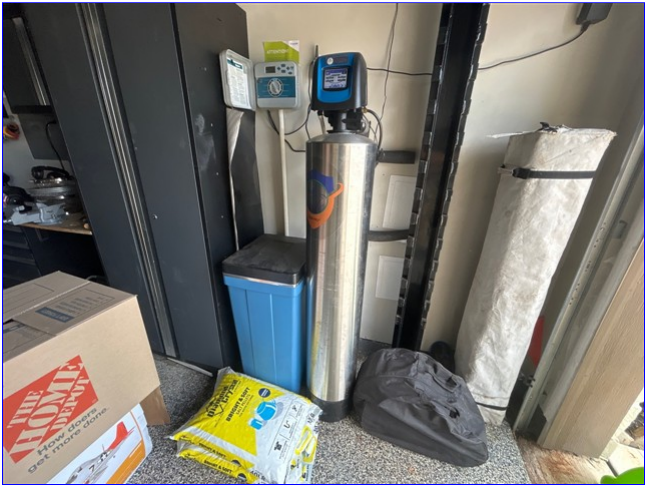
(2) The home has a whole home water softening system installed in in the garage. The system did not appear to be leaking and the brine tank had salt tabs in it. No water testing or quality sampling is performed and this system is outside of the scope of this inspection. For a detailed inspection I recommend contacting a qualified and licensed plumber.

F. Item 2 (Picture) View of water softener installed in garage

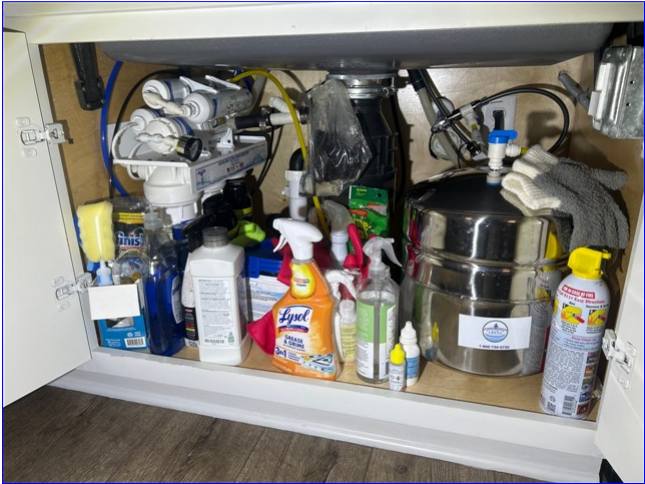
(3) There is a water filter present at this house. The filter appeared to be in working order, however checking filters is beyond the scope of the home inspection as far as any testing. I recommend changing the filter upon move in.

F. Item 3 (Picture) View of drinking water filtration system installed under kitchen sink

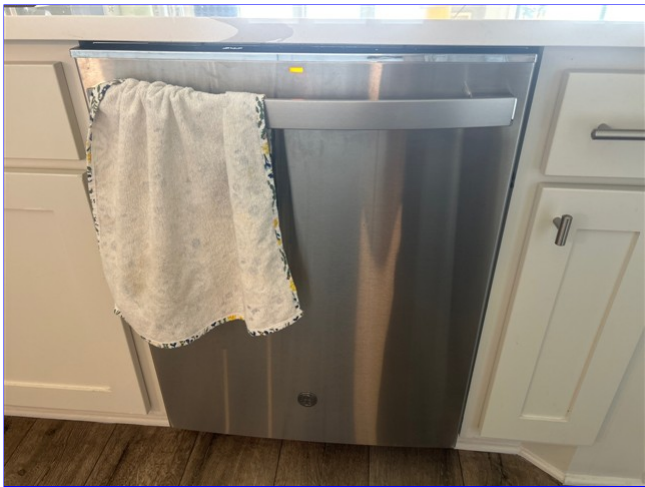
The dishwasher was inspected for rust on the interior of the dishwasher and dish racks. The dishwasher was also inspected for proper door function and soap dispenser operation. A function check was performed on the dishwasher and the appliance was run for one complete cycle on normal wash and heat dry mode. There were no deficiencies detected concerning the function of the dishwasher at the time of the inspection.

A. Item 1 (Picture) View of the dishwasher

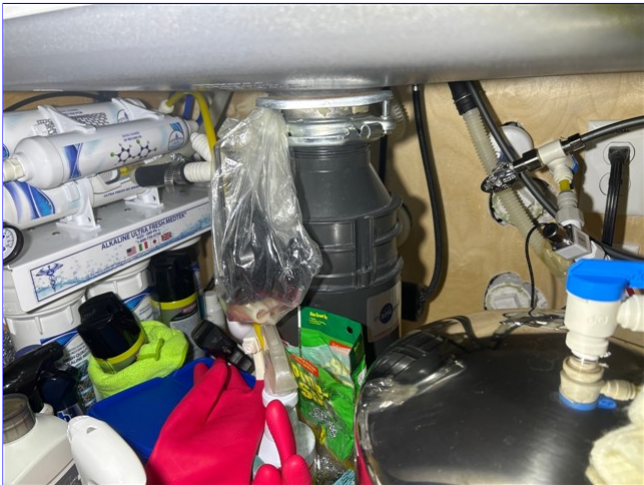
There were no deficiencies detected concerning the function of the food waste disposer at the time of the inspection. The food waste disposer was turned on and the grinding hammers were inspected for freedom of movement. The disposer was also inspected for the proper wiring and plumbing as well as for any possible water leaks.

B. Item 1 (Picture) View of the garbage disposal

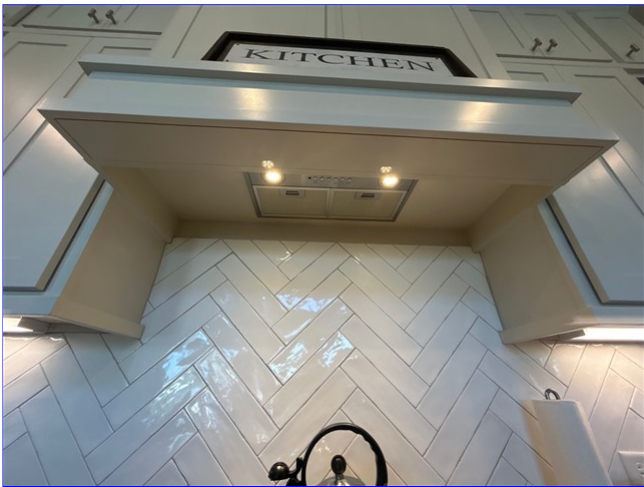
There were no deficiencies detected concerning the function of the range exhaust vent at the time of the inspection. The range exhaust vent was tested on all available fan speeds and the light was tested on all available settings. The range exterior vent exit was also inspected for function and defects.

C. Item 1 (Picture) View of the range vent hood

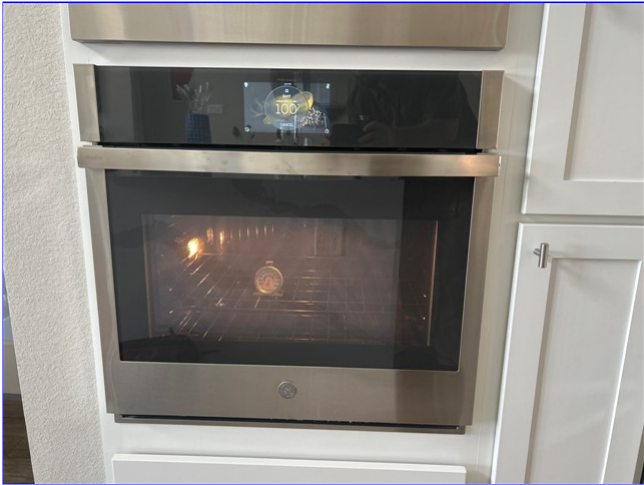
**Comments:**  
(1) There were no deficiencies detected concerning the function of the oven at the time of the inspection. The oven was set to 350 Degrees F and given time to preheat. The oven temperature was then measured with a thermometer. At the time of the Inspection the thermometer temperature measurement and the oven temperature were within 25 degrees of each other and this is considered an acceptable tolerance.

D. Item 1 (Picture) View of the oven

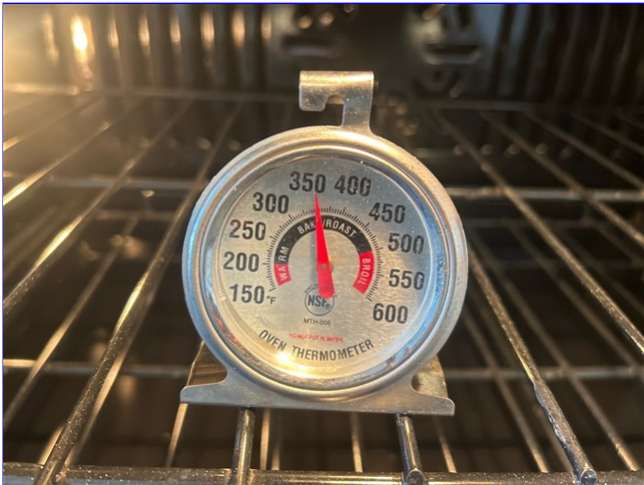
D. Item 2 (Picture) View of the measured oven temperature

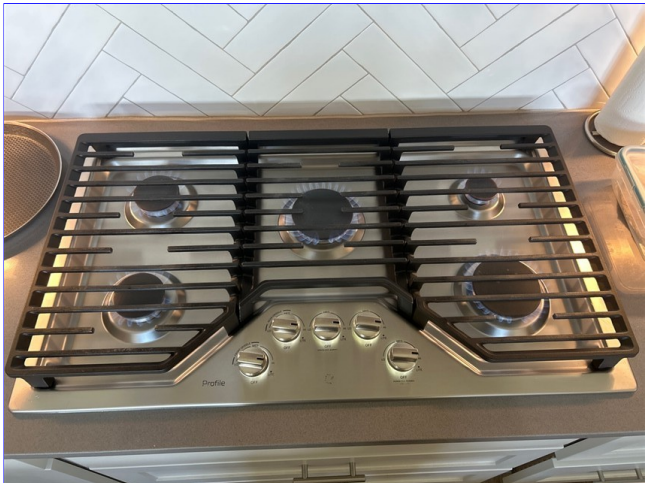
(2) There were no deficiencies detected concerning the function of the cooktop at the time of the inspection. The cooktop burners were tested on high and low settings. The gas shut off was within 6' of the cooktop as required.

D. Item 3 (Picture) View of the gas range with burners lit for inspection

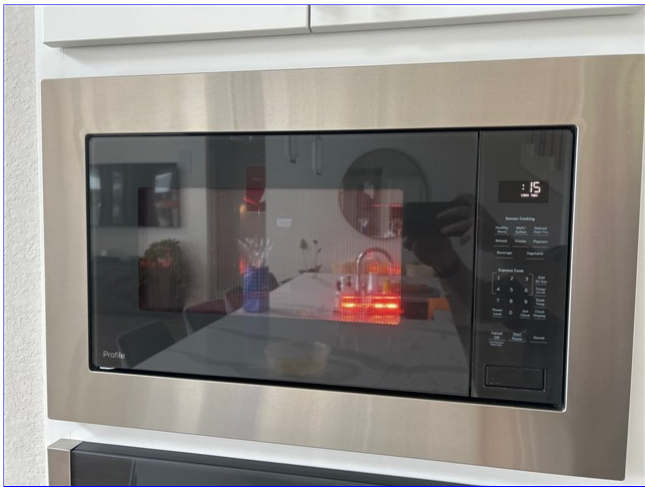
There were no deficiencies detected concerning the function of the microwave at the time of the inspection. The microwave was tested for function using a microwave detector/tester to test for the presence of microwaves and the microwave pattern within the microwave. The turn table was also inspected for function.

E. Item 1 (Picture) View of the microwave

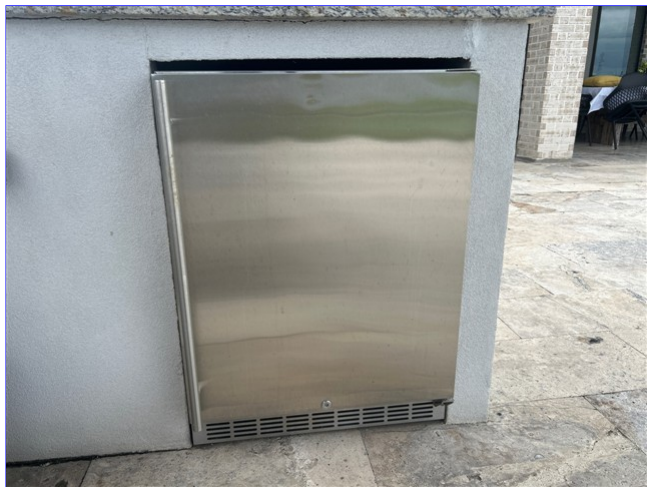
- (1) This house comes equipped with a outdoor refrigerator, RCS brand. The refrigerator appeared to be functioning as intended during the inspection. The freezer/refrigerator sections were both cold, there was ice in the ice maker, and the ice/water dispenser functioned properly at the time of inspection.

I. Item 1 (Picture) View of the outdoor refrigerator

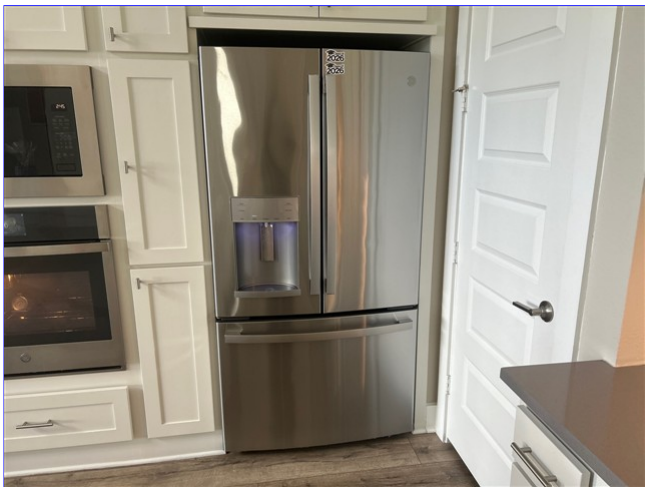
- (2) This house comes equipped with a refrigerator, GE brand. The refrigerator appeared to be functioning as intended during the inspection. The freezer/refrigerator sections were both cold, there was ice in the ice maker, and the ice/water dispenser functioned properly at the time of inspection.

I. Item 2 (Picture) View of the refrigerator

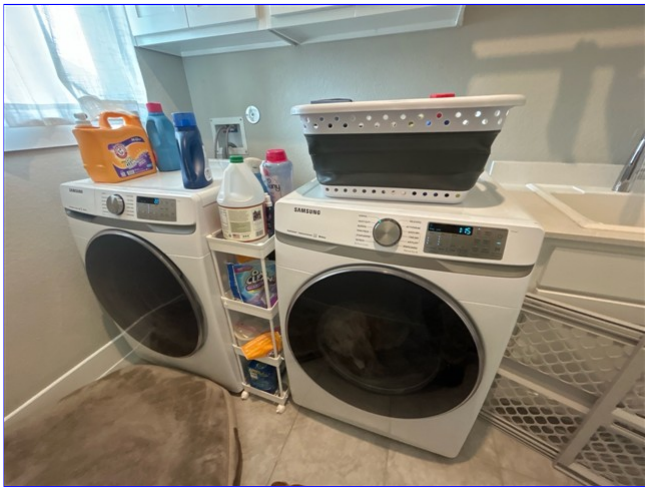
(3) This house comes equipped with a washer and dryer, Samsung brand. The washer was activated and ran through one complete normal cycle and appeared to be functioning as intended during the inspection. The dryer had the current owners possessions inside and was therefore not tested during the inspection

I. Item 3 (Picture) View of the washer and dryer

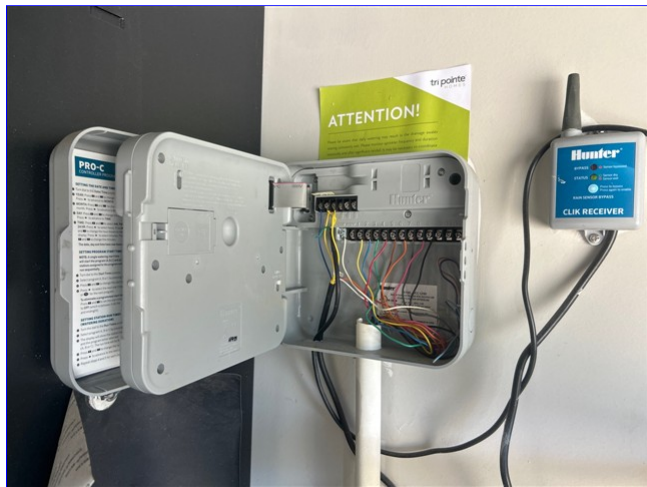
inspection. A backflow preventer was present and appeared to be installed correctly. A rain/moisture sensor switch was also detected during the inspection. The property has a 9 zone sprinkler system. All the sprinkler heads in all zones performed as intended. Some of the spray heads may need to be adjusted to get the best coverage and to prevent them from spraying unwanted areas such as driveways, sidewalks, walls and fences.

A. Item 1 (Picture) View of the sprinkler controller in the garage open for inspection

I recommend consulting with a qualified landscape and irrigation contractor as needed.

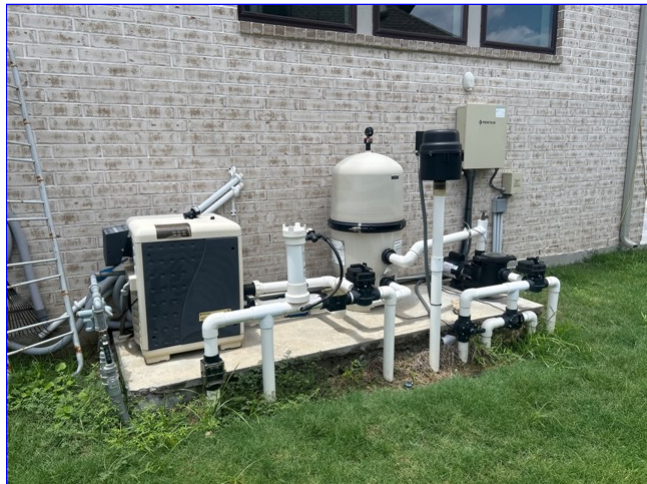
This home has a pool installed in the back yard. This system was inspected by a third party contractor and I recommend reviewing their report for details about the condition of this system and its associated components at the time of inspection.

B. Item 1 (Picture) View of pool equipment installed at the right side of the home

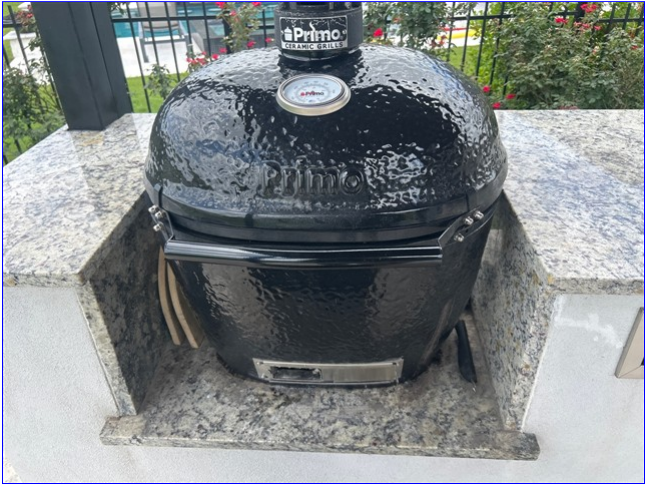
(2) There were no deficiencies observed at the time of the inspection regarding the solid fuel smoker or the solid fuel grill.

H. Item 3 (Picture) View of solid fuel smoker

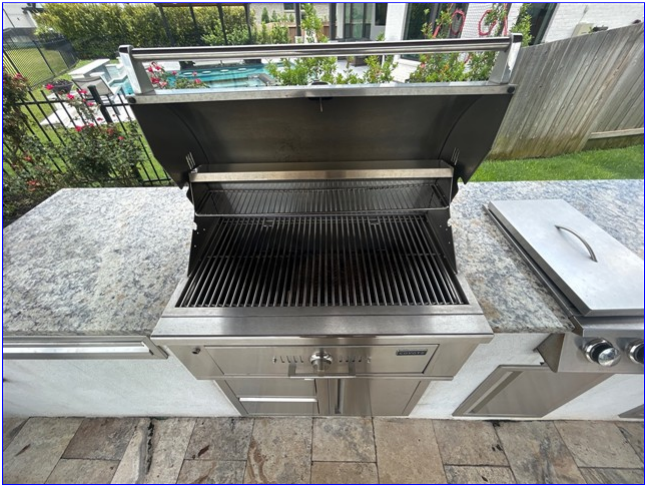
H. Item 4 (Picture) view of solid fuel grill
