## FOUNDATION INSPECTION

5407 Fleming Rock Ln  
Fulshear, TX 77441

08/04/2026

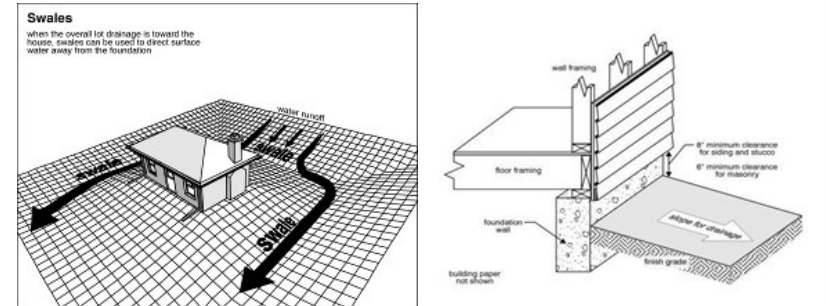
Perimeter Grading/Drainage: Appeared Adequate

The perimeter drainage around the property appeared to generally be adequate. It could not be determined with certainty if water would pool at any localized low areas around the property. Further investigation with the homeowner is recommended to determine if there are any drainage problems or water that ponds on the property after a rain.

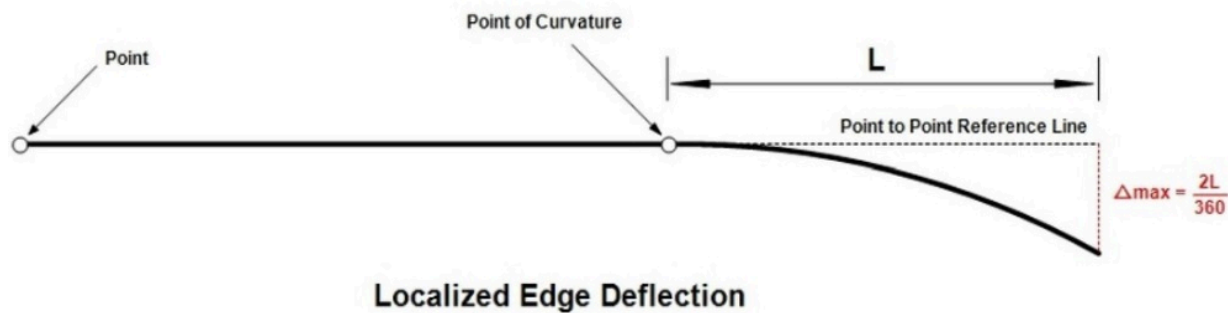
#### Foundation Deflection Analysis - Single: Edge Deflection Analysis - Some Deflection - OK

In accordance with the "Guidelines for the Evaluation and Repair of Residential Foundations" Version 3 by the Texas Section of the American Society of Civil Engineers (ASCE), we looked at our graphs of the actual shape of the foundation and determined that the deflection curve of the foundation most closely resembles the localized edge-condition deflection described in the ASCE Guidelines rather than overall deflection or tilt deflection. Therefore, our analysis of this foundation will use the recommended Guidelines for localized edge-condition deflection.

According to the ASCE Guidelines, the evaluation of localized **localized edge-condition deflections** shall be evaluated as a cantilevered member (allowable deflection = one inch deflection in a 15-foot horizontal distance ( $2L/\Delta = 360$  per the building code)).

From the point of curvature located at the foyer to the study ( $L = 16$  feet), the maximum allowable deflection is 1.07 inches. We calculated a deflection of 0.75 of an inch at the time of inspection across this span, which is **less than the maximum allowable deflection, and is acceptable**. This observation can be observed along the **Red Line** in the sketch below.
