## RESIDENTIAL INSPECTION REPORT

1130 Twin Deer Ln  
Canyon Lake, TX 78133

# PROPERTY INSPECTION REPORT FORM

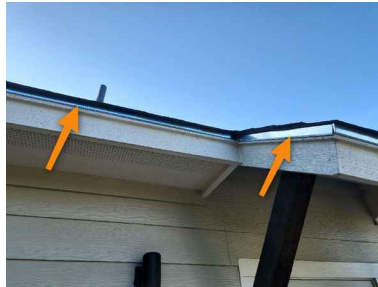
Deficiencies with the drip edge were present at the time of inspection. Evaluation and remediation is recommended.

For Example: Unpainted Drip Edge Flashings

Recommendation: Contact a qualified roofing professional.

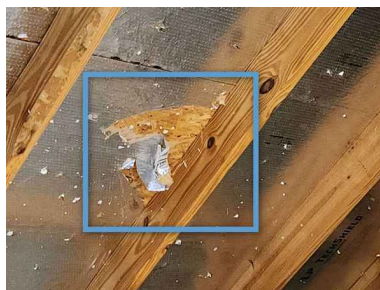
Attic

One or more areas of the radiant barrier was Loose or damaged. This condition reduces the effectiveness of the barriers ability to reduce heat buildup. Evaluate and remedy as needed.

Recommendation: Contact a qualified professional.

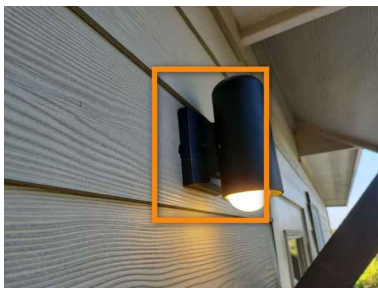
One or more areas were not properly sealed/caulked. Most exterior sealants have a lifespan of 5 to 8 years and should be regularly maintained with that lifespan in mind. Evaluation and remediation is recommended.

For Example:Seal Around Light Fixtures

Recommendation: Contact a qualified professional.

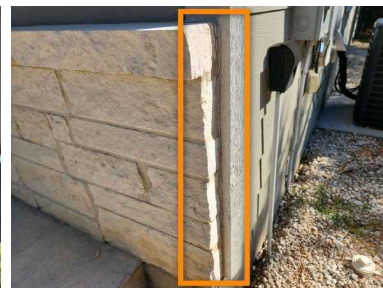
For Example:Seal Trim Boards

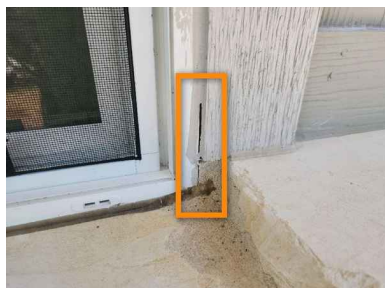
For Example:Seal Around Windows

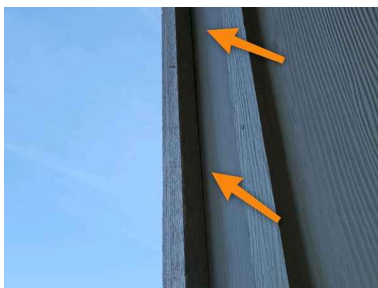
For Example:Seal Trim Boards

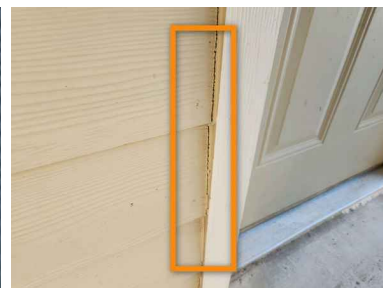
For Example:Seal Door Trim

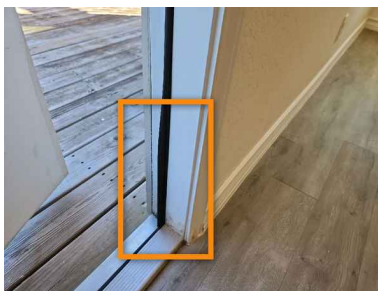
Primary Bedroom Balcony

Door was missing standard weatherstripping. This can result in significant energy loss and moisture intrusion. Evaluation and remediation is recommended.

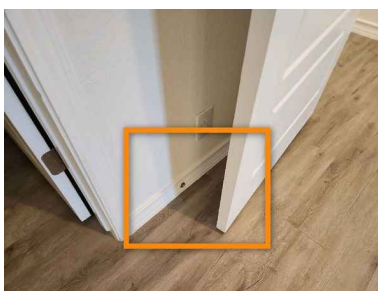
Missing Door Stopper Primary Bedroom

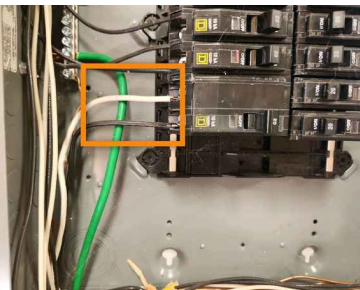
Garage Electrical Panel

**2: Missing Knockouts**

Safety "knockouts" were missing from the panel cover. Evaluation and/or remediation by a licensed electrician is recommended.

Recommendation: Contact a qualified electrical contractor.

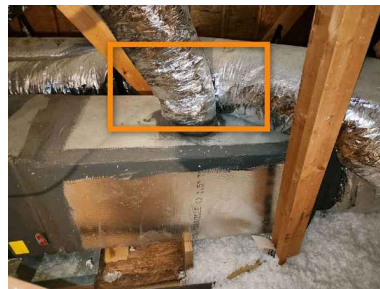
At the time of inspection one or more defects were present in the duct work. Evaluation and remediation as needed.

For Example:Ducts in Contact in the Attic

Recommendation: Contact a qualified professional.

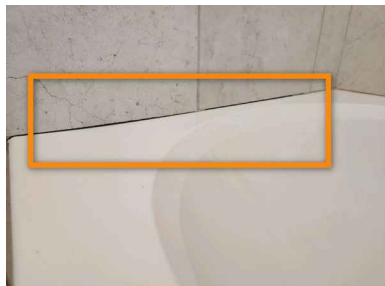
Hall Bathroom

**3: Shower/Tub: Missing/Deteriorated Caulking or Grout****☞Recommendation**

Evaluation and remediation is recommended.

Recommendation: Contact a qualified professional.

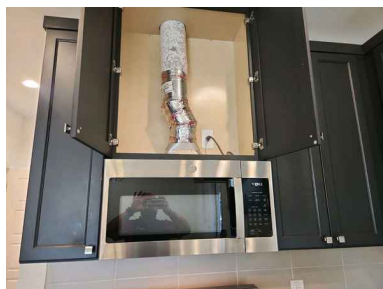
## 1: Vents to Exterior and Recirculates

When vented to the exterior the exhaust fan should not also recirculate. Evaluation and remediation is recommended.

Recommendation: Contact a qualified professional.
