Lone Star Stucco, LLC

## Moisture Assessment Report

2409 Langston Street

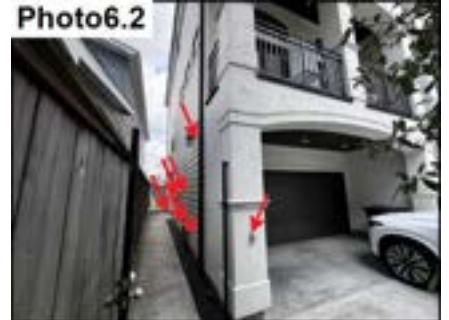
Photo6.2

- The penetration sealants are aged in this location. The inspector suggests to have a qualified waterproofing contractor seal this area in an effort to prevent moisture intrusion. Please refer to photos #6.2, #6.3, #6.4, #6.5, #6.6, #7.1, #7.2, #7.3 and #7.4 for more detail.

Penetration Sealants / Seal

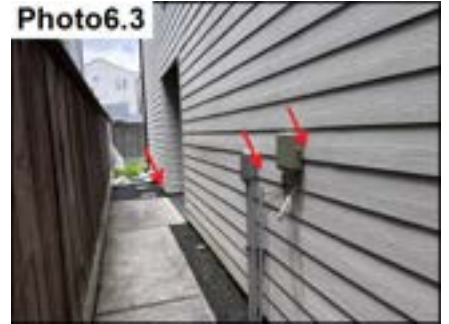
Photo6.3

Penetration Sealants / Seal

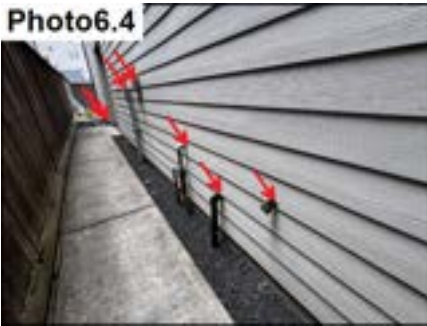
Photo6.4

Penetration Sealants / Seal

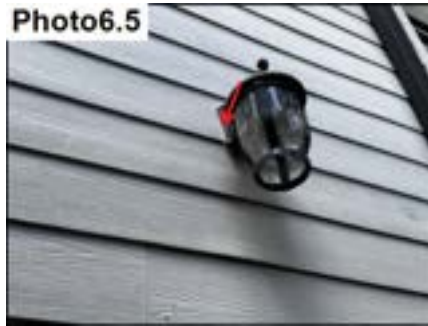
Photo6.5

Penetration Sealants / Seal

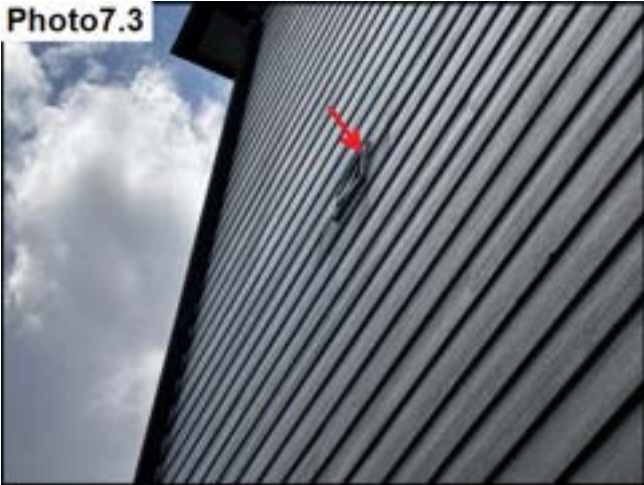
Photo7.3

Penetration Sealants / Seal

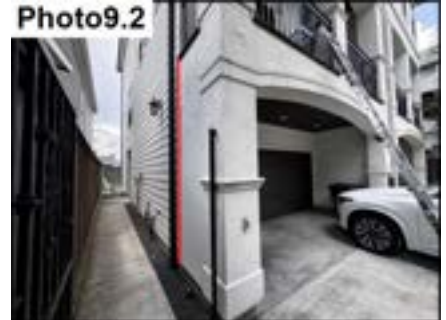
Photo9.2

- Siding/stucco termination sealants are aged or separated at this location. The inspector suggests to have a qualified waterproofing contractor further assess and seal this area with a low modulus sealant in an effort to prevent moisture intrusion. These types of sealants are of high quality and compatible with stucco and other termination points. Please refer to photos #9.2, #9.3, #9.4, #9.5 and #9.6 for more detail.

Siding & Stucco Termination / Seal

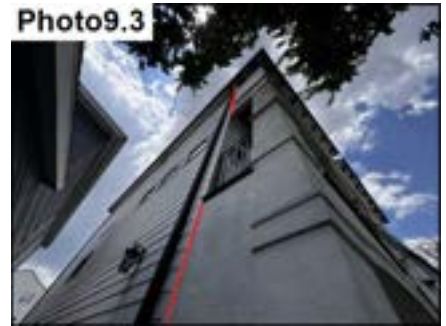
Photo9.3

Siding & Stucco Termination / Seal

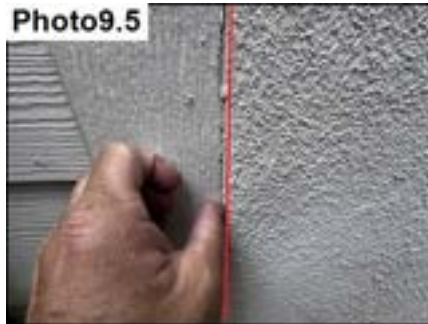
Photo9.5

Siding & Stucco Termination / Seal

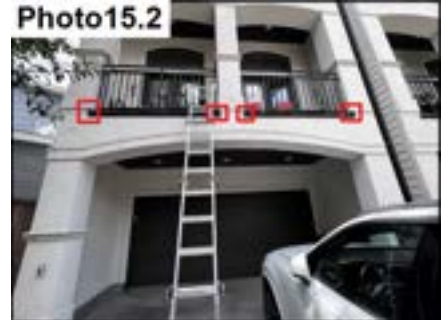
Photo15.2

- The balcony flashing sealants are aged at this location, allowing excess moisture into the system. The inspector suggests to have a qualified waterproofing contractor further assess and seal this area with a low modulus sealant in an effort to prevent moisture intrusion. These types of sealants are of high quality and compatible with stucco and other termination points. Please refer to photos #15.2, #15.3, #15.4, #15.5 and #15.6 for more detail.

Balcony Flashing Sealants / Seal

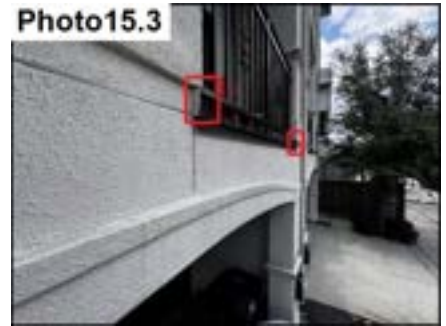
Photo15.3

Balcony Flashing Sealants / Seal

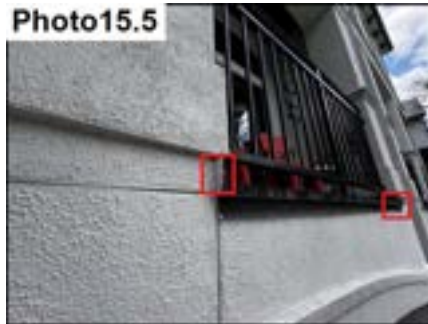
Photo15.5

Balcony Flashing Sealants / Seal

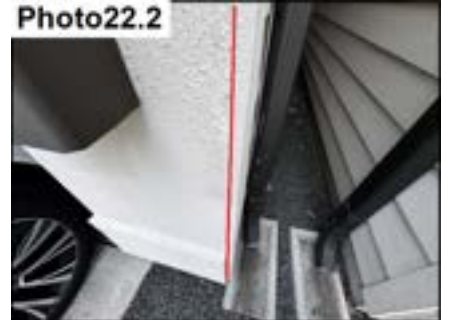
Photo22.2

- Siding/stucco termination sealants are aged or separated at this location. The inspector suggests to have a qualified waterproofing contractor further assess and seal this area with a low modulus sealant in an effort to prevent moisture intrusion. These types of sealants are of high quality and compatible with stucco and other termination points. Please refer to photos #22.2, #22.3, #22.4, #22.5 and #22.6 for more detail.

Siding & Stucco Termination / Seal

| Grid Location | Item Description | Moisture Readings | Substrate Condition | Observations |
|---|---|---|---|---|
| Red Line | Stucco Termination | | | Siding/stucco termination sealants are aged or separated at this location. The inspector suggests to have a qualified waterproofing contractor further assess and seal this area with a low modulus sealant in an effort to prevent moisture intrusion. These types of sealants are of high quality and compatible with stucco and other termination points. Please refer to photos #22.2, #22.3, #22.4, #22.5 and #22.6 for more detail. |

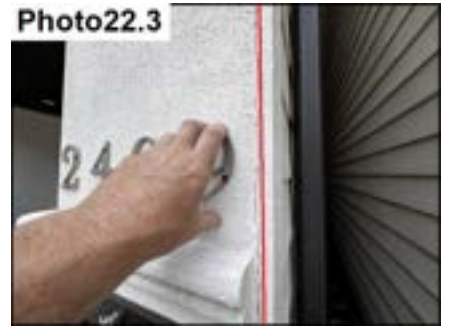
Photo22.3

Siding & Stucco Termination / Seal

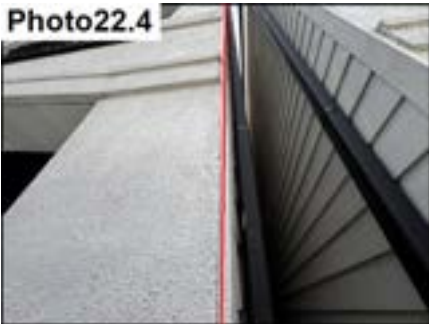
Photo22.4

Siding & Stucco Termination / Seal

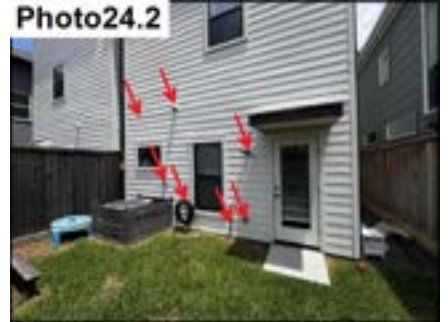
Photo24.2

- The penetration sealants are aged in this location. The inspector suggests to have a qualified waterproofing contractor seal this area in an effort to prevent moisture intrusion. Please refer to photos #24.2, #24.3, #24.4, #24.5 and #24.6 for more detail.

Penetration Sealants / Seal

| Grid Location | Item Description | Moisture Readings | Substrate Condition | Observations |
|---|---|---|---|---|
| Red Arrows | Penetrations | | | The penetration sealants are aged in this location. The inspector suggests to have a qualified waterproofing contractor seal this area in an effort to prevent moisture intrusion. Please refer to photos #24.2, #24.3, #24.4, #24.5 and #24.6 for more detail. |

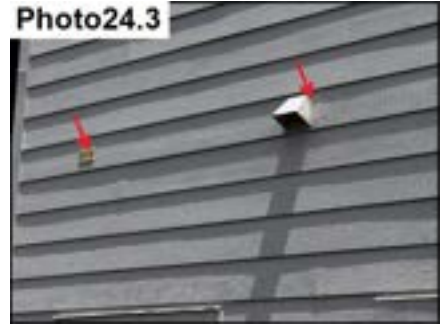
Photo24.3

Penetration Sealants / Seal

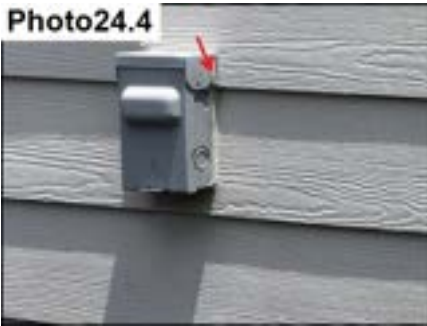
Photo24.4

Penetration Sealants / Seal

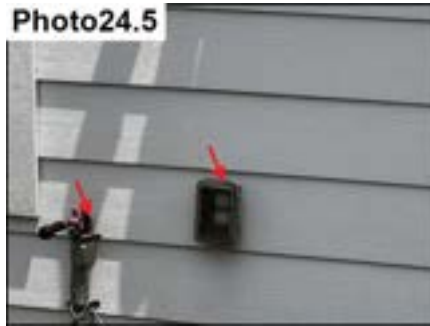
Photo24.5

Penetration Sealants / Seal

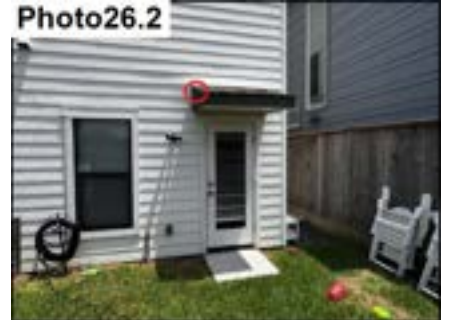
Photo26.2

- The roof diverter flashing sealants are aged at this location. The inspector suggests to have a qualified waterproofing contractor further assess and seal this area in an effort to prevent moisture intrusion. Please refer to photos #26.2, #26.3, #26.4, #26.5 and #26.6 for more detail.

Roof Diverter Flashing Sealants / Seal

| Grid Location | Item Description | Moisture Readings | Substrate Condition | Observations |
|---|---|---|---|---|
| Red Circles | Flashing | | | The roof diverter flashing sealants are aged at this location. The inspector suggests to have a qualified waterproofing contractor further assess and seal this area in an effort to prevent moisture intrusion. Please refer to photos #26.2, #26.3, #26.4, #26.5 and #26.6 for more detail. |

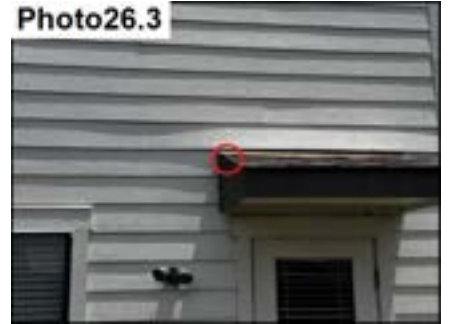
Photo26.3

Roof Diverter Flashing Sealants / Seal

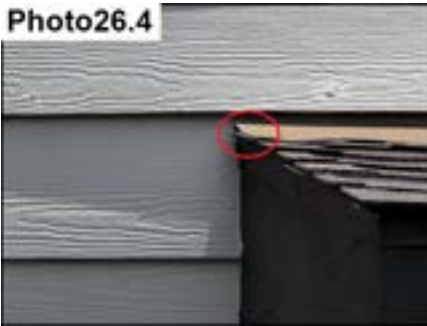
Photo26.4

Roof Diverter Flashing Sealants / Seal

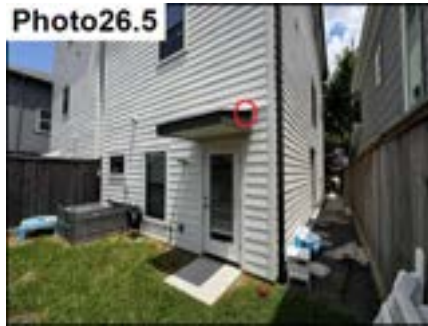
Photo26.5

Roof Diverter Flashing Sealants / Seal
