# Home Inspection Report

3202 Mirro Drive, Manitowoc , WI 54220

Halverson Home Inspection LLC  
108 Eaton Court  
Valders , WI 54245  
920-905-5995  
th Alverson4@new.rr.com

073025-147

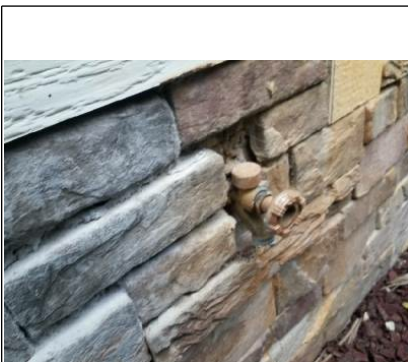
East hose bib not operating at time of inspection
