## Peak Home Inspections

## Home Inspection Report

**850 E Ellsworth Ln**

Inspected on Tue, May 11 2021 at 2:00 PM

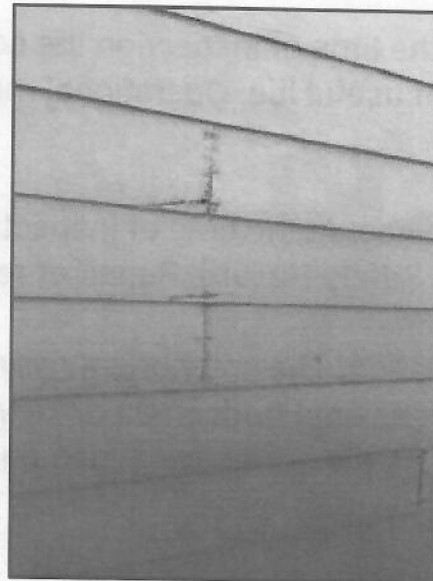
Figure 5-2

- 2) The siding and trim on the garage has wood rot. Recommend repair or replacement by a qualified contractor.

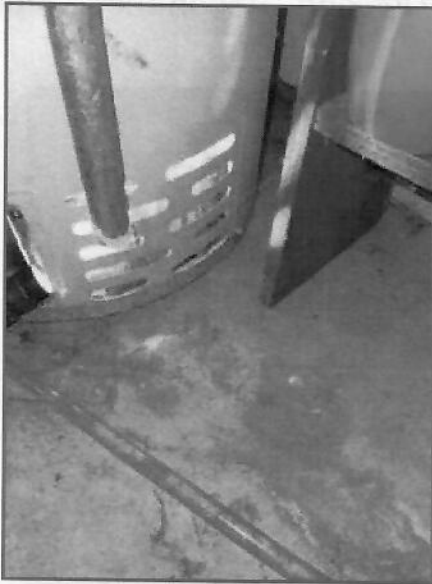
Figure 24-5

13) The water heater is heavily corroded and actively leaking. Recommend replacement by a licensed plumber.

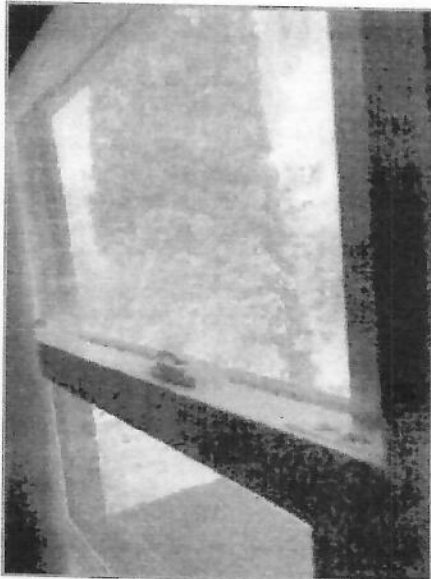
Figure 26-3

15) Two windows in vestibule, two windows in the living room, one window in the northeast bedroom and one window in the northwest bedroom have broken thermal seals and have allowed moisture between the panes of glass. Recommend repair or replacement by a qualified window contractor.

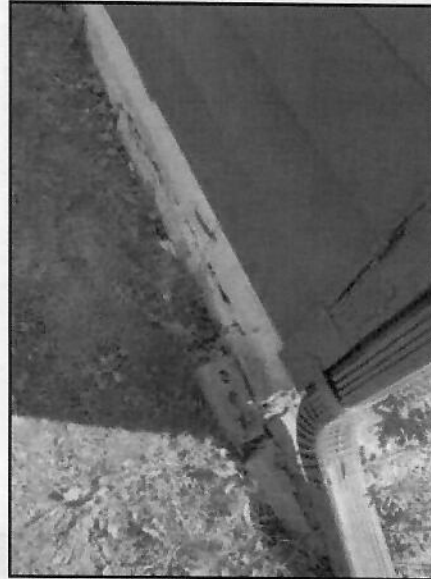
Figure 6-2

3) The block foundation on the back corner of the garage is damaged. Recommend repair or replacement by a qualified contractor.
