Disclosure of Pre-Sale Inspection Report

2220 Stonecroft Dr.

# PROPERTY INSPECTION REPORT

**2220 Stonecroft Dr Grafton WI**  
**Inspection Prepared For: Tracy Prohuska**  
**Agent: Jaime Lubner - Compass**

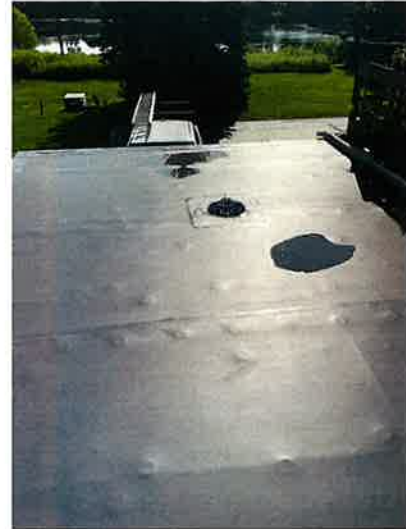
New flat roof

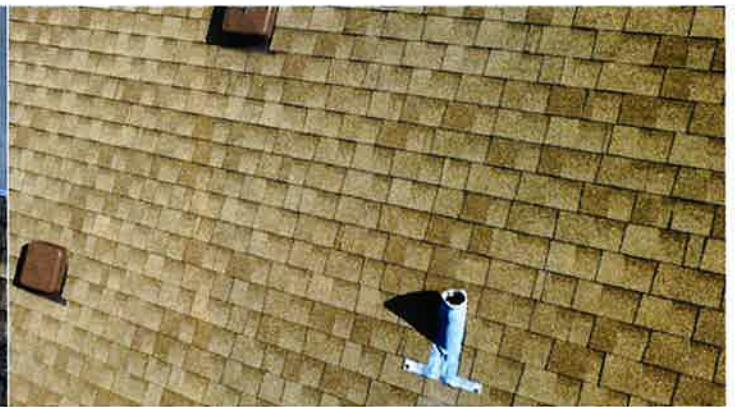
Lead flashing satisfactory

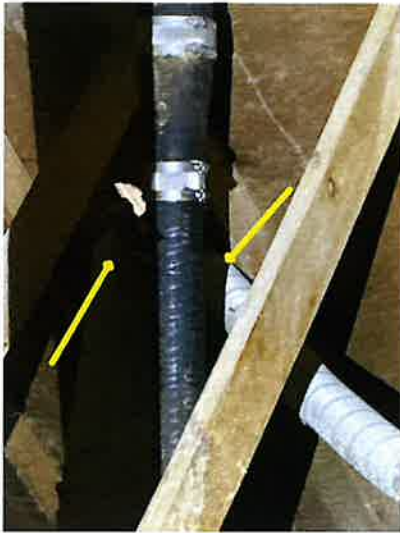
| Page 34 Item: 4 | Attic/Structure/Framing/Insulation | • Condensation staining in the attic is being remediated. Be sure the fans from below exhaust through the roof properly. They are not sealed through to the exterior. Improve insulation over the pull down along with adding a weatherstripping. The attic has soffit baffles but they don't appear to be soffit vents. Make roofing vent ventilation improve improvements. Check with contractors for planned repairs. |

Fans don't vent sealed through the roof opening

6. Pg. 23, item 7: Ice maker & water are functioning on refrigerator
7. Pg. 41, item 1: Seller installed cover on open junction box
8. Pg. 34, item 4: P&R addressed additional condensation staining in attic. See attached documentation.

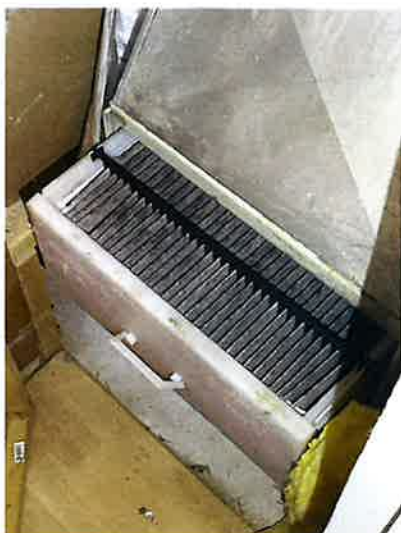
Dirty furnace filter needs to be changed.

12. Pg. 25, item 1: Seller caulked tub spout; repaired vanity cabinet drawer & fixed lock on pocket door
13. Pg. 39/40, item 1: Seller replaced furnace filter
