# HOME INSPECTION REPORT

**5314 West Nokomis Road, Brown Deer, WI**

Date of Inspection: 6/30/2026 Time: 5:00 PM

Inspector: David Nason

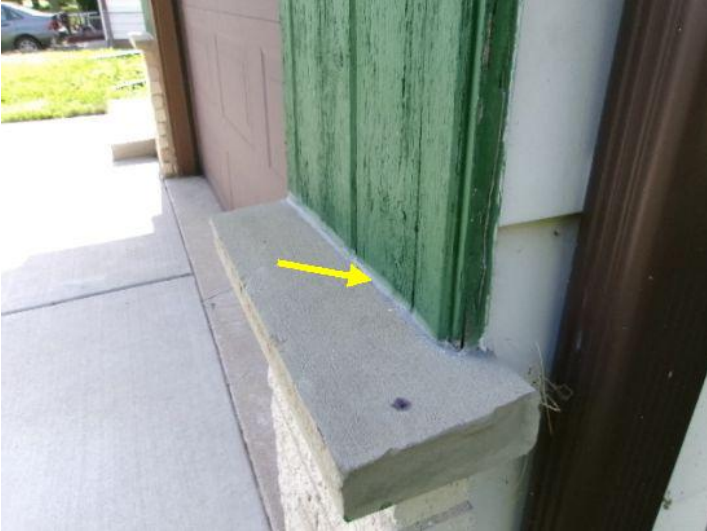
### 9. Flashing

| Page 15 Item: 9 | Flashing | • <b>MAINTENANCE:</b> The flashing from the siding to the stone sills at the front elevation is minimal and should extend at least 1" beyond the siding. The roof overhang is helping to keep moisture off the sills and no major concerns were observed. Maintain caulk as needed. |

- Due to a hip style roof and windows and doors are under the overhangs, there is no need for flashing above the windows and doors.
- **MAINTENANCE:** The flashing from the siding to the stone sills at the front elevation is minimal and should extend at least 1" beyond the siding. The roof overhang is helping to keep moisture off the sills and no major concerns were observed. Maintain caulk as needed.

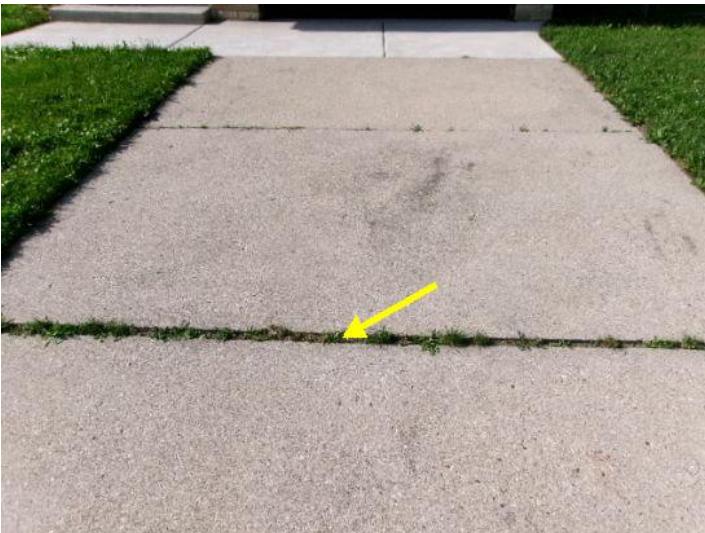
## 1. Driveway

| Repair | | |
|---|---|---|
| Page 16 Item: 1 | Driveway | <ul style="list-style-type: none"> <li>• <b>REPAIR:</b> The concrete driveway appeared to be in overall satisfactory condition. Some joints are opening up possibly caused by water and gravity causing the concrete to slip downhill. Suggest sealing joints to prevent additional moisture intrusion. The large crack near the bottom of the driveway may be caused by a poor sub base in the area; repair or replacement needed.</li> </ul> |

- Concrete section of the driveway near the garage appeared to be newer and observed to be in good condition.
- **REPAIR:** The concrete driveway appeared to be in overall satisfactory condition. Some joints are opening up possibly caused by water and gravity causing the concrete to slip downhill. Suggest sealing joints to prevent additional moisture intrusion. The large crack near the bottom of the driveway may be caused by a poor sub base in the area; repair or replacement needed.

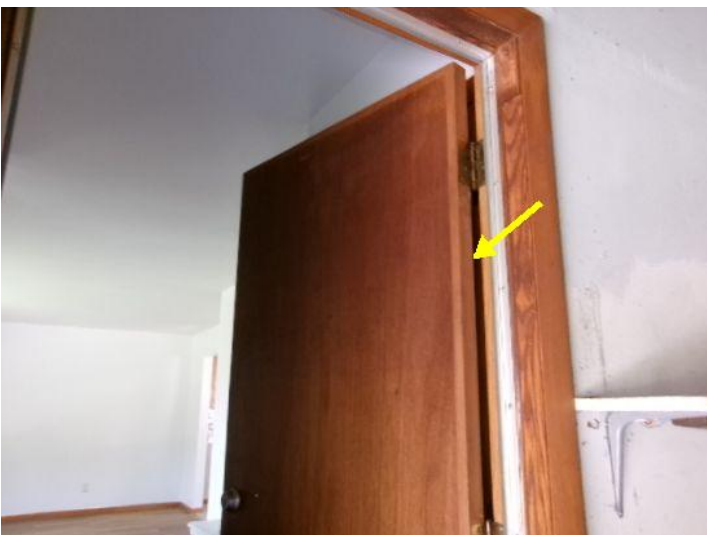
### 10. Fire Door

- **DEFECT:** The door between the garage and house is a solid core wood door however it is not a labeled fire rated door, there are gaps at the jamb, and the threshold was removed when the new flooring was installed. Fire doors are fundamental to the integrity of fire barriers which provide resistance to the spread of fire, smoke, and toxic gasses. Although a fire door may not have been required when the house was built, this door will not afford protection from fire, smoke, or combustion gases and is a safety hazard. Replacement needed, which will require some re-work of the flooring.

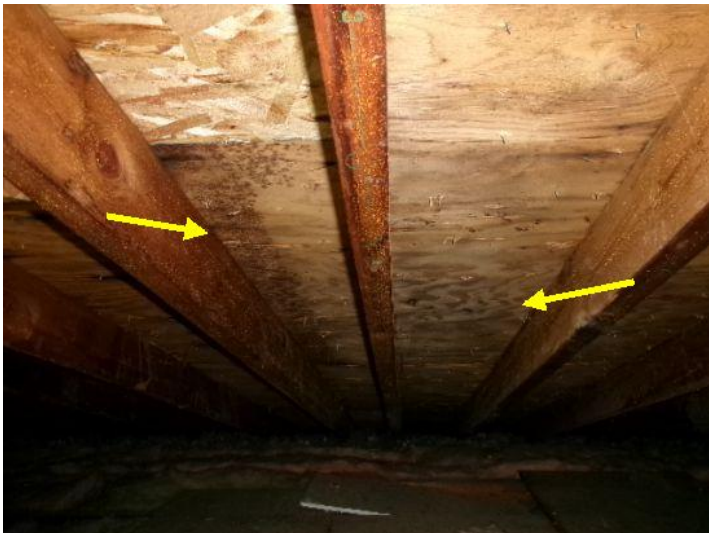
| Page 22 Item: 2 | Structure | <ul style="list-style-type: none"> <li>• <b>FURTHER EVALUATION:</b> Staining was observed on the roof sheathing on the north facing slope and above the bathroom that may be an organic growth likely caused by excessive condensation during cold weather months, due to air leaking into the attic from the home. Recommend further evaluation of the condition of the attic; proper cleaning of the structure may also be needed by a qualified professional contractor that specializes in this type of cleaning.</li> </ul> |

• **FURTHER EVALUATION:** Staining was observed on the roof sheathing on the north facing slope and above the bathroom that may be an organic growth likely caused by excessive condensation during cold weather months, due to air leaking into the attic from the home. Recommend further evaluation of the condition of the attic; proper cleaning of the structure may also be needed by a qualified professional contractor that specializes in this type of cleaning.

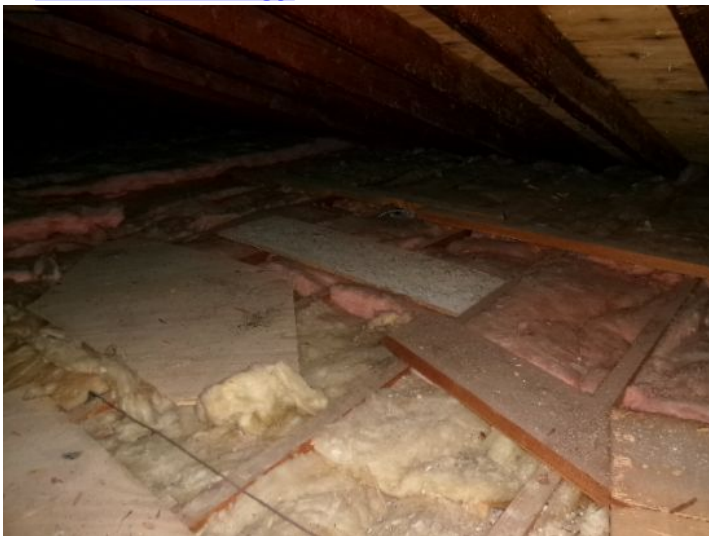
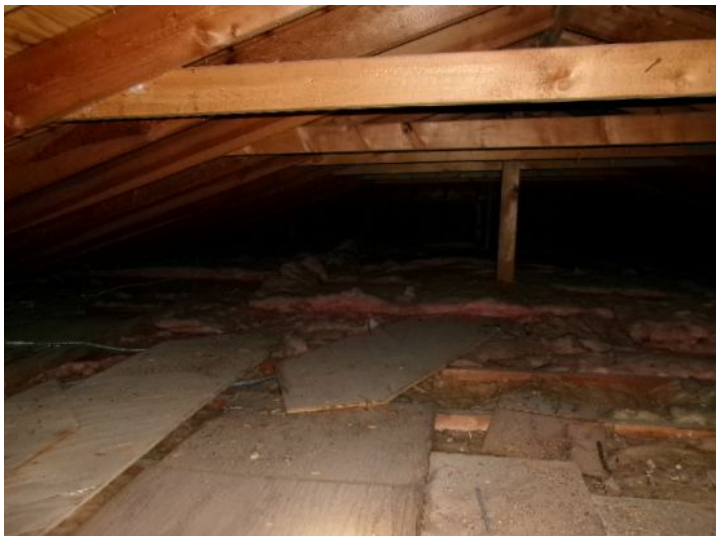
- **IMPROVEMENT:** The insulation in the attic is minimal by current standards, typical for a home this age. Higher energy costs and possible frost or condensation on roof boards during cold weather months should be expected due to heat loss. If additional energy efficiency is desired, recommend further evaluation of the attic environment including the amount of insulation present, exhaust venting, attic ventilation, and air leak sealing from the heated living space by a qualified insulation professional familiar with attic moisture issues. Or consider having an energy audit performed by Focus on Energy, search <https://www.focusonenergy.com>

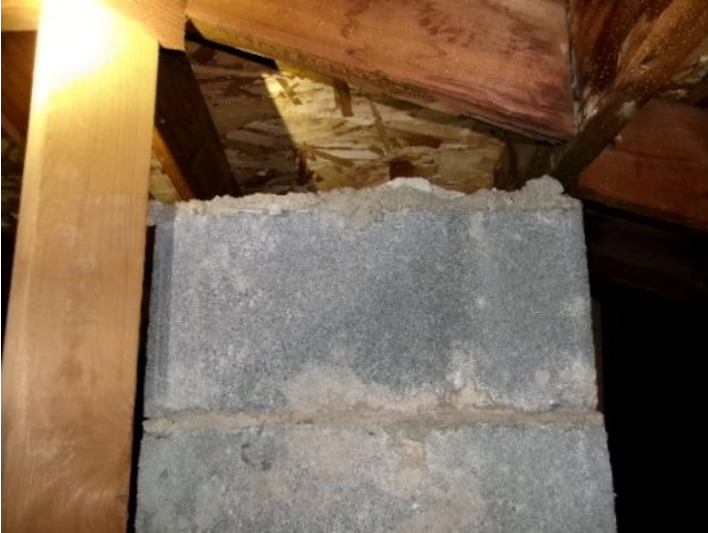
#### 9. Chimney

| Page 44 Item: 7 | Masonry Chimney | • REPAIR: Recommend sealing old openings and gaps in the chimney to prevent warm air from rising into the attic. |

- The masonry chimney has been removed below the roof line and is no longer in use. Recommend sealing the flue to prevent warm air from the basement leaking into the attic.

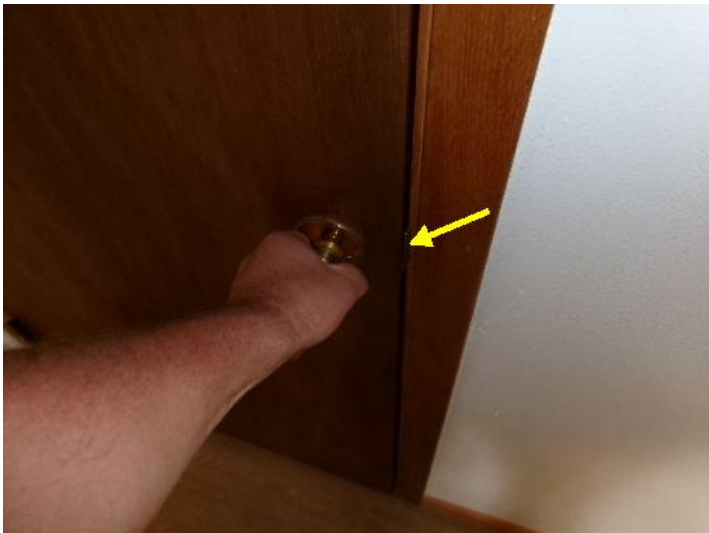
## 6. Interior Doors & Hardware

| Page 25 Item: 6 | Interior Doors & Hardware | • REPAIR: The latches at a bedroom and bathroom door need adjustment to latch properly. |

- Except as noted, a representative number of interior doors were opened and closed and appeared to be in satisfactory condition.
- **REPAIR:** The latches at a bedroom and bathroom door need adjustment to latch properly.

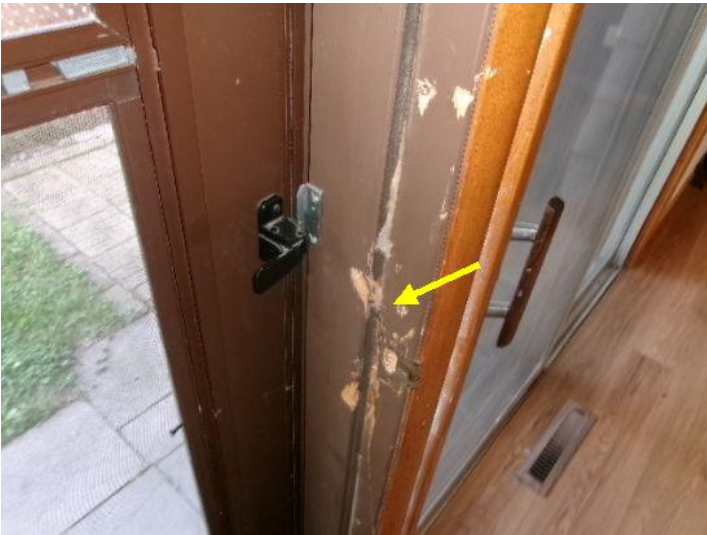
## 7. Exterior Doors

| Page 25 Item: 7 | Exterior Doors | • REPAIR: Damage observed at the frame of the rear entry door apparently from a forced entry attempt. Repair/replacement needed. |

- Front entry door was functional and observed to be in satisfactory condition.
- **REPAIR:** Damage observed at the frame of the rear entry door apparently from a forced entry attempt. Repair/replacement needed.

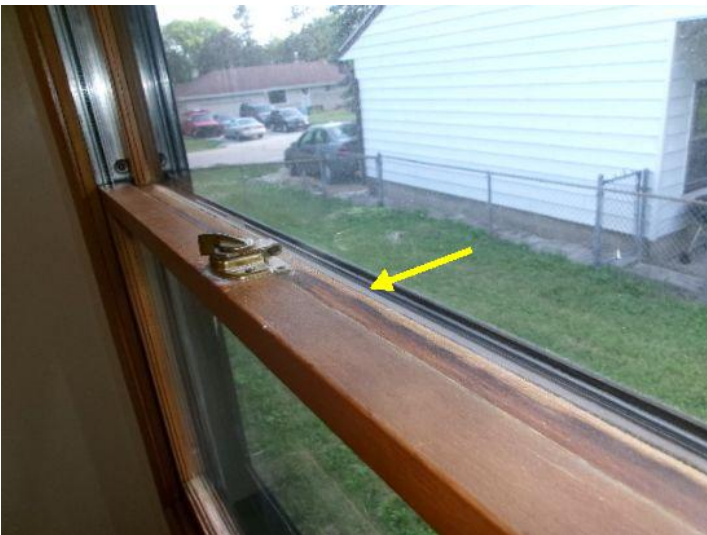
#### 10. Windows

| Page 26 Item: 10 | Windows | • REPAIR: At least one window, in the bathroom, has balances that are broken which prevent the lower sash from staying up when opened. Repair needed. |

- Except as noted, a representative number of the windows were operated and appeared to be functional and in satisfactory condition.
- Operable windows need to be opened and cleaned regularly to extend their life and maintain proper operation.
- Locking all windows when not opened prevents air leakage or moisture intrusion, in winter and summer, by compressing the weatherstripping around the operable sash.
- **MAINTENANCE:** Failing finish observed at several wood window sash and sills due to age, moisture and/or sun exposure. Sand, stain, and varnish as needed; use an exterior spar varnish with UV protection for longer life.
- **REPAIR:** At least one window, in the bathroom, has balances that are broken which prevent the lower sash from staying up when opened. Repair needed.

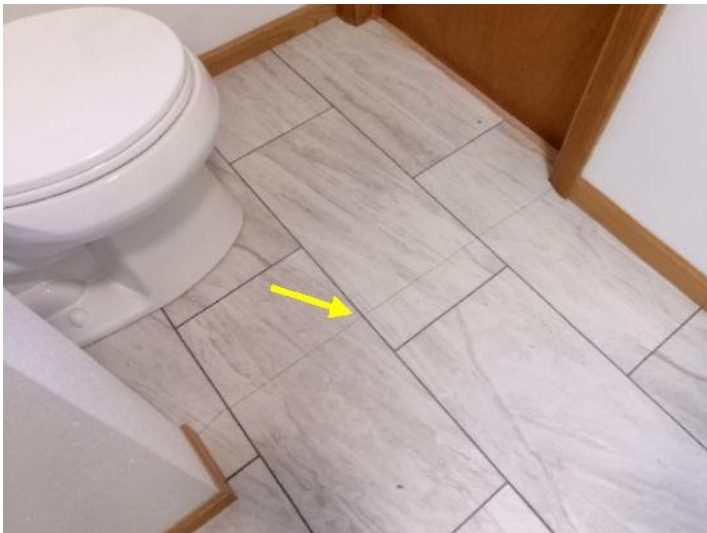
| Page 28 Item: 2 | Floor | • REPAIR: Damaged wood transition observed at the hall/bathroom door opening. Repair needed. |

- Except as noted, floor observed to be functional and in satisfactory condition.
- Several cracked tiles observed in the bathroom floor; no major concerns observed. Suggest caulking or re-grouting as needed.
- **REPAIR:** Damaged wood transition observed at the hall/bathroom door opening. Repair needed.

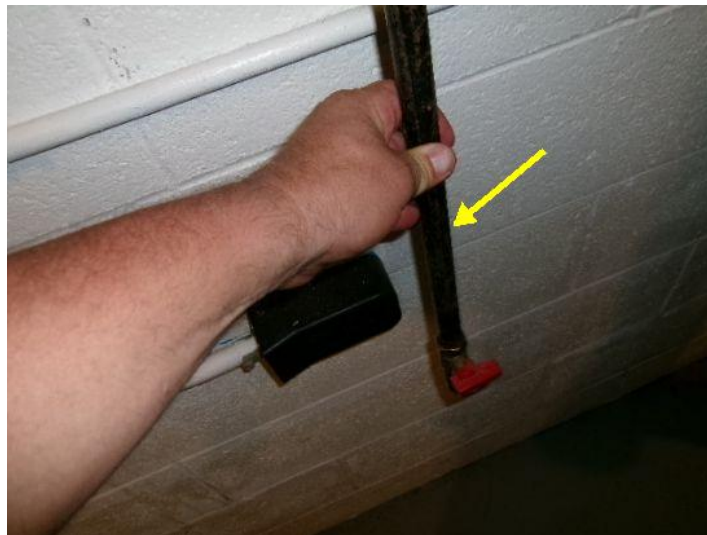
### 7. Laundry

| Page 32 Item: 7 | Laundry | • REPAIR: Gas pipe not secured to the wall. Recommend securing properly to prevent loosening at pipe joints or kinking the flexible gas connector. |

- All accessible plumbing appeared to be functional; no leaks observed, however laundry appliances were not operated.
- Rubber washing machine supply hoses require replacement every 3-5 years. Recommend using reinforced hoses to minimize the chance for water leaks and damage.
- **REPAIR:** Gas pipe not secured to the wall. Recommend securing properly to prevent loosening at pipe joints or kinking the flexible gas connector.

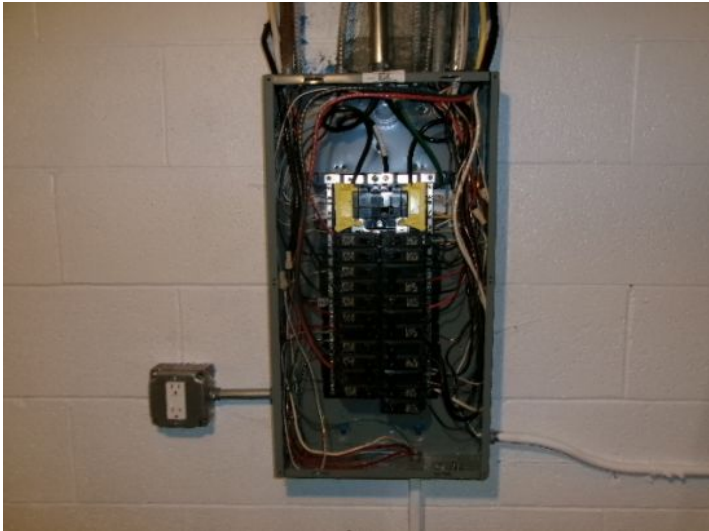
| Page 35 Item: 1 | Main Electrical Panel | • REPAIR: The main panel is not labeled properly, which may indicate the panel was updated without a permit or final inspection. Recommend having the circuits properly labeled for safety in case of an emergency. |

- No major system, safety, or function concerns observed in the main electrical panel.
- The main electrical panel appeared to be grounded and bonded, however the exterior grounding rod was not visible for inspection.
- **REPAIR:** The main panel is not labeled properly, which may indicate the panel was updated without a permit or final inspection. Recommend having the circuits properly labeled for safety in case of an emergency.

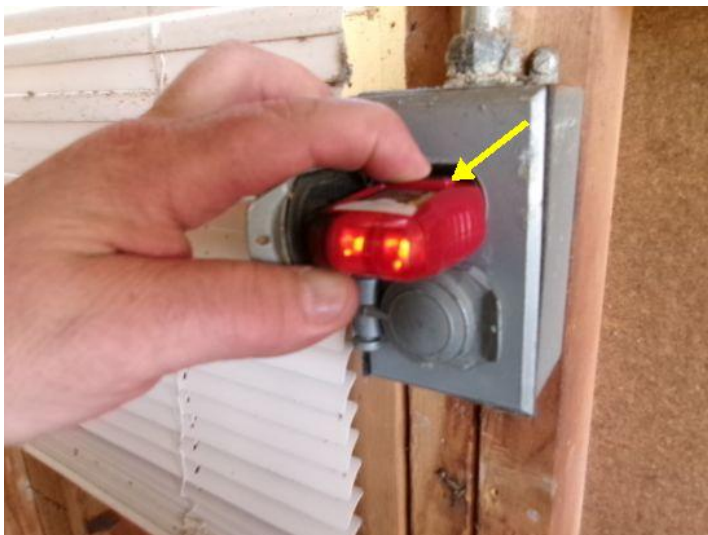
### 15. Garage

| Page 37 Item: 15 | Garage | • REPAIR: The overhead door opener is plugged into an extension cord as permanent wiring. Installation of a receptacle near the opener needed. |

- **REPAIR:** The overhead door opener is plugged into an extension cord as permanent wiring. Installation of a receptacle near the opener needed.
- **DEFECT:** The original receptacle present is not a GFCI which is a safety hazard. Correction or replacement needed.

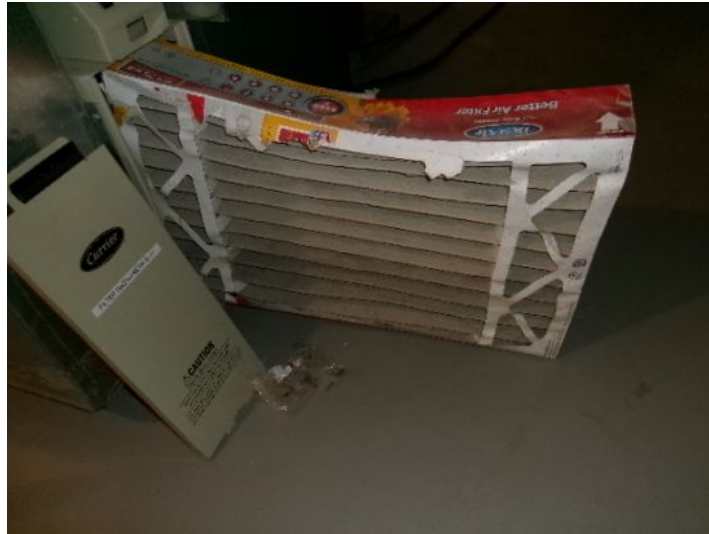
| Grounds | | |
|---|---|---|
| Page 39 Item: 4 | HVAC Filter | <ul style="list-style-type: none"> <li>• <b>MAINTENANCE:</b> The furnace filter was filthy and removed. Replacement needed very soon.</li> </ul> |

- **MAINTENANCE:** The furnace filter was filthy and removed. Replacement needed very soon.

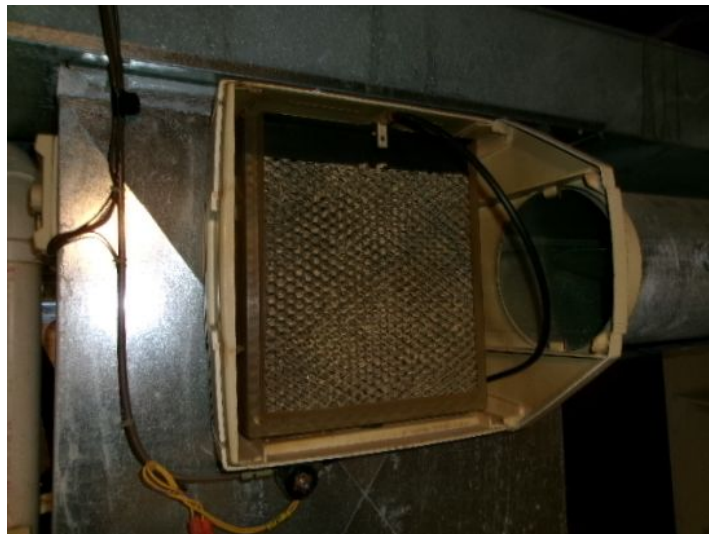
#### 5. Humidifier

| Grounds | | |
|---|---|---|
| Page 39 Item: 5 | Humidifier | <ul style="list-style-type: none"> <li>• <b>MAINTENANCE:</b> The humidifier filter appeared to have some scale buildup and will need to be replaced soon or before the next heating season.</li> </ul> |

- **MAINTENANCE:** The humidifier filter appeared to have some scale buildup and will need to be replaced soon or before the next heating season.

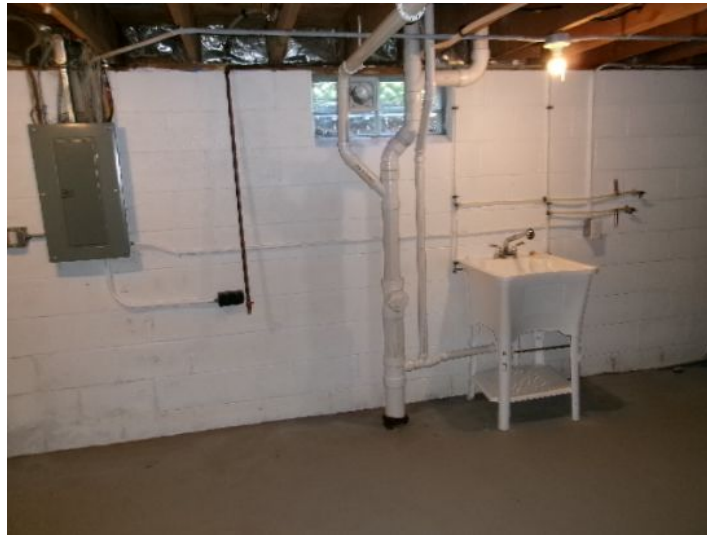
- Unfinished basement foundation walls
- All of the foundation walls were visible for inspection.
- Areas where electrical conduit or other mechanicals are on the foundation walls prevented checking for plumb with a 4' level.

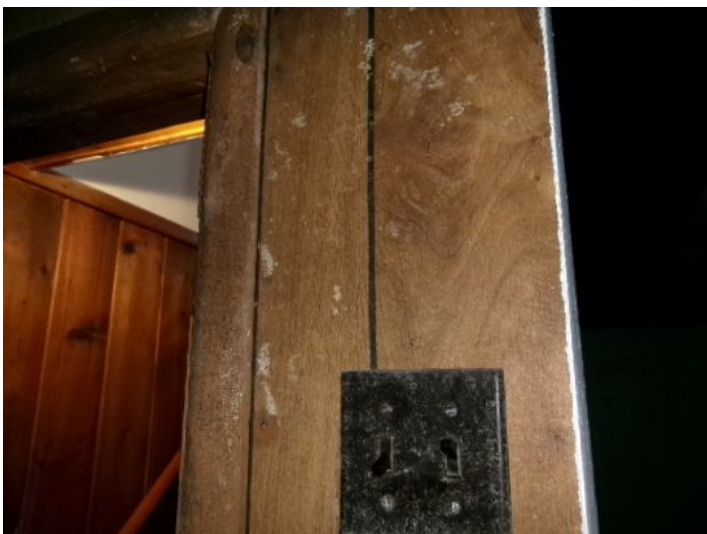
- None of the foundation walls were finished.
- **FURTHER EVALUATION:** Stains and possible organic growth were observed on the walls around the stair possibly caused or excessive humidity in the basement. Recommend further evaluation by a qualified contractor to clean and/or remove the damaged surfaces.

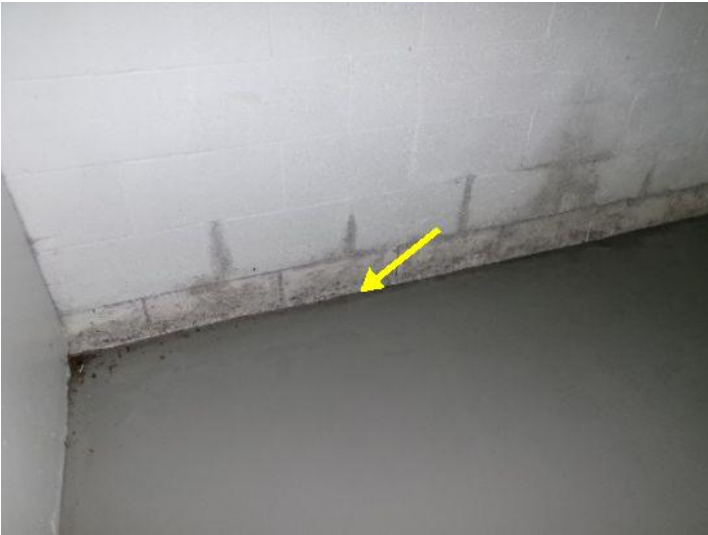
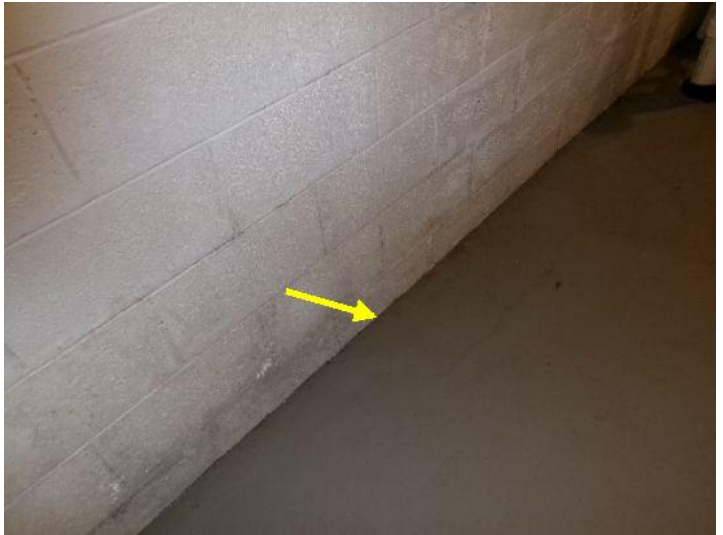
- Drain tile is a non-visible component of the home because it is buried under the concrete floor and/or along the exterior of the foundation, therefore the presence of or effectiveness of the drain tile can not be visually determined.
- **FURTHER EVALUATION:** Staining and seepage was observed at the bottom course of block and on the floor along the east foundation wall. These conditions may be an indication of a compromised drain tile system. Recommend further evaluation by a qualified independent drain tile consultant to evaluate the condition of the drain tile to determine if repair or replacement of the drain tile is necessary.

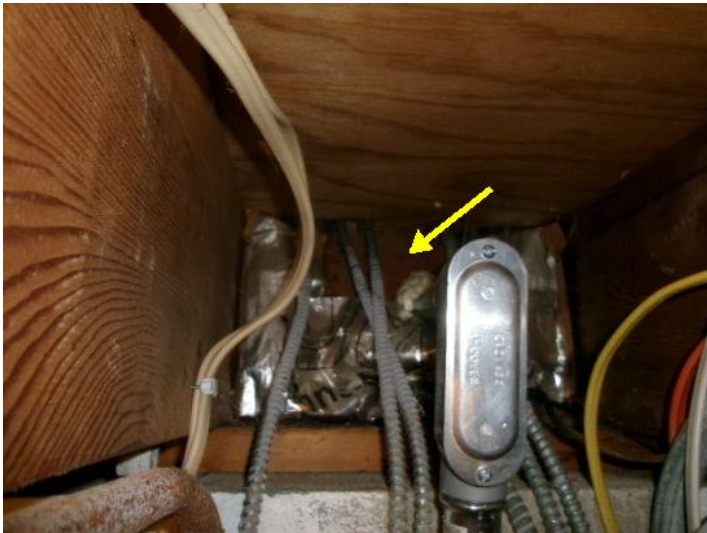
- **IMPROVEMENT:** Insulate gaps or holes and around penetrations in the box sills with expanding foam insulation to prevent cold air drafts or pest intrusion; replace missing or disturbed insulation.
