# REPORT SUMMARY

5314 West Nokomis Road

Brown Deer, WI, 53223

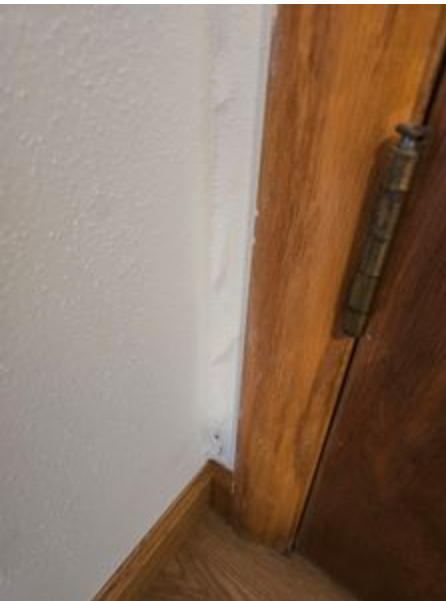
### 5.2 · PAINT CRACKING

Wall paint was cracking in one or more areas. Recommend a qualified painter evaluate and apply a new coat.

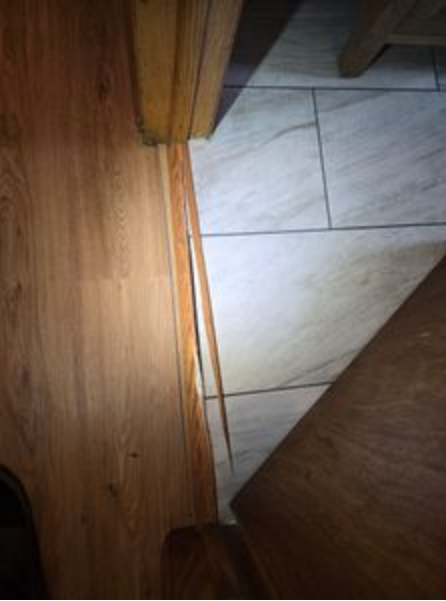
### 5.3 · DAMAGED TRANSITION STRIP

The transition strip between the flooring surfaces was observed to be loose and displaced due to damage. This condition created an uneven transition that may present a tripping hazard and was susceptible to further deterioration with normal use. Recommend further evaluation and any necessary repairs by a qualified contractor.

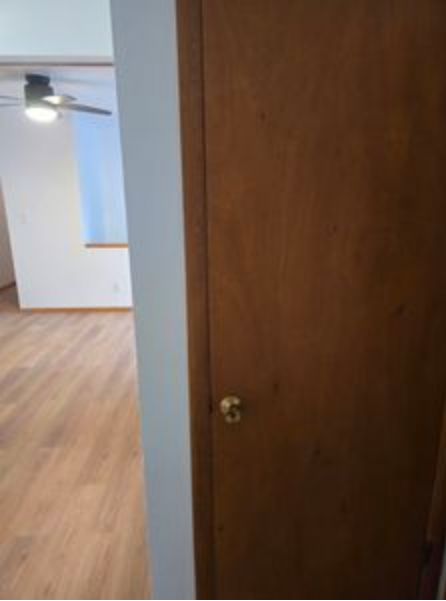
### 5.6 · HARD TO OPEN

A door was difficult to open and close during the inspection, which indicated possible binding or alignment concerns at the door assembly. Recommend further evaluation and any necessary repairs by a qualified contractor.

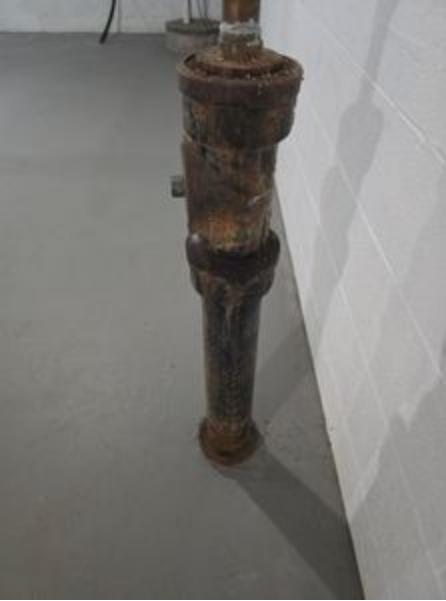
### 6.1 · RUSTING PIPE

Rust was observed on the drain pipe. This can lead to deterioration and possible leaks over time. Evaluation and repair or replacement by a qualified plumber is recommended.

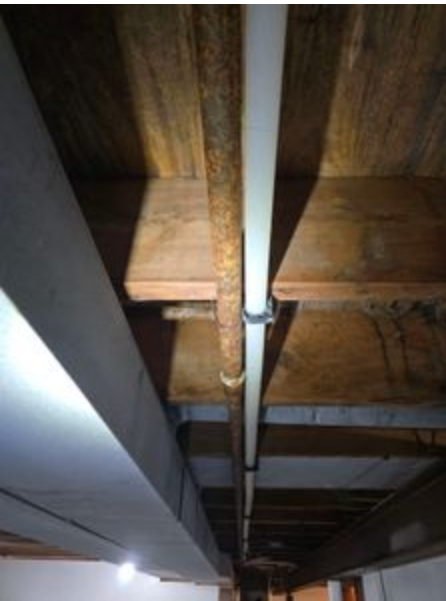
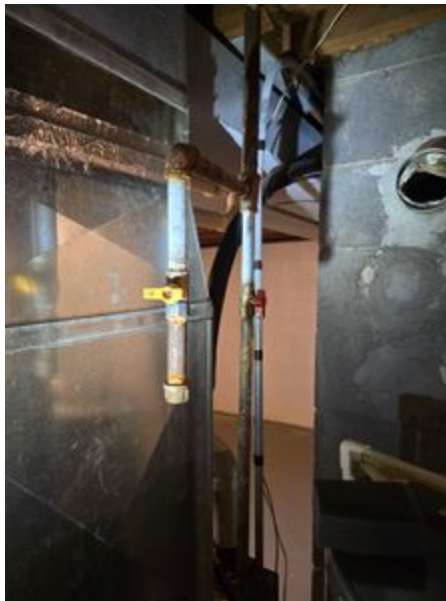
### 6.2 · CORROSION

Gas pipes were corroded. This can lead to gas leaks. Recommend contacting local utility company for evaluation and repair.

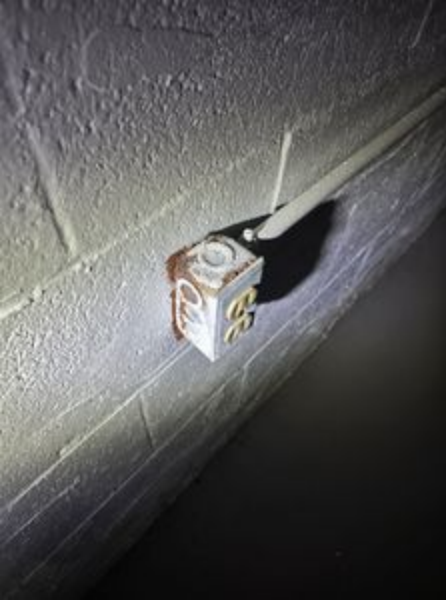
### 7.2 · CORRODED ELECTRICAL RECEPTACLE

Rust was observed on an electrical receptacle, indicating evidence of moisture exposure and deterioration. Corrosion at electrical components may affect reliability and warrants further evaluation to determine the condition of the receptacle and identify any associated moisture concerns. Recommend further evaluation and any necessary repairs by a qualified electrical contractor.

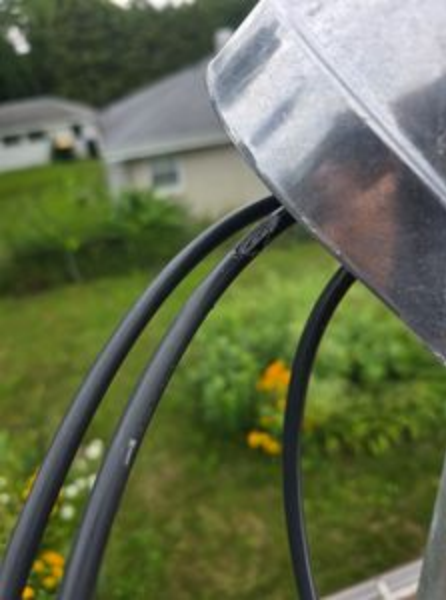
### 7.7 · FRAYED SHEATHING

Wires on service entrance are damaged or frayed. Recommend contacting your electric utility company or a qualified electrician to evaluate and repair.

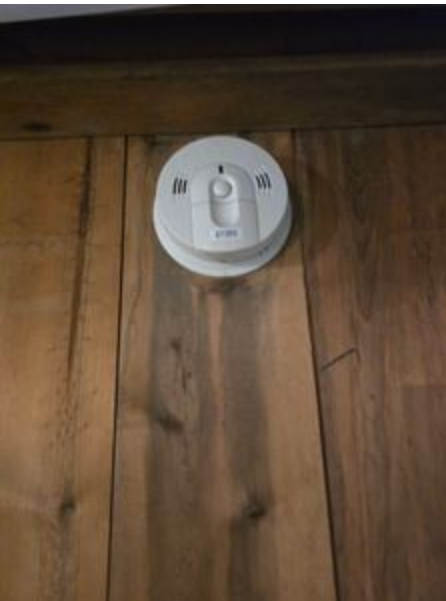
### 7.8 · DEFECTIVE

Smoke detector in the Attic was not working. Recommend replacement.

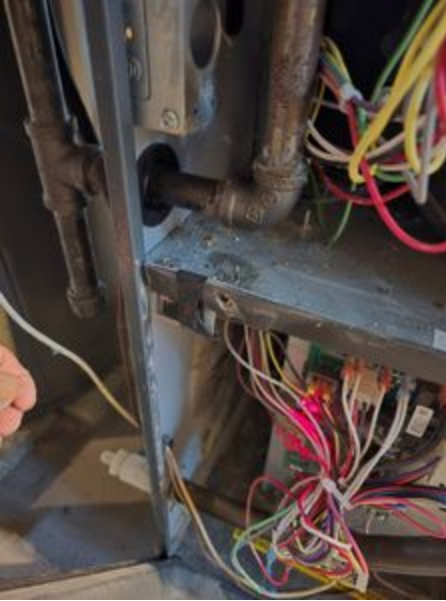
### 9.2 · FURNACE SAFETY SWITCH MALFUNCTION

The furnace safety switch was observed to not operate as intended during testing, which may prevent the system from responding properly to unsafe operating conditions. This condition represented a potential safety concern. Recommend prompt evaluation and any necessary repairs by a qualified HVAC contractor.

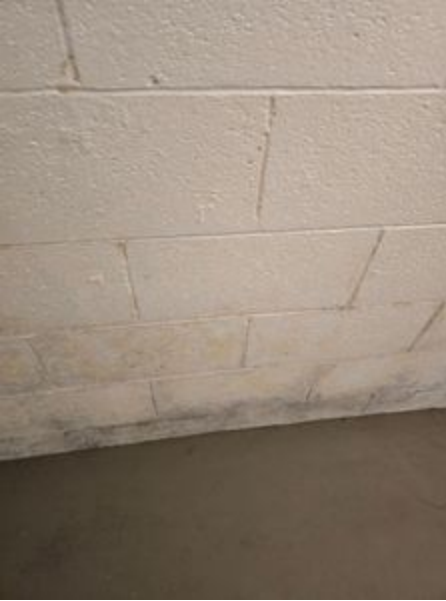
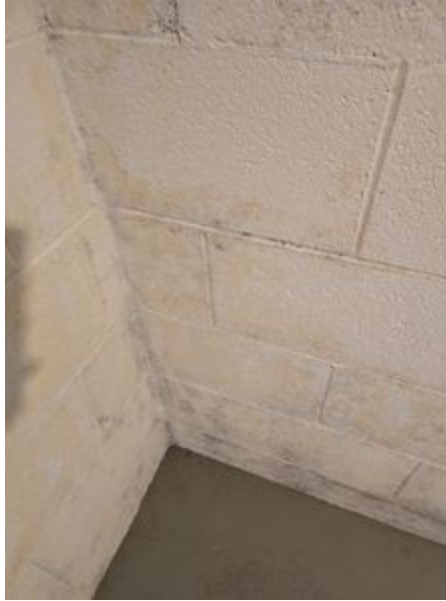
### 10.1 · SUSPECTED ORGANIC GROWTH

Dark and yellow, organic-appearing staining consistent with suspected microbial growth was observed on basement surfaces at the time of inspection; the substance was not tested or confirmed, and its composition was unknown. This condition may be associated with elevated moisture conditions and can contribute to deterioration of building materials. Recommend further evaluation and any necessary remediation by a qualified mold or environmental specialist.

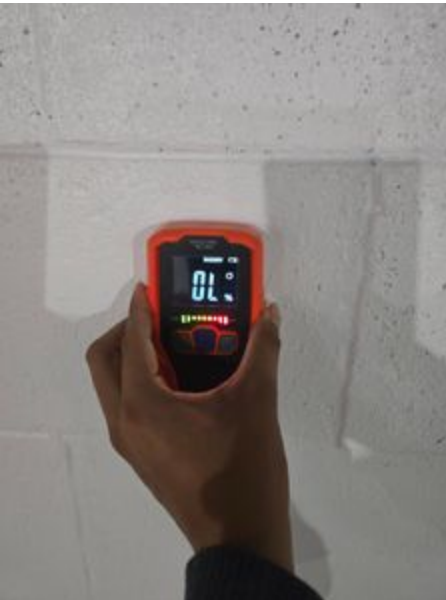
## 10.2 · HIGH MOISTURE LEVELS

High levels of moisture were noted in the basement foundation wall. Recommend monitoring and finding source of moisture intrusion to prevent damage to structure.

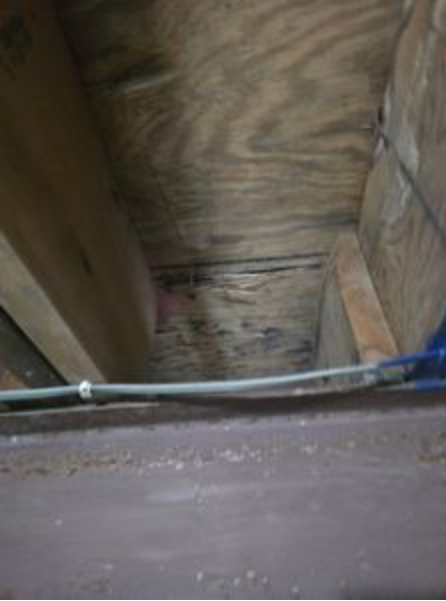
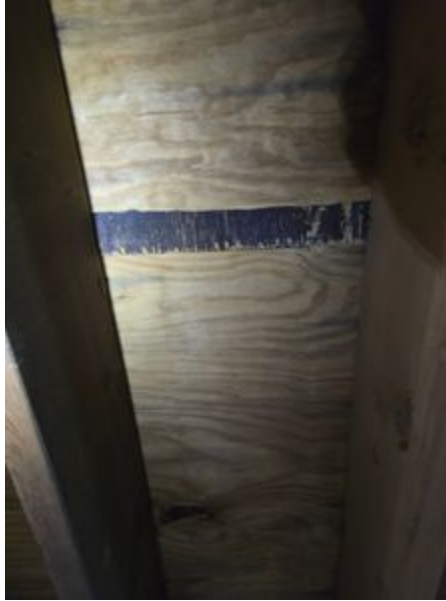
### 10.3 · WOOD ROT

Wood deterioration and rot were observed at the floor framing and underside of the subfloor. The affected wood exhibited dark staining and visible deterioration consistent with prolonged moisture exposure. Recommend further evaluation and any necessary repairs by a qualified flooring contractor or carpenter.

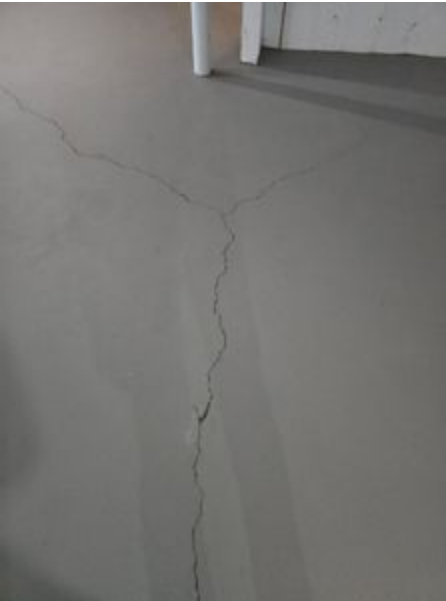
#### 10.4 · MINOR CRACKING

The concrete foundation floor exhibited minor cracking consistent with typical shrinkage. No displacement was observed at the time of inspection.

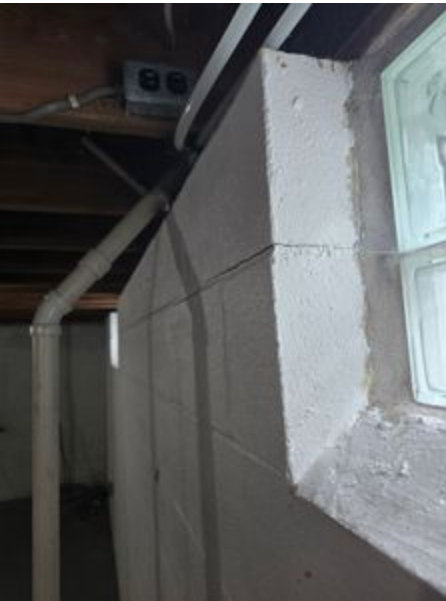
## 10.8 · WALL(S) BOWING/LEANING

Foundation wall is bowing and/or leaning. Repair of wall is required.
