**Tri-State Home Inspections LLC**  
4235 Fairway St  
La Crosse WI 54601  
563-380-2515  
tristate.org@gmail.com

**Report:** 7742-hawkins **Address:** N2067 County Rd F

## **Confidential Inspection Report**

**N2067 County Rd F**  
**La Crosse, WI 54601**

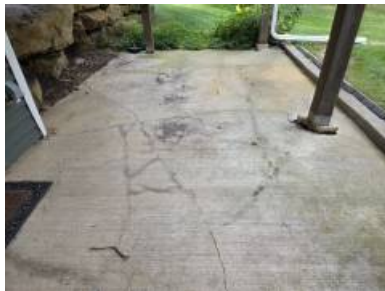
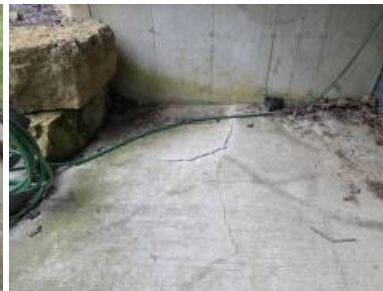
**Slab:**

☐ ☒ ☐ ☐ Patio type: Concrete  
 • Surface raised/settled  
 • Cracks (1/4-inch or less) were visible in the concrete. Cracks exceeding 1/4- inch should be filled and the surface sealed with an appropriate material as needed to avoid continued damage to the driveway surface from freezing moisture.  
 • I recommend sealing with concrete around the deck post to prevent further erosion and damage.

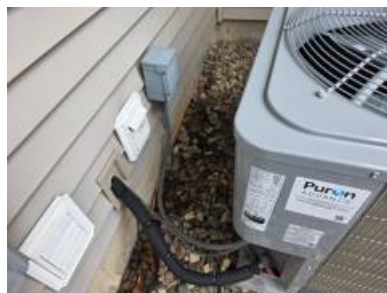
The clothes dryer vents correctly to the exterior; however, it empties at a location that causes the air conditioning condenser cabinet to collect the lint. This reduces the efficiency of the air conditioning system, and it could result in system failure.

Termination of dryer venting must be to the exterior with a proper hood or roof cap equipped with a backdraft damper. Small orifice metal screening should not be part of the hood or roof cap as this will catch lint and block the opening in a very short time. The hood opening should point down and exhibit 12 inches of clearance between the bottom of the hood and the ground or other obstruction.
