**REAL ESTATE CONDITION REPORT**

THIS CONDITION REPORT CONCERNS THE REAL PROPERTY LOCATED AT 700 Creekwood Drive  
IN THE City  
(CITY) (~~VILLAGE~~) (~~TOWN~~) OF West Bend COUNTY OF  
Washington STATE OF WISCONSIN.

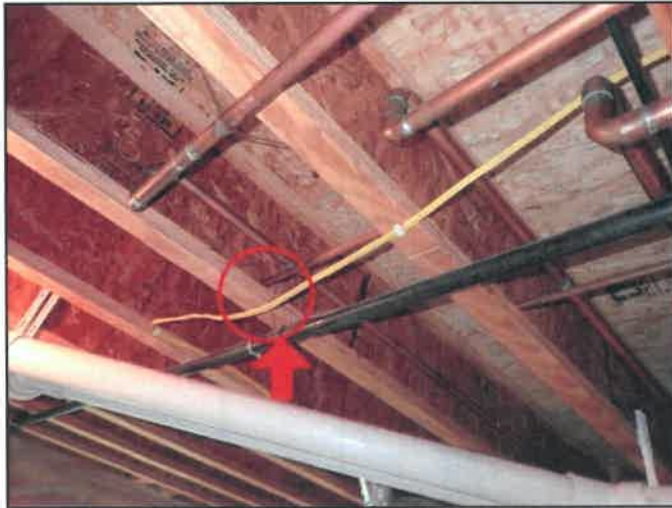
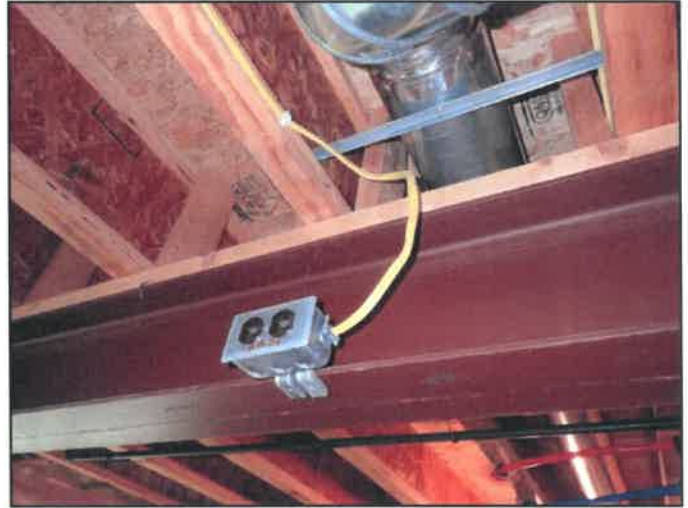
Condition: • [Not well secured](#)

**Implication(s):** Electric shock | Fire hazard

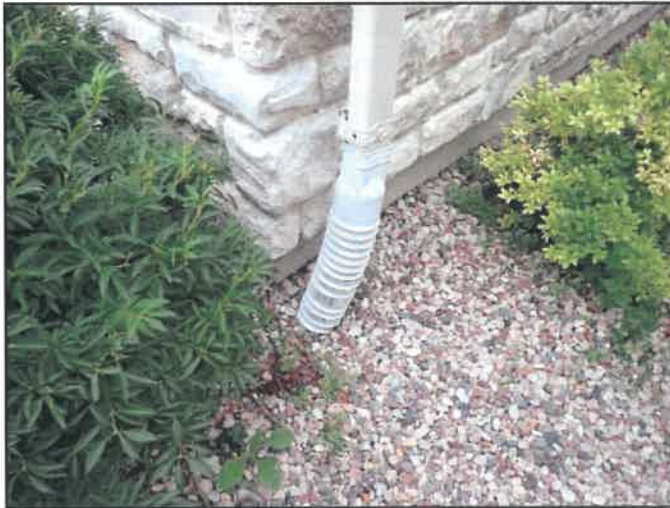
The downspouts that go underground can be damaged or clogged and lead to water intrusion issues. Bringing them above grade is likely a better option. All downspouts should also discharge at least 4-6 feet away from the structure and have a consistent negative pitch away from the structure.

67. Discharge below grade

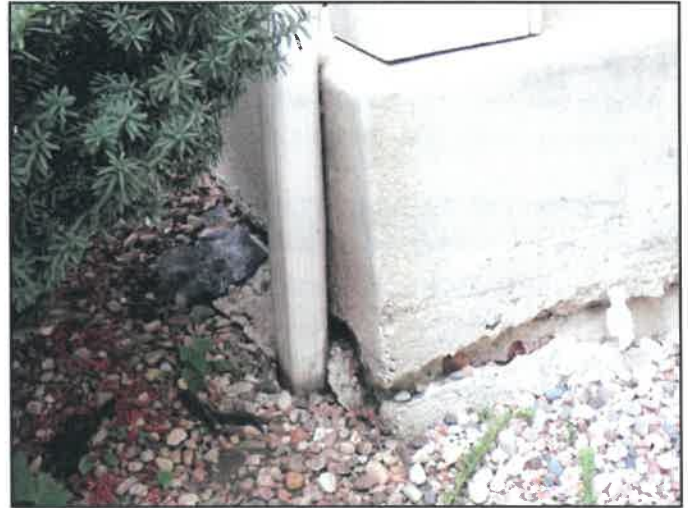
68. Discharge below grade

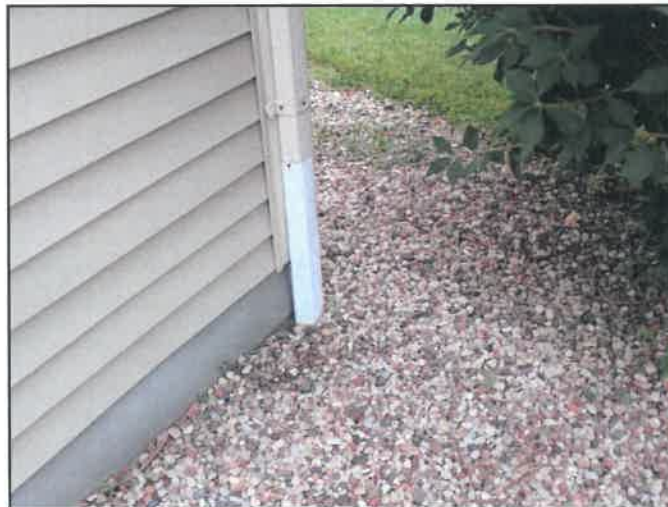
69. Discharge below grade

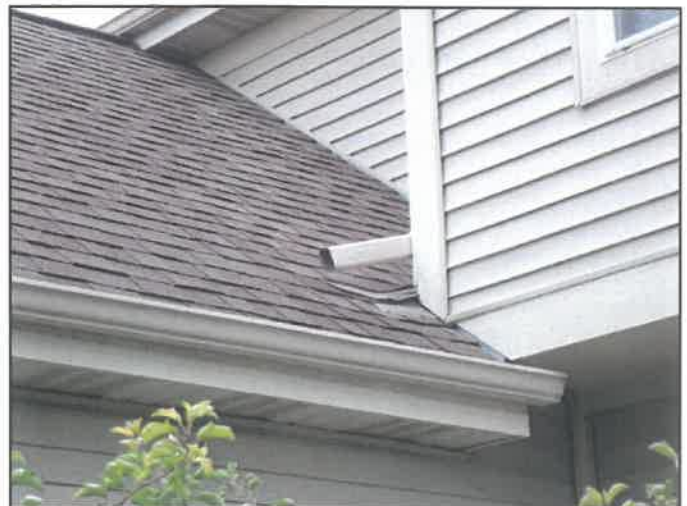
All downspouts should lead to either the gutters or the ground level. Discharging onto the roofing materials will cause them to wear faster and shorten the roof lifespan and can lead to damage of the surrounding materials.

71. Discharge onto roofs

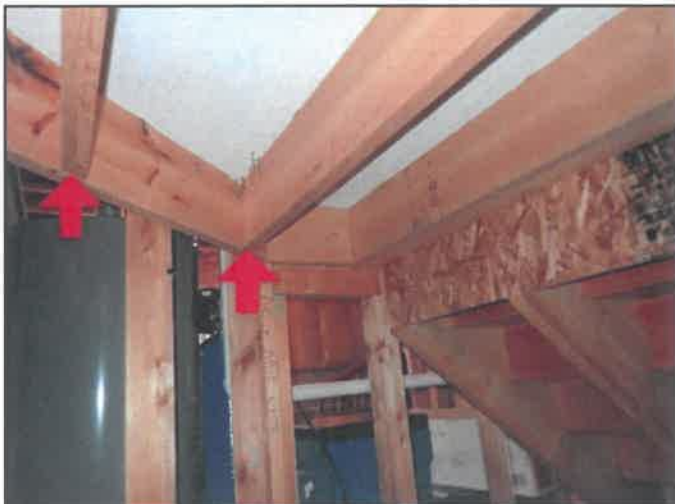
104. Poor end bearing, joist hanger connections

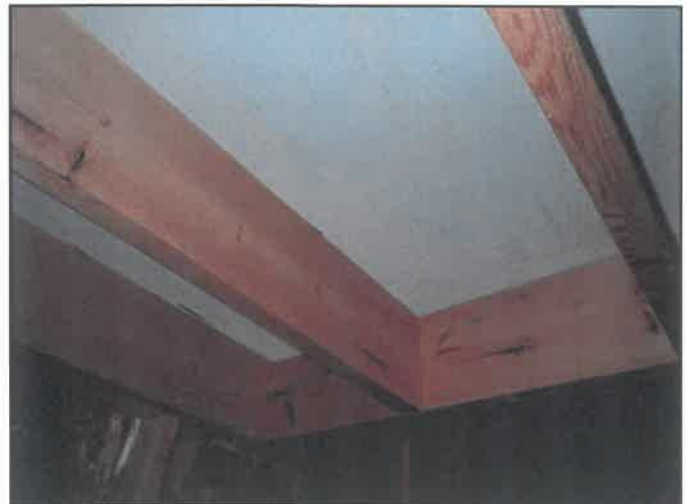
105. Poor end bearing, joist hanger connections

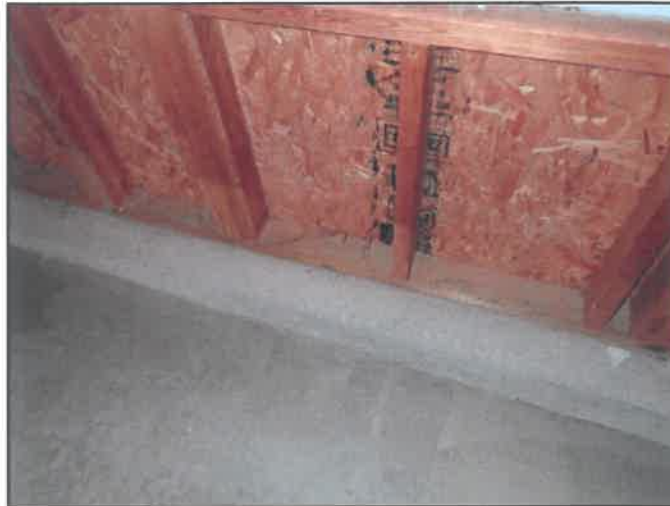
**109.** *Bottom plates have poor bearing*

### 20. Condition: • [Bottom plates have poor bearing](#)

The bottom plate of the garage walls should be anchored to the foundation with proper bolts, nuts, and washers. There may be straps, but this could not be verified as they were not visible.

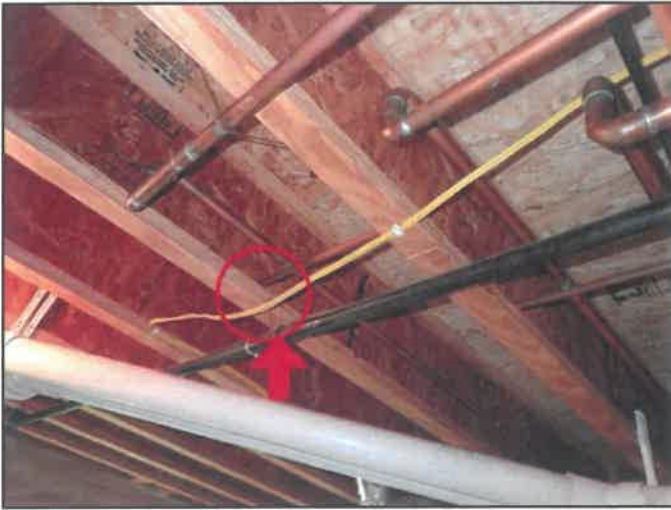
121. Not well secured

#### **22. Condition:** • [Not well secured](#)

**Implication(s):** Electric shock | Fire hazard

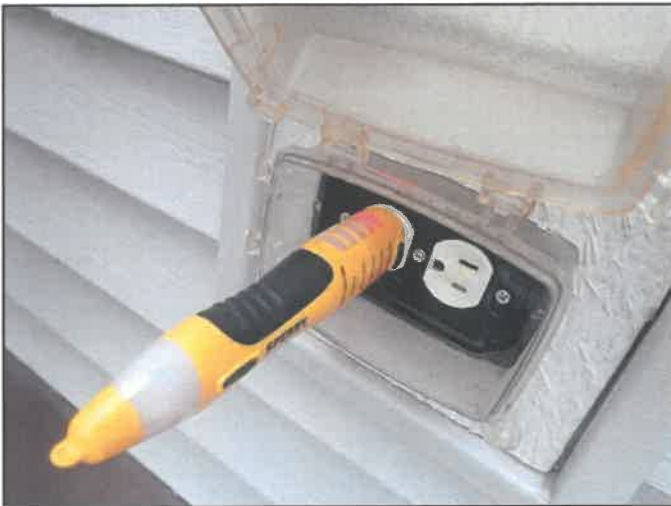
123. Test faulty on GFCI/GFI (Ground Fault...

### 23. Condition: • [Test faulty on GFCI/GFI \(Ground Fault Circuit Interrupter\)](#)

There needs to be a functioning GFCI outlet wherever there is electrical use in proximity to water usage. Some of the currently installed units are malfunctioning and need to be corrected or replaced. They appear to be miswired and may need to be replaced.

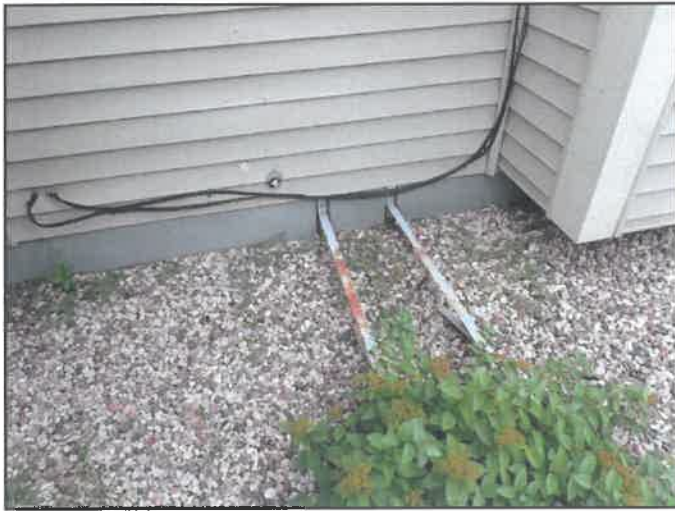
**26. Condition:** • There is evidence that the air conditioner was moved.

177. previous A/C location

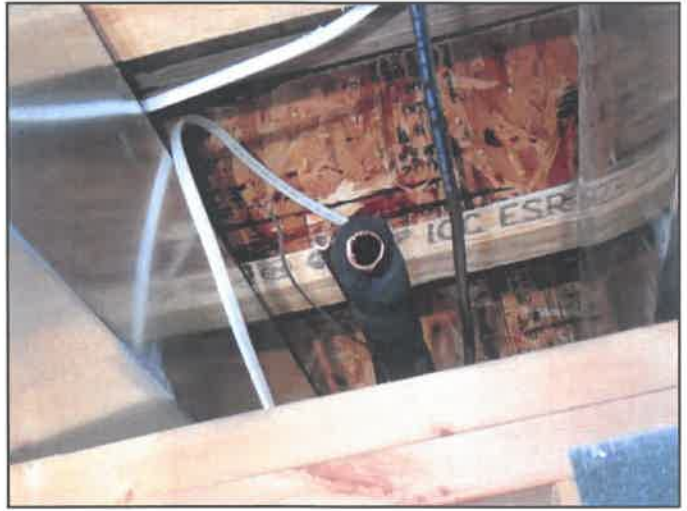
178. Not well secured

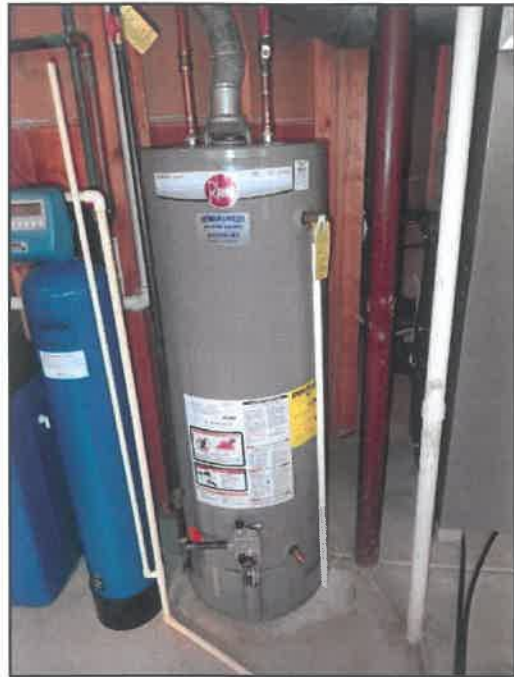
The water heater is slightly under performing and needs to be evaluated and repaired/replaced by a qualified plumber.

217. Service water heater

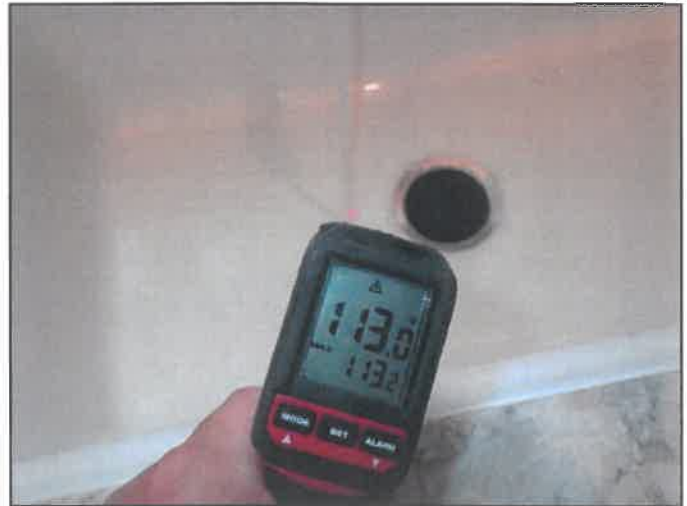
219. Service water heater

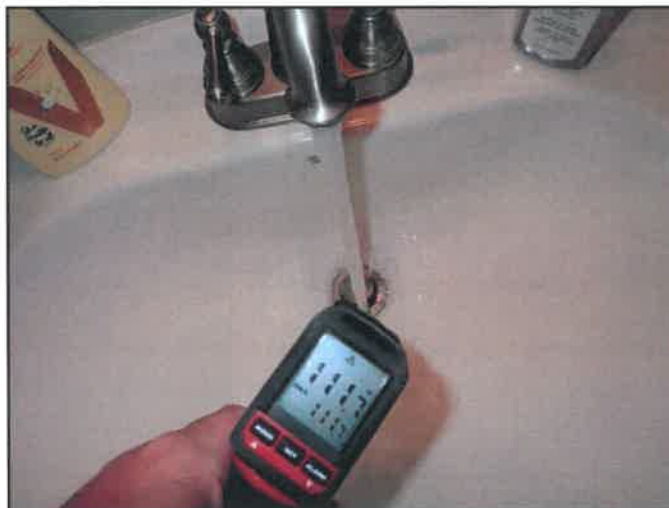
220. Service water heater

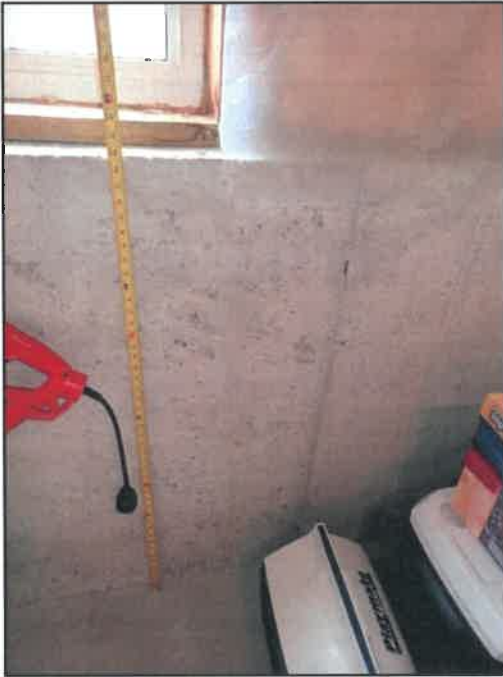
239. not proper egress measurement

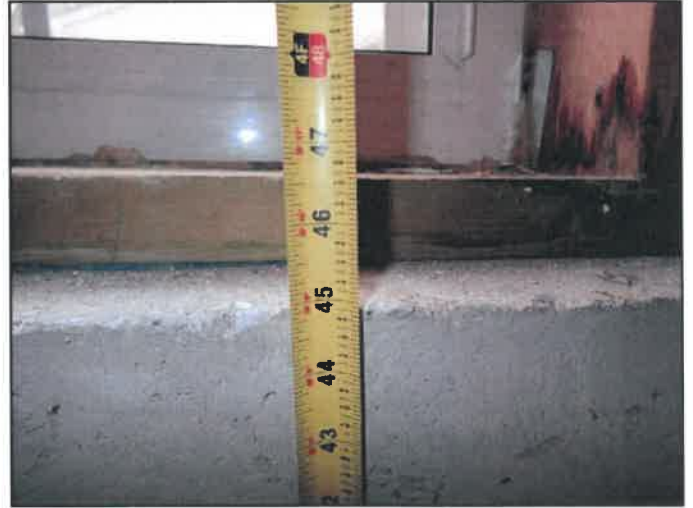
240. not proper egress measurement

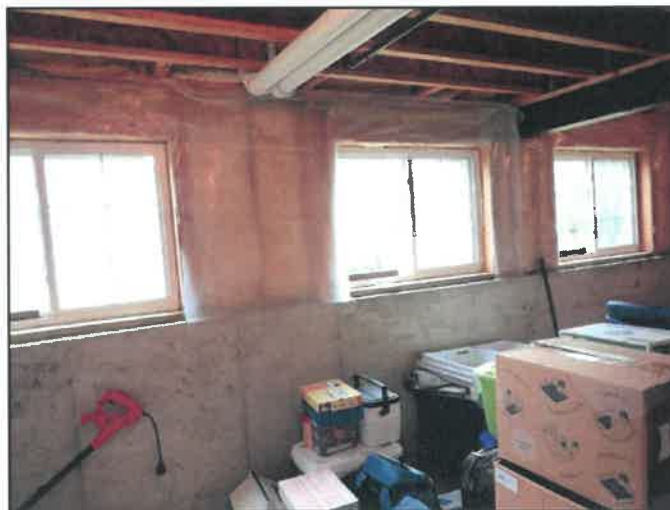
241. not proper egress measurement
