# PRO-VIEW, INC.

## HOME INSPECTION REPORT

514 Alverno Rd. Manitowoc, WI 54220

18134

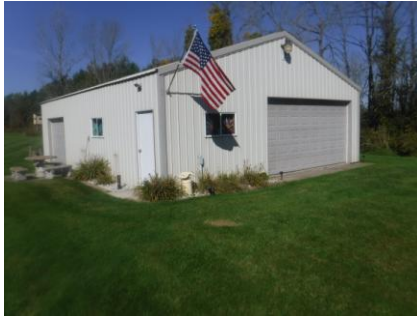
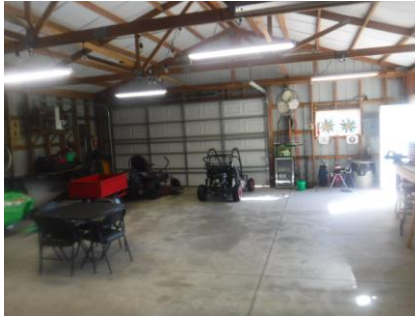
**GARAGE DOOR:**  
 Garage door and opener was in normal working order.  
**GARAGE INTERIOR:**  
 Sill plates not visible.

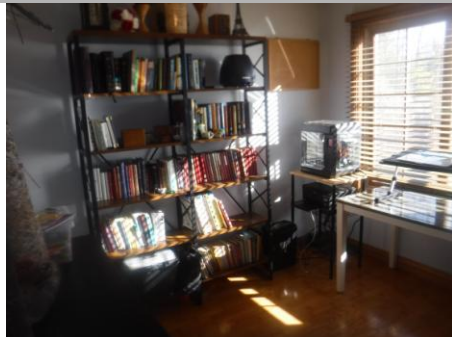
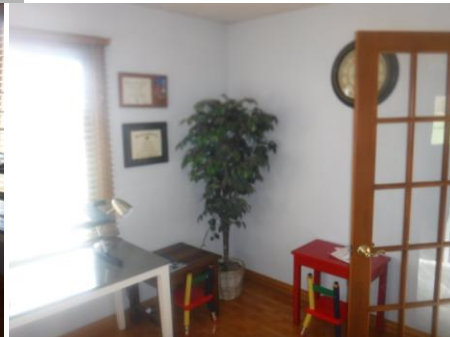
**LOCATION: FIRST FLOOR OFFICE**

Surface deterioration apparent. Maintain as needed.

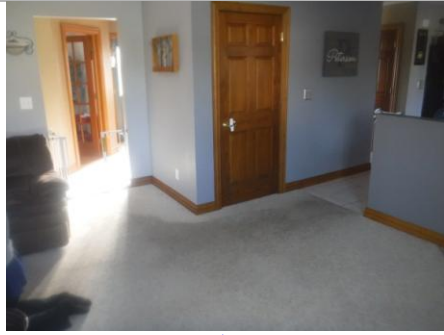
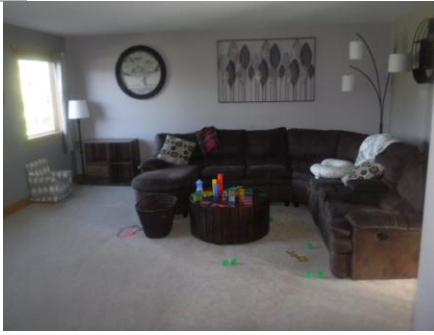
**LOCATION: FIRST FLOOR LIVING ROOM**

Surface deterioration apparent. Maintain as needed.

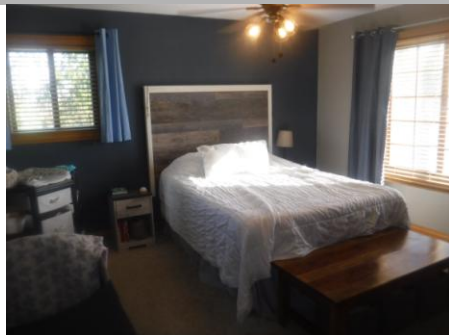
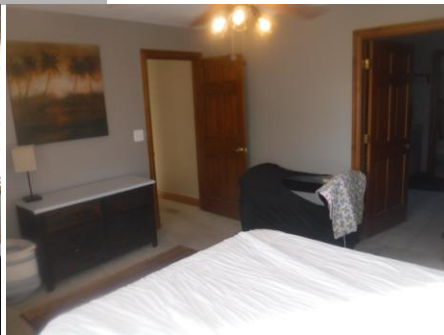
**LOCATION: FIRST FLOOR BEDROOM**

Surface deterioration apparent. Maintain as needed.

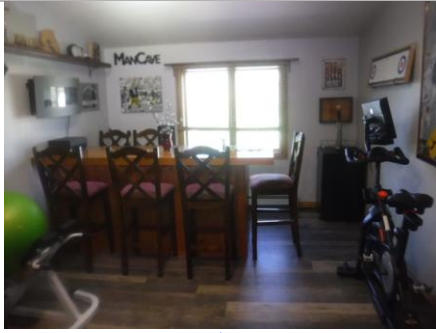
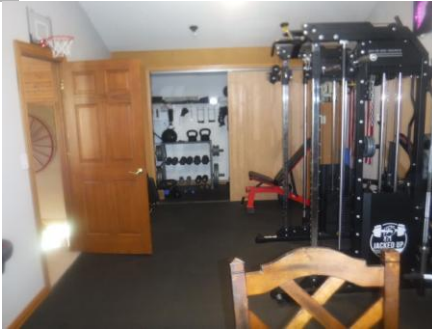
**LOCATION: SECOND FLOOR  
BEDROOM**

Surface deterioration apparent. Maintain as needed.

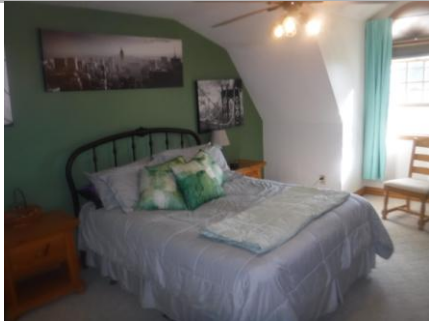
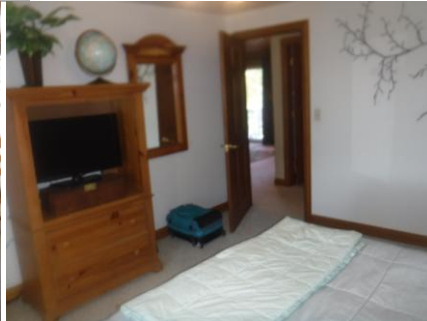
**LOCATION: SECOND FLOOR  
BEDROOM**

Surface deterioration apparent. Maintain as needed.

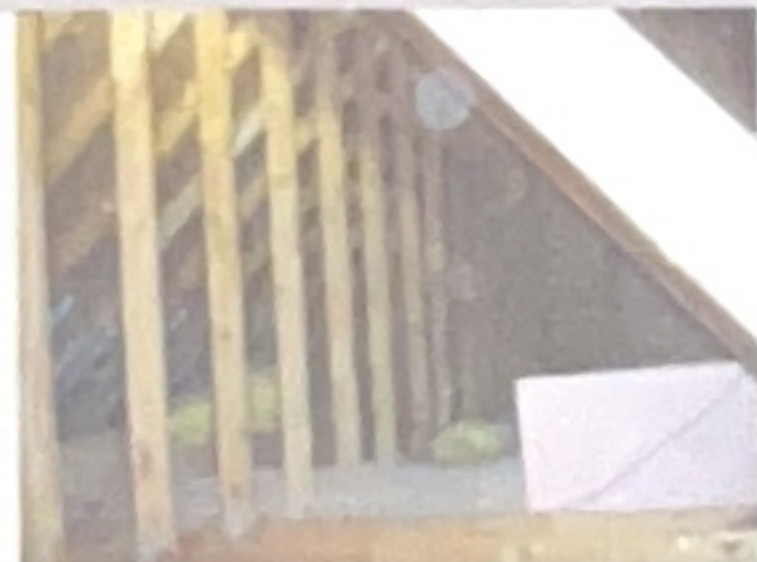
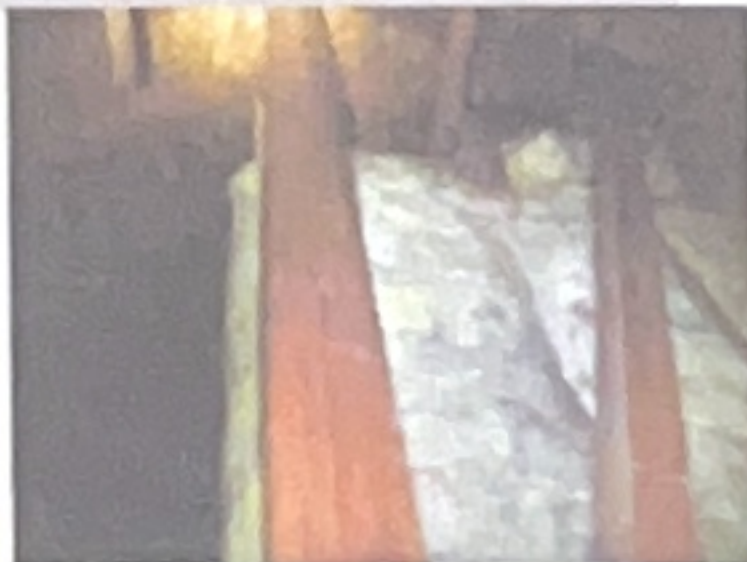
**Roof Sheathing:** ☐ Plywood ☒ OSB☐ 1x Wood☐ *Rotted*☒ *Stained*☐ *Delaminated***Evidence of Condensation/Moisture Leaking:**☒ Yes☐ No

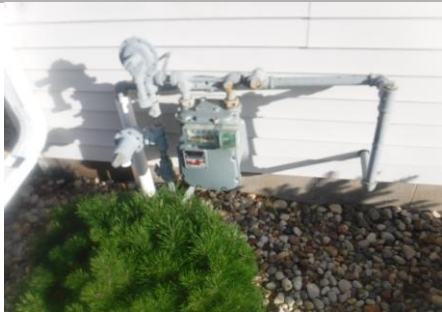
**MAIN FUEL SHUT-OFF LOCATION**

**Gas Line:** ☐ Copper ☐ Brass ☒ Black iron ☐ Stainless steel ☒ CSST ☐ Not visible  
**Condition:** ☒ Satisfactory ☐ Marginal ☐ Poor

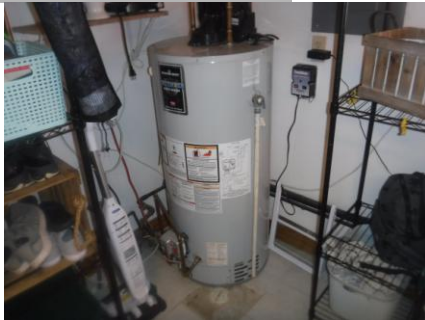
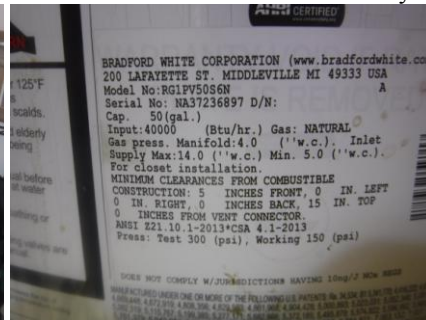
**WATER HEATER**☐ N/ACondition: ☐ Satisfactory ☒ Marginal ☐ Poor

Brand name: **Bradford white**Serial #: **NA37236897**Type: ☒ Gas ☐ Electric☐ Oil ☐ OtherUnit Elevated: ☐ Yes ☐ No ☒ N/A☐ **Tank/Piping corroded/leaking**Capacity: **50** gallonsApproximate age: **10+** year(s)Combustion Air Venting Present: ☒ Yes ☐ No ☐ N/ASeismic restraints needed: ☐ Yes ☐ No ☒ N/ARelief Valve: ☒ Yes ☐ No Extension proper: ☒ Yes ☐ No☐ **Missing** ☐ **Recommend repair**Vent Pipe: ☐ N/A ☒ Satisfactory ☒ Power vent ☐ **Improper**☐ **Rusted** ☐ **Recommend repair**

Roof that is 25+ years  
Boiler that is 28+ years  
Water heater that is 10+ years  
Window, siding and door maintenance and or repair  
Water damaged/stained sheathing in attic  
Balcony maintenance/repair

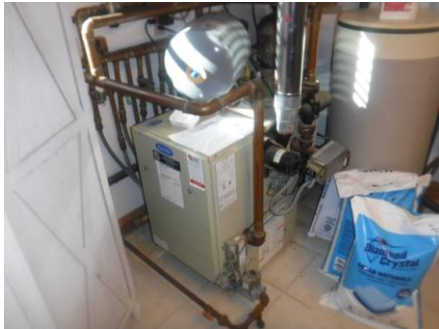
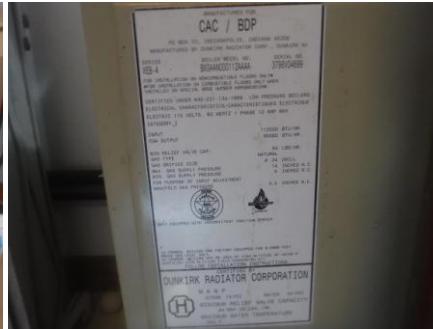
**BOILER SYSTEM**☐ N/A

**Brand Name:** Carrier      Approximate age: 28+ year(s)      ☐ Unknown  
 Model #: BW3AAN000112AAAA      Serial #: 3798V04699  
**Energy Source:** ☒ Gas      ☐ LP      ☐ Oil      ☐ Electric  
**Distribution:** ☒ Hot water      ☒ Baseboard      ☒ Radiant  
**Circulator:** ☒ Pump      ☐ Gravity      ☒ Multiple Zones  
**Controls:** Temp/pressure gauge exist: ☒ Yes      ☐ No      **Operating:** ☒ Yes  
**Relief valve:** ☒ Yes      ☐ No      ☐ Missing      Extension proper: ☒ Yes      ☐ No  
**Operated:** ☒ Fired      ☐ Did not fire  
☒ **Recommend HVAC technician examine/service annually**

**System Condition:** ☐ Satisfactory      ☐ Marginal      ☒ Unknown

Recommend having a contractor to evaluate annually to ensure proper operation.

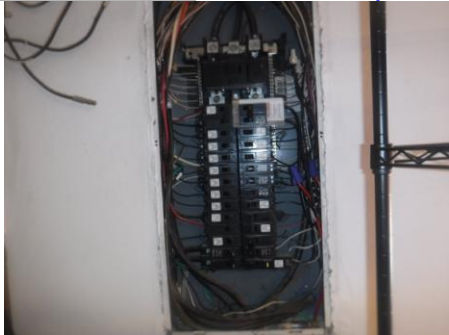
**MAIN PANEL** Location: Utility room
**Condition:** ☒ Satisfactory ☐ Marginal ☐ Poor

**Adequate Clearance To Panel:** ☒ Yes ☐ No Amperage: 200 Volts 120/240 ☒ Breakers ☐ Fuses  
**Appears Grounded:** ☒ Yes ☐ No ☐ Not visible  
**G.F.C.I. present:** ☒ Yes ☐ No **Operative:** ☐ Yes ☒ Not tested  
**A.F.C.I. present:** ☐ Yes ☒ No **Operative:** ☐ Yes ☐ No  
**MAIN WIRE:** ☒ Copper ☐ Aluminum ☐ Copper clad aluminum ☐ Not visible  
☐ *Tapping before the main breaker* ☐ *Double tapping of the main wire*  
**Condition:** ☒ Satisfactory ☐ Poor ☐ **Federal Pacific Panel Stab Lok®**  
**BRANCH WIRE:** ☒ Copper ☐ **Aluminum\*** ☐ Copper clad aluminum ☐ Not visible  
**Condition:** ☒ Satisfactory ☐ Poor ☐ *Recommend electrician evaluate/repair\**  
☒ Romex ☐ BX cable ☐ Conduit ☐ *Knob & tube\*\**  
☐ *Double tapping* ☐ *Wires undersized/oversized breaker/fuse*  
☐ Panel not accessible ☐ Not evaluated
