Proposal for: Geotechnical Engineering Exploration and Analysis  
Burns Residence  
W288 N8053 Park Drive  
Merton, Wisconsin  
Proposal No. 1GP-2602025

Geotechnical Engineering Exploration and Analysis  
Burns Residence  
Merton, Wisconsin  
Proposal No. 1GP-2602025

**PROJECT: Retaining Wall Evaluation for Catherine Burns**  
**W288N8053 Park Drive**  
**Merton, Wisconsin**

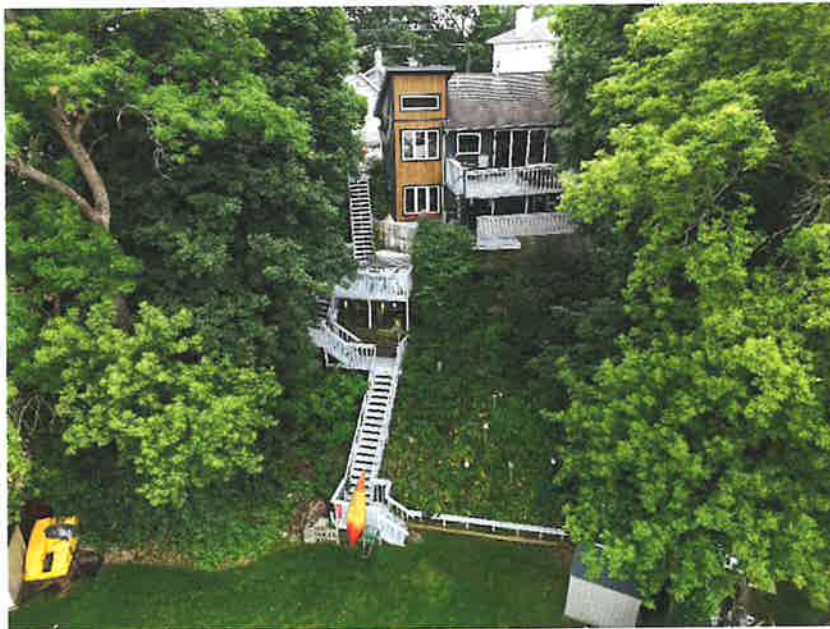
**Photo 1 – Existing Residence and Property, Viewing South**

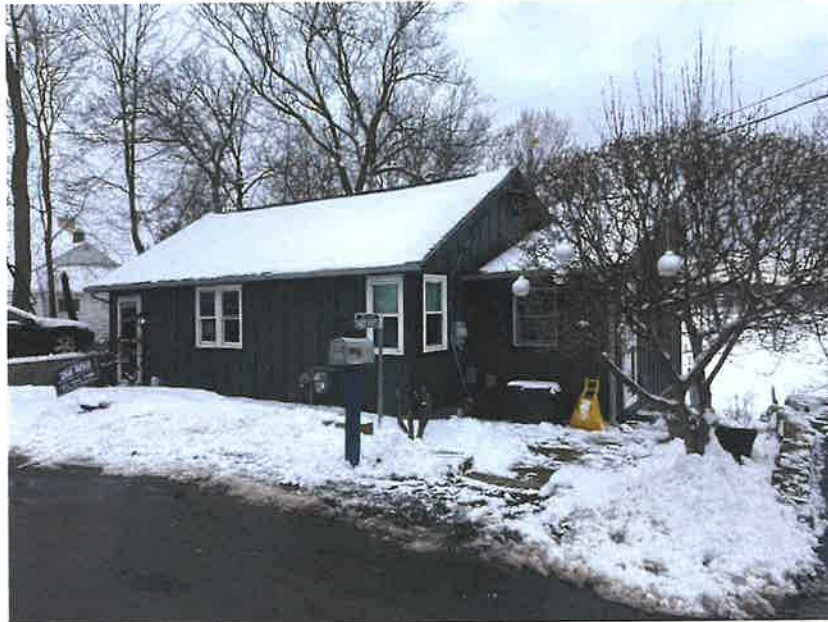
**Photo 2 –Residence, Viewing North from Park Drive**  
(January 19, 2026)

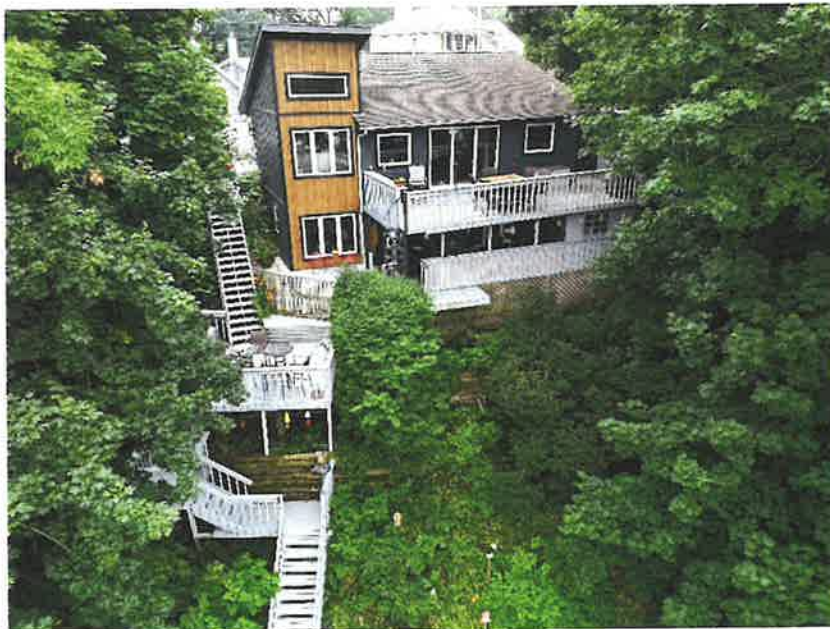
**Photo 3 – Existing Residence and Property Enlarged, Viewing South**  
(August 6, 2026)

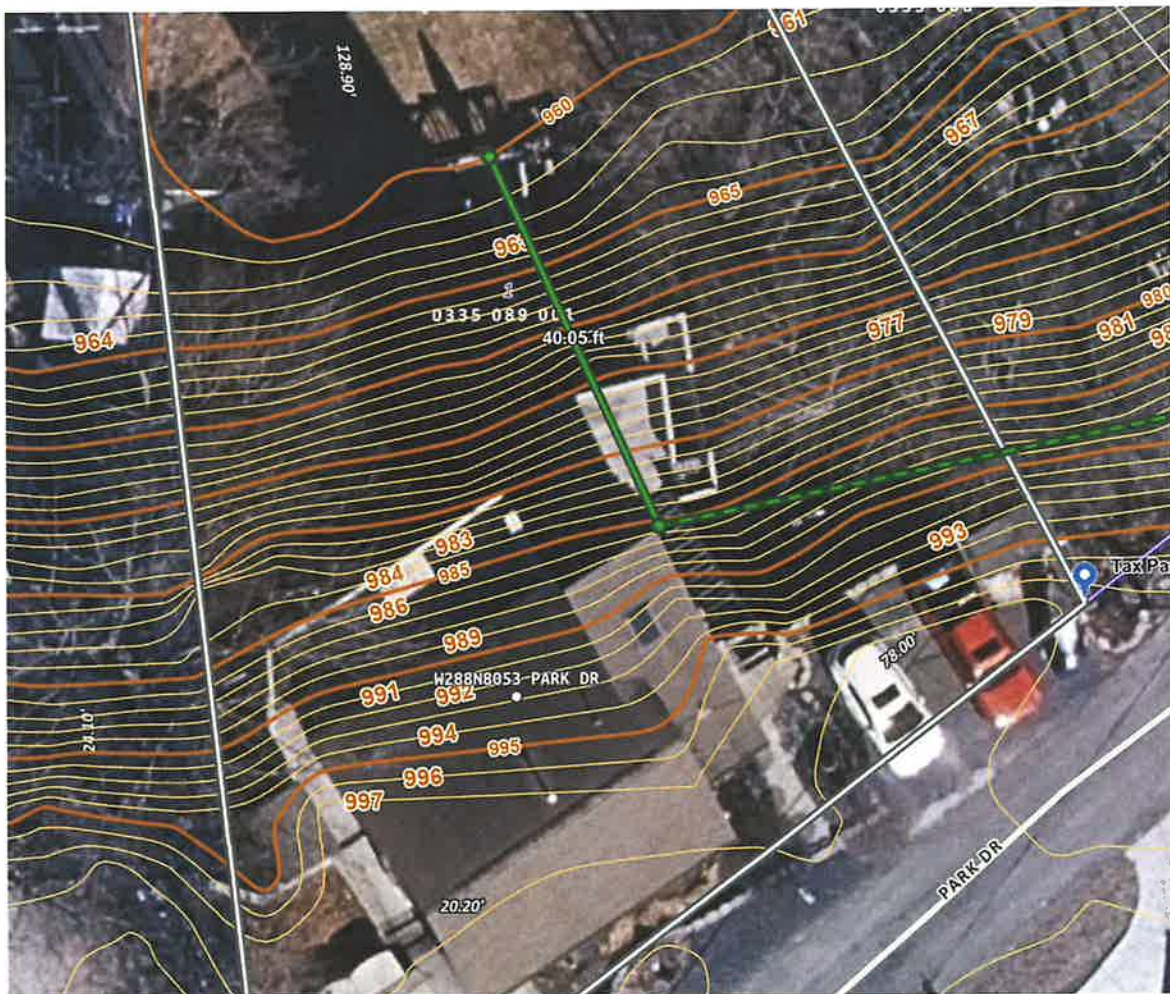
The property to the north of the residence slopes down towards the lake, approximately 25 feet vertically in 40 feet horizontally, or a slope of approximately 62.5% (25 feet / 40 feet = 0.625). This is a steep slope.

Figure 1 – Site Aerial Showing 1 Foot Contour Lines and Distance Measurement from Lawn Area to Northeast Corner of Residence (approximately 40 feet)

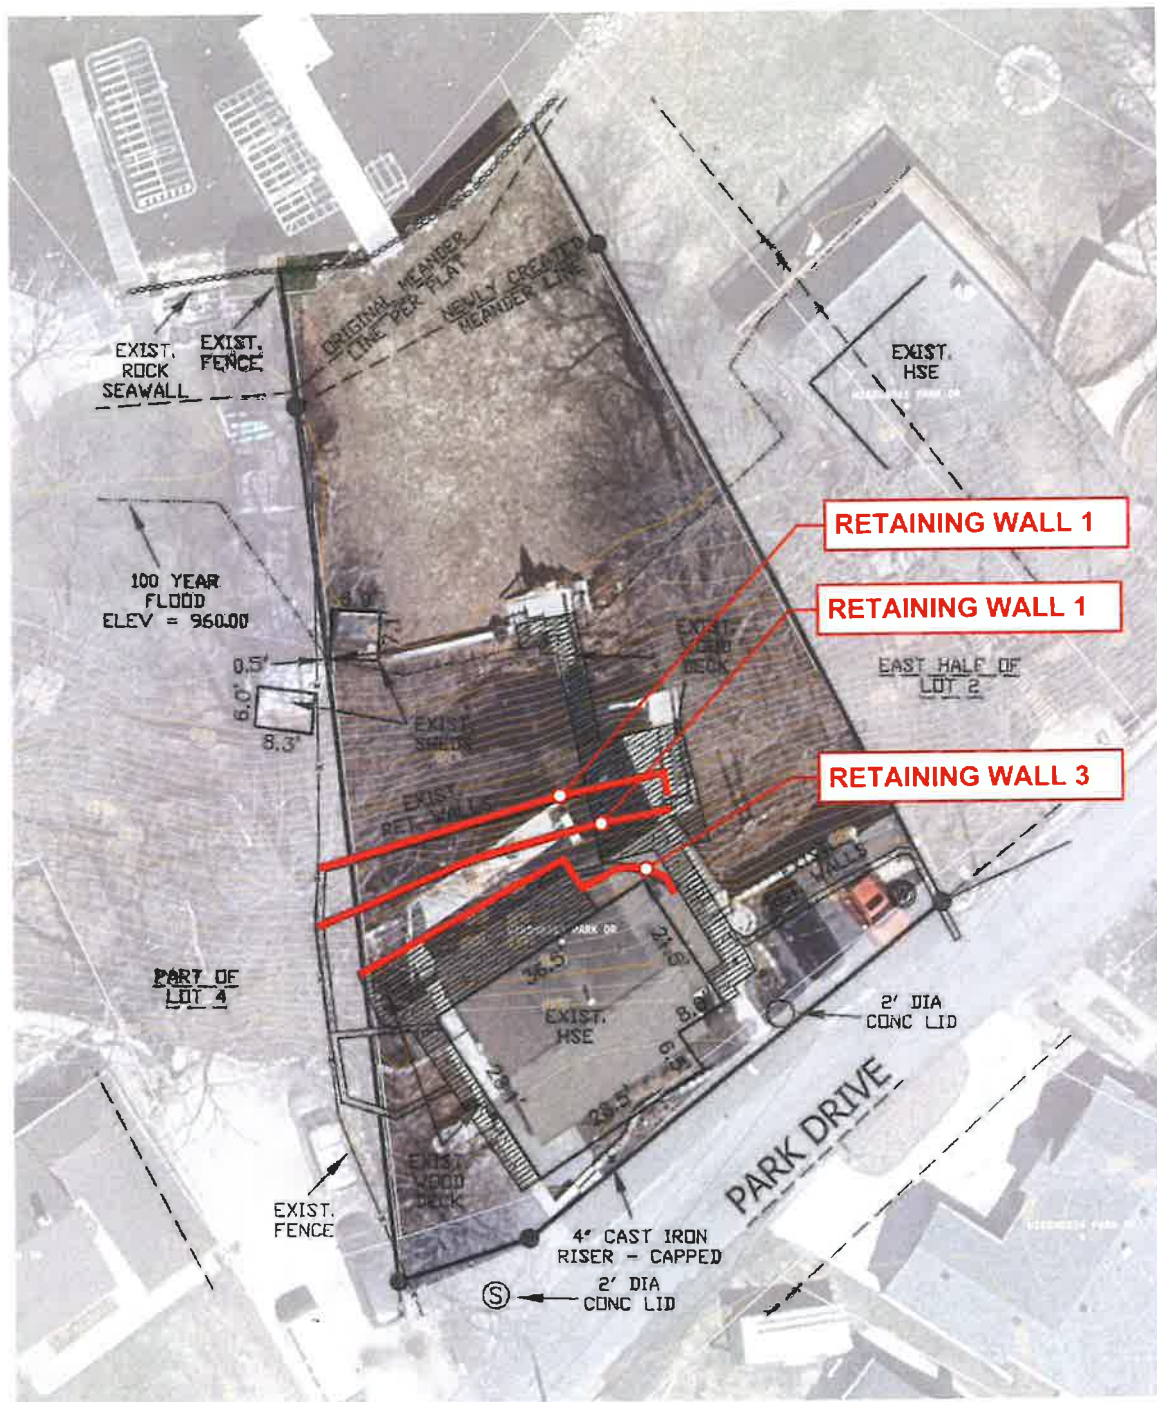
Figure 2 – Site Plan Showing 1 Foot Contour Lines, Survey Information, and Retaining Wall Locations

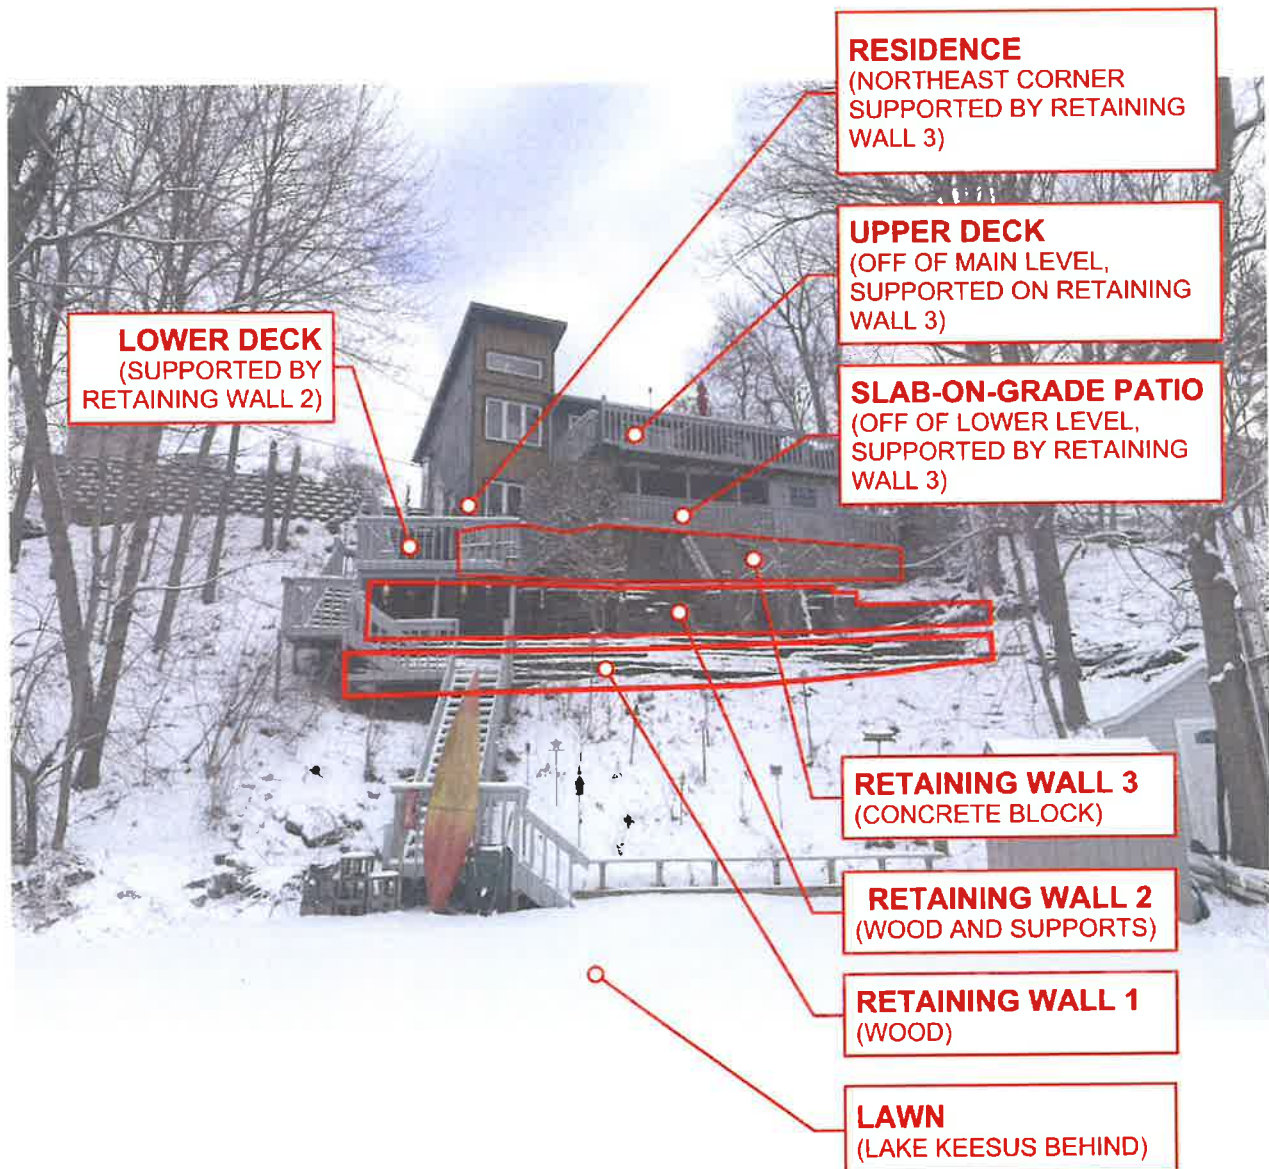
I created the following annotated photograph to label the retaining walls and other major site elements. The wood decks and stairs are largely supported by the three bearing walls. For example, the Upper Deck support columns bear on top of Retaining Wall 3, the Lower Deck joists are supported by Retaining Wall 3 and the Lower Deck support columns bear on top of Retaining Wall 1.

Figure 3 – Annotated Photograph Showing Retaining Wall and Major Site Elements

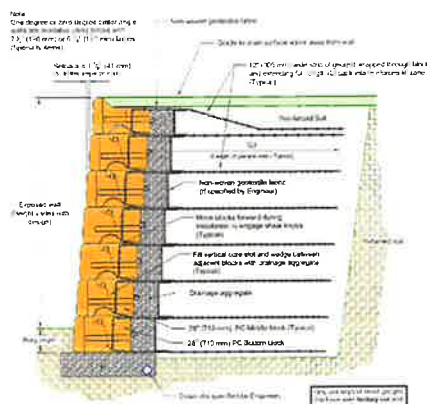
**Figure 4 – Conceptual Example Drawing of Retaining Wall Design**

Hiring a Design Professional (Engineer) to design a new retaining wall system for the north slope (see example images below) (this service is often provided by the retaining wall supply company, for example using precast concrete retaining wall blocks and related components)

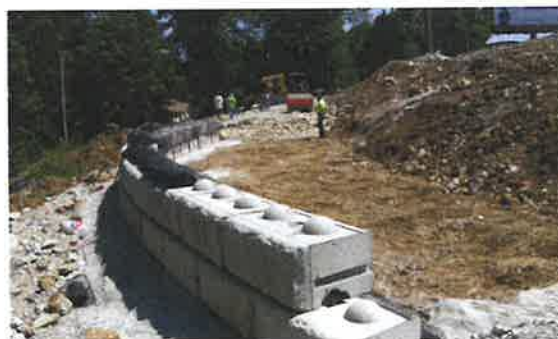
**Figure 5 – Conceptual Example Photo of Retaining Wall Installation**

2. Hiring a Contractor to demolish and remove the existing wood decks, stairs, and railings in the area
3. Hiring a Landscaping Contractor to remove the existing Retaining Walls, prepare the site, and install new precast concrete retaining wall block system
4. Hiring a Contractor to install new wood decks, railings, and stairs

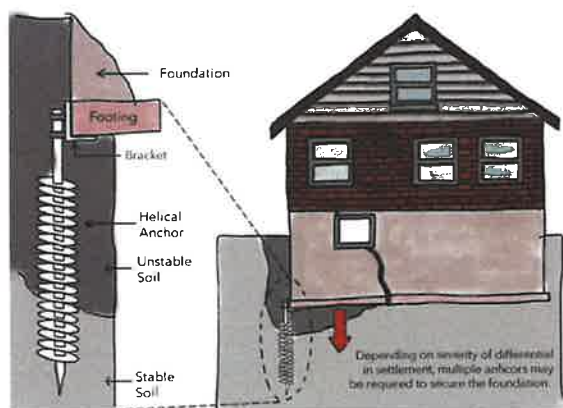
Figure 4 – Conceptual Diagram of  
Helical Pier Installation at Foundation

4. Hiring a Design Professional (Engineer) to design an underpinning solution for the house foundation, if required (see example images of helical piers below)

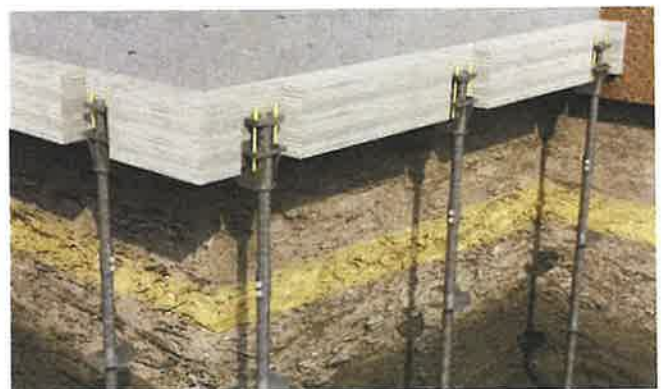
Figure 5 – Conceptual Example Photo  
of Helical Piers
