HOME SHIELD INSPECTIONS LLC
608-394-2020
mike@hs-inspections.com
https://www.hs-inspections.com

RESIDENTIAL HOME INSPECTION WITH A HEALTHY DOSE OF REALITY

2224 Kane St
La Crosse, WI 54603

Nick Santos
05/13/2025

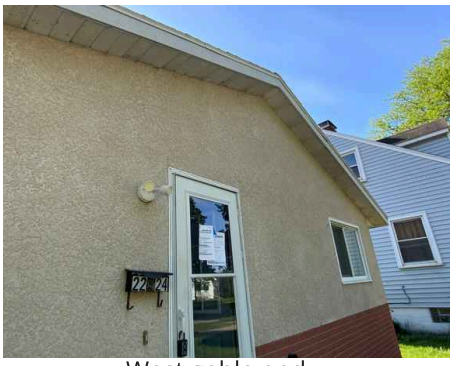
West gable end

I looked for flashing installed at the eaves (near the gutter edge) and at the gables (the diagonal edge of the roof). There should be metal drip flashing material installed in these locations. The flashing helps the surface water on the roof to discharge into the gutter. Flashing also helps to prevent water intrusion under the roof-covering.

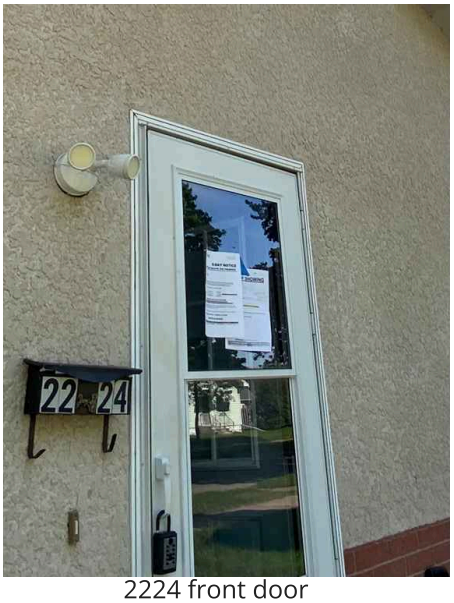
2224 front door

2224 back door

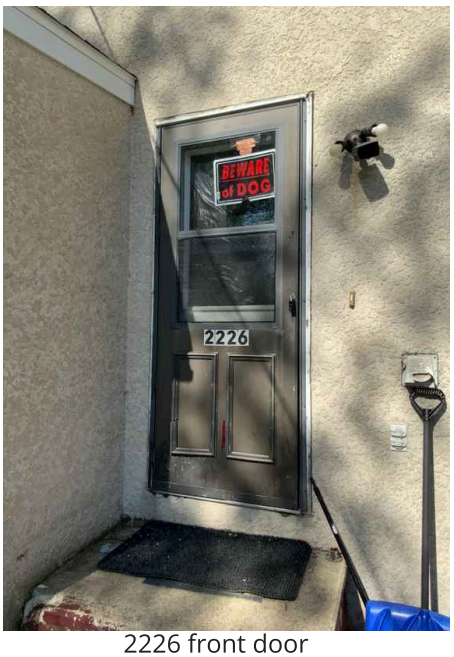
2226 back door

2226 front door

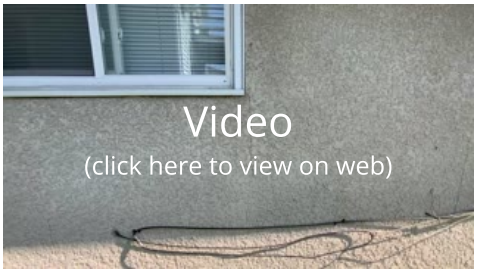
3.3.1 Wall-Covering, Flashing & Trim

CRACKING - MINOR

Siding showed cracking in one or more places. Recommend monitoring.

Recommended DIY Project

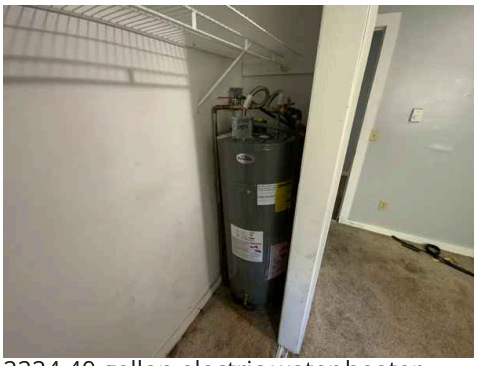
10.4.1 Hot Water Source

DEFECT AT TPR VALVE DISCHARGE

I observed a defect a the TPR (temperature, pressure, and relief) valve. The discharge pipe that serves a temperature pressure relief valve must:

- Not be connected to the drainage system.
- Discharge through an air gap located in the same room as the water heater.
- Not be smaller than the diameter of the outlet of the valve.
- Serve a single relief device.
- Discharge to the floor.
- Discharge in a manner that does not cause personal injury or structural damage.
- Discharge to a termination point that is readily observable.
- Not be trapped.
- Be installed so as to flow by gravity.
- Terminate no more than 6 inches above the floor or flood level rim of the waste receptor. And not less than 2 times the discharge pipe diameter.
- Not have valves or tee fittings.
- Be constructed of materials listed or rated for such use.
- Be one nominal size larger that the size of the relief valve outlet, where the relief valve discharge piping is installed with insert fittings.

Contact a qualified plumbing contractor.

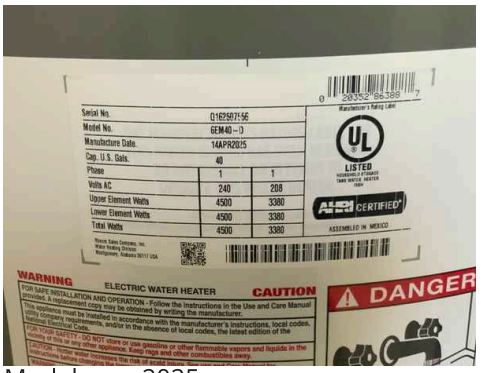
2224 40 gallon electric water heater

Model year 2025

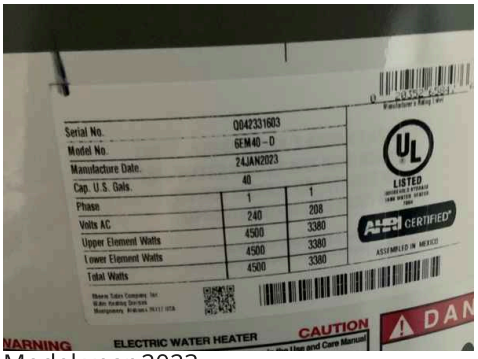
2226 40 gallon electric water heater

Model year 2023
