WOOD DESTROYING PESTS AND ORGANISMS INSPECTION REPORT

Building Address: 6527 Marlow Av., Bell Gardens, CA 90201		Date of Inspection 07/22/2025	Number of Pages 12

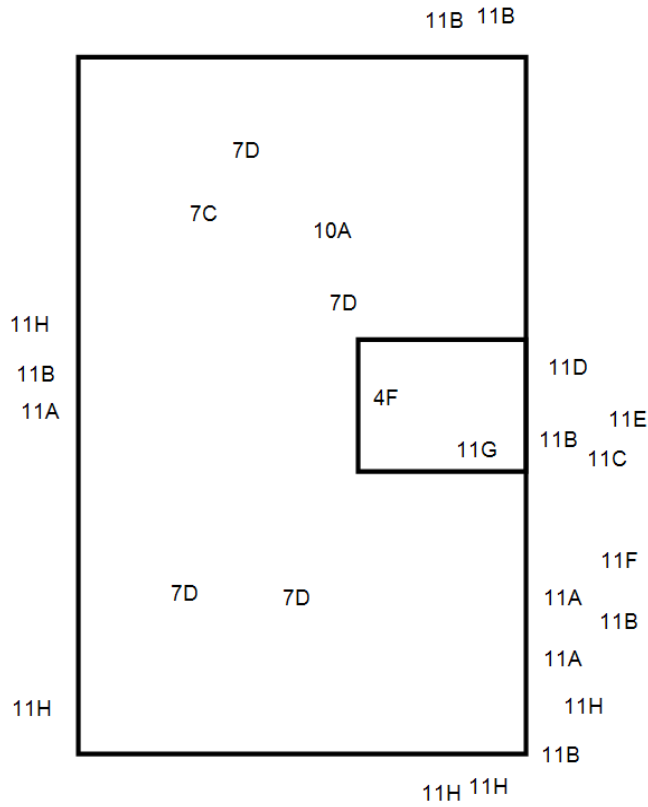
This Diagram is not to scale

The drawing is located on the final page.

- 11L PRICE: See 11A (Section I)
FINDINGS: Evidence of drywood termite damaged wood members noted at time of inspection at carport siding, 3x3 osb as indicated on the diagram.
RECOMMENDATION: Repair, replace or re-inforce termite damaged wood members as necessary. Timbers not structurally weakened will be repaired with a wood filler. No paint is included in this estimate. During course of repairs if additional wood damage is discovered supplemental will be issued with new repairs . There may be an additional charge.
