WOOD DESTROYING PESTS AND ORGANISMS INSPECTION REPORT

BUILDING NO. 1448	STREET, CITY, STATE, ZIP Wild Oak Court, Lakeport CA 95453	Date of Inspection 3/28/2022	No. of Pages 7

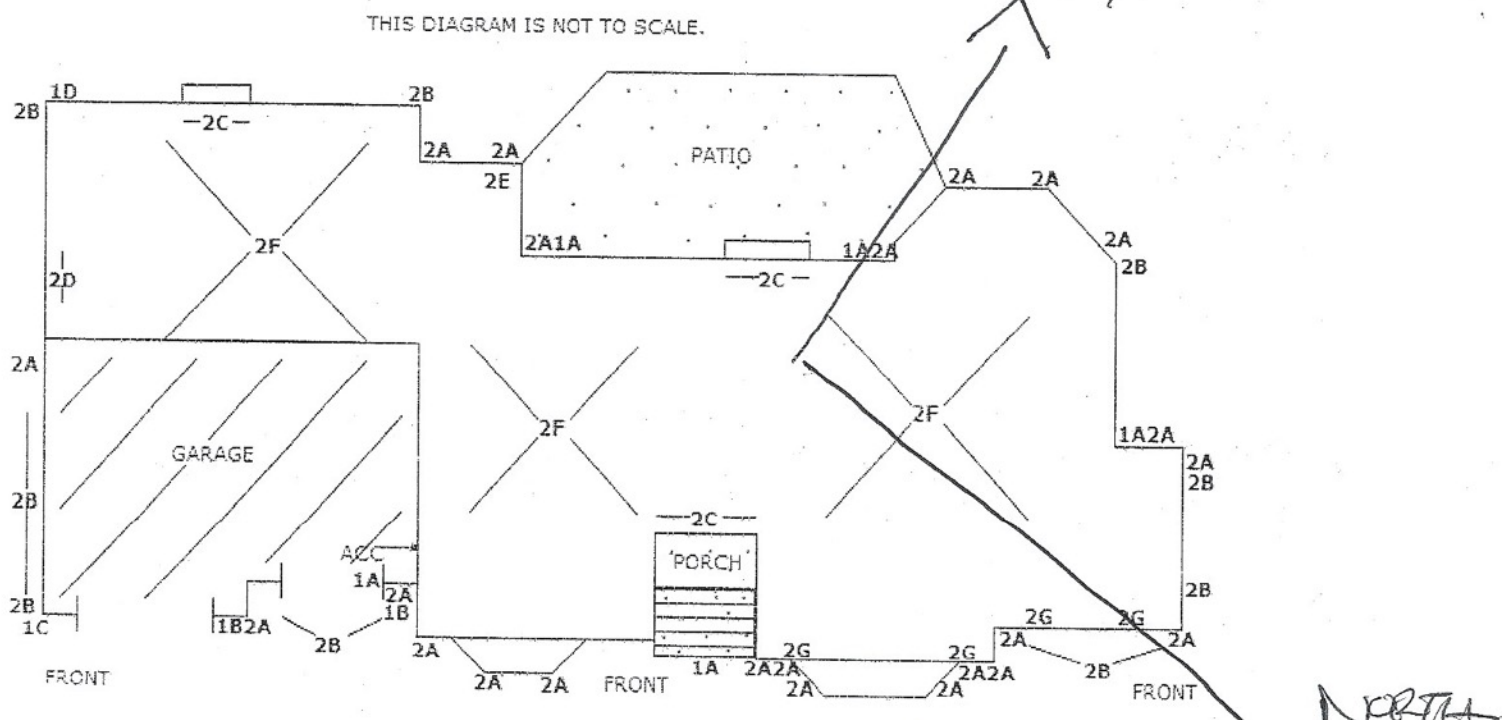
Other Tags Posted: None Noted	
An inspection has been made to the structure(s) shown on the diagram in accordance with the Structural Pest Control Act. Detached porches, detached steps, detached decks and any other structures not on the diagram were not inspected.			
Subterranean Termites <input type="checkbox"/> Drywood Termites <input type="checkbox"/> Fungus/Dryrot <input checked="" type="checkbox"/> Other Findings <input checked="" type="checkbox"/> Further Inspection <input checked="" type="checkbox"/>			
If any of above boxes are checked, it indicates that there were visible problems in accessible areas. Read the report for details on checked items.

ITEM 1A **FINDING:** Fungus has damaged the roof sheathing at the front, back, and right side of the structure.
