HOME SHIELD INSPECTIONS LLC
608-394-2020
mike@hs-inspections.com
https://www.hs-inspections.com

RESIDENTIAL HOME INSPECTION WITH A HEALTHY DOSE OF REALITY

1024 Park Ridge Dr
Onalaska, WI 54650

MaKayla Garey
02/11/2026

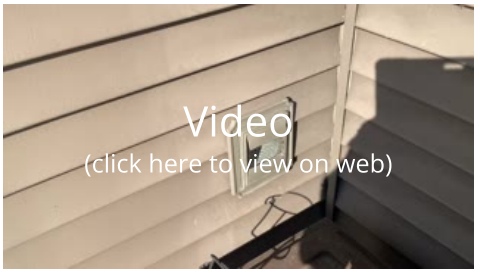
3.12.1 Exhaust Hoods

Minor Defect

DAMAGED EXHAUST HOOD

I observed an exhaust hood that was damaged. The hood is missing some louver panels.

Recommended DIY Project

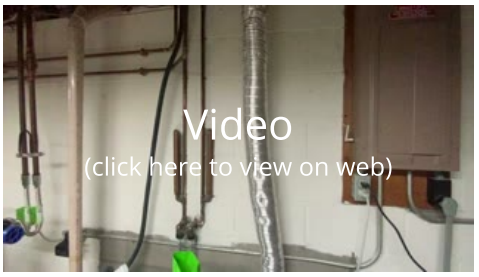
6.2.1 Clothes Dryer

Minor Defect

DAMAGED DRYER EXHAUST PIPE

I observed indications of a damaged exhaust pipe of the clothes dryer.

Contact a qualified appliance repair professional.

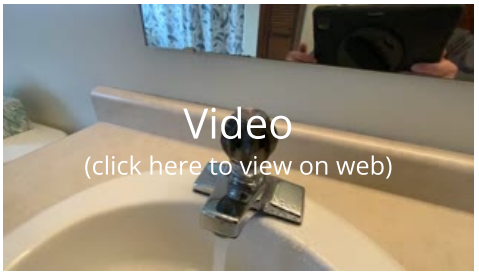
11.2.1 Sinks, Tubs & Showers

Major Defect

ACTIVE WATER LEAK

I observed indications of an active water leak.

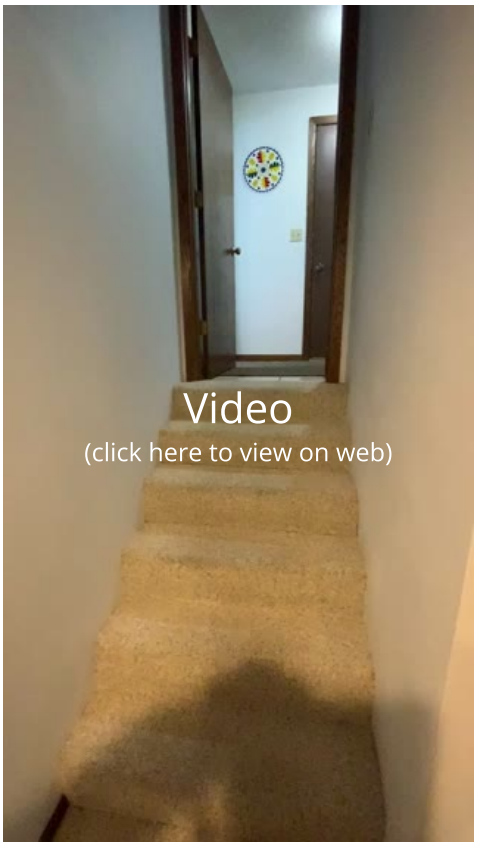
17.5.1 Stairs, Steps, Stoops, Stairways & Ramps

Minor Defect

MISSING HANDRAIL

I observed a missing handrail.

There is more than one step here, and I recommend installing a handrail for safety.
