# WOOD DESTROYING PESTS AND ORGANISMS INSPECTION REPORT

BUILDING NO. <b>3398</b>	STREET, CITY, STATE, ZIP <b>Ogden Road, Lucerne CA 95458</b>	Date of Inspection <b>3/5/2026</b>	No. of Pages <b>10</b>
-----------------------------	---	---------------------------------------	---------------------------

General Description: Two Story, Single Family Dwelling, Wood Exterior, Attached Porch, Deck. Partially Furnished/ Unoccupied	Inspection Tag Posted: Subarea
	Other Tags Posted: Aardvark Termite Control 6-11-2012

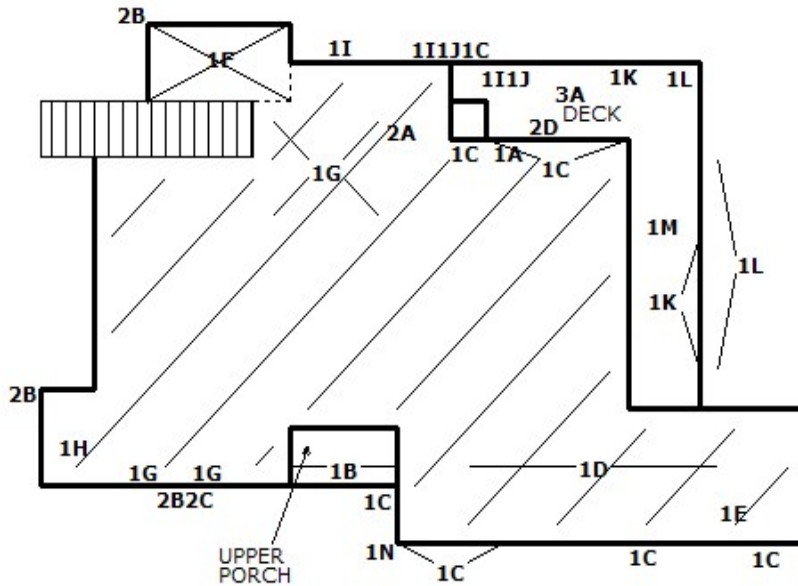
An inspection has been made to the structure(s) shown on the diagram in accordance with the Structural Pest Control Act. Detached porches, detached steps, detached decks and any other structures not on the diagram were not inspected.

FRONT

THIS DIAGRAM IS NOT TO SCALE.
