# Cal Land Engineering & Associates, Inc.

Subject: Report of Geotechnical Engineering Investigation, Proposed Residential Development, 1003 Carbon Canyon Road, Lot 7, Block 3, Tract 2037, APN: 1000-143-04, Chino Hills, California. CLE Project No.: 25-210-003bEG

**REPORT OF GEOTECHNICAL ENGINEERING  
INVESTIGATION**

**Proposed Residential Development**

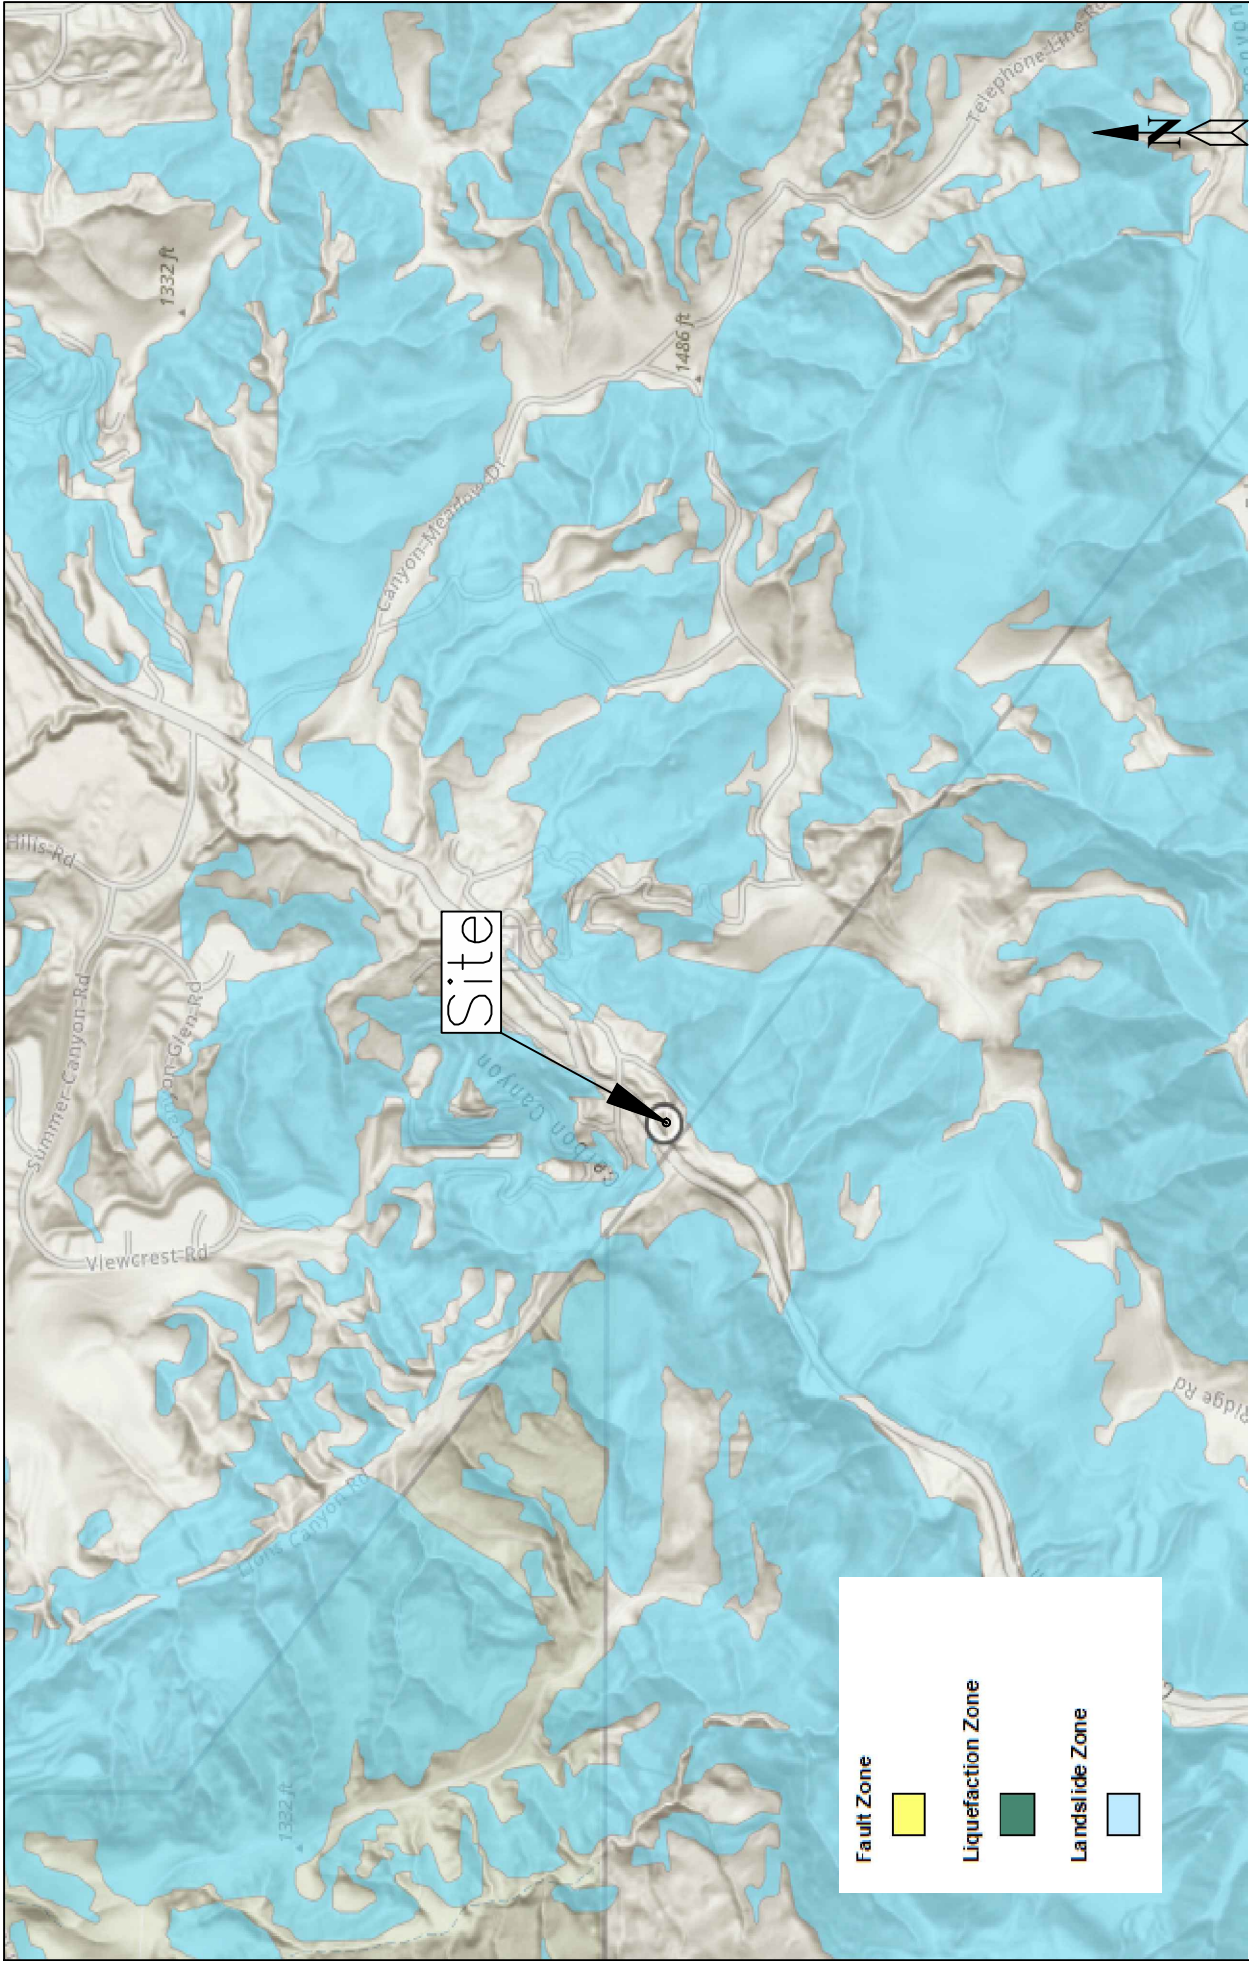
FIGURE 2

Map modified from "Earthquake Zones of Required Investigation" by CGS

Based on our review of the "Earthquake Zones of Required Investigation" by California Geological Survey (CGS), shown on the attached Seismic Hazard Map (Figure 2), it is concluded the subject site is not included within any Earthquake Fault Zones as created by the Alquist-Priolo Earthquake Fault Zoning Act (CGS, 2018). Our review of geologic literature pertaining to the site area indicates that there are no known active or potentially active faults located within or immediately adjacent to the subject property. The nearest known active regional fault is the Elsinore fault located approximately 2.6 miles from the subject site.

Based on our review of the "Earthquake Zones of Required Investigation" by California Geological Survey (CGS), shown on the attached Seismic Hazard Map (Figure 2), it is concluded that the site is not located in the mapped potential liquefaction areas.

Based on our review of the "Earthquake Zones of Required Investigation" by CGS, shown on the attached Seismic Hazard Map (Figure 2), it is concluded that the subject site is not located in the mapped potential seismic induced landslide areas. However, the adjacent properties bounding the site on the east, south, and west, are located in the mapped potential seismic induced landslide areas. Based on our slope stability analysis, it is our opinion that the existing slope is considered grossly and surficially stable under the design conditions, provided the slope is properly maintained and normal rainfall with no concentrated flow on slope.
