# WOOD DESTROYING PESTS AND ORGANISMS INSPECTION REPORT

| Building Address:<br><b>20892 McKinley Way, Groveland, CA 95321</b> | | Date of Inspection<br><b>11/08/2023</b> | Number of Pages<br><b>6</b> |
| General Description:<br>Multi-Level Two Story Wood Frame Wood Siding Occupied Furnished | | Inspection Tag Posted: Interior | |

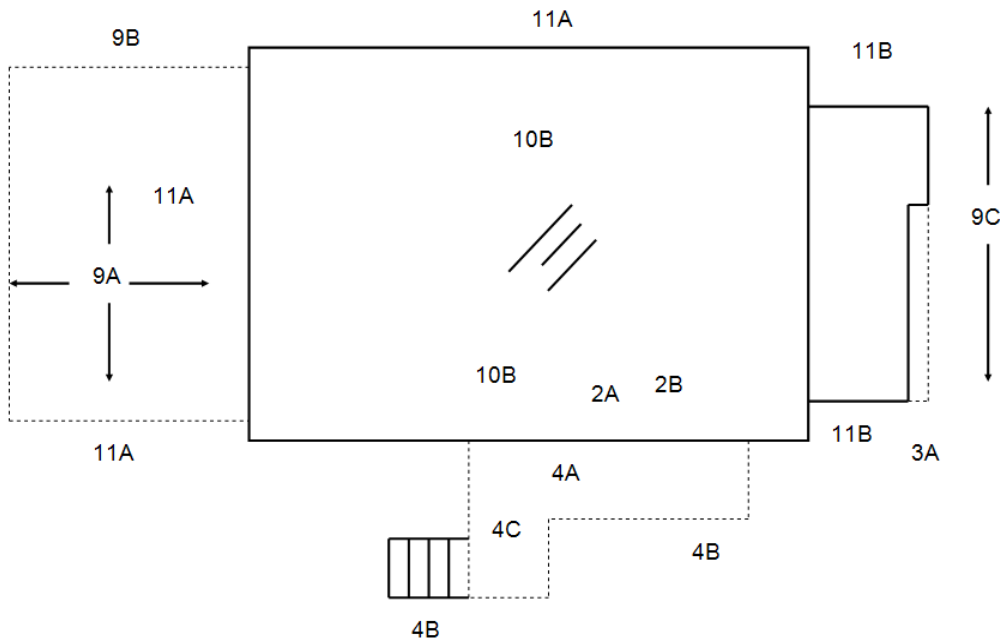
| An inspection has been made of the structure(s) shown on the diagram in accordance with the Structural Pest Control Act. Detached porches, detached steps, detached decks and any other structures not on the diagram were not inspected. | | | |

This Diagram is not to scale
