# WOOD DESTROYING PESTS AND ORGANISMS INSPECTION REPORT

| Building No.<br><b>1764</b> | Street<br><b>DEAVERS DR</b> | City<br><b>SAN MARCOS</b> | Zip<br><b>92069</b> | Date of Inspection<br><b>09/12/26</b> | Number of Pages<br><b>1 of 4</b> |

**Report # 266310**

General Description:  
**2 Story, single family residence, concrete slab, attached garage, wood frame & stucco, occupied w/ tile roof.**

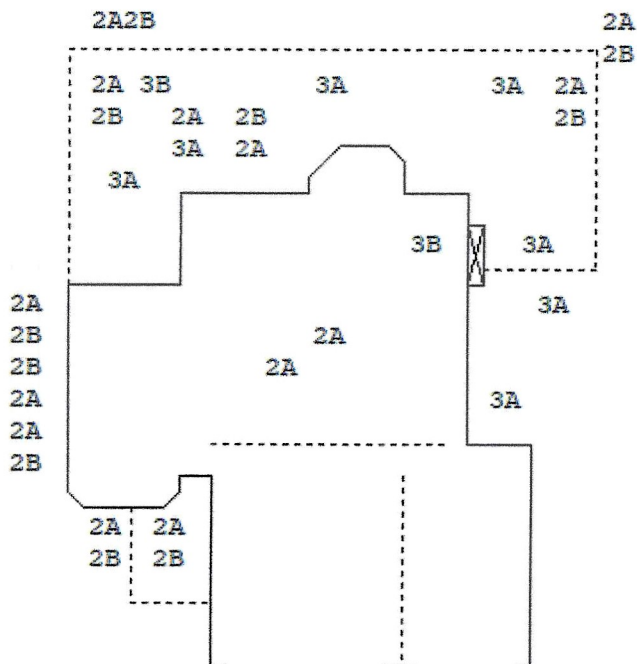
An inspection has been made of the structure(s) shown on the diagram in accordance with the Structural Pest Control Act. Detached porches, detached steps, detached decks and any other structures not on the diagram were not inspected.
