# WOOD DESTROYING PESTS AND ORGANISMS INSPECTION REPORT

| Building No.<br><b>4519</b> | Street<br><b>BANNOCK AVE</b> | City<br><b>SAN DIEGO</b> | Zip<br><b>92117</b> | Date of Inspection<br><b>08/28/26</b> | Number of Pages<br><b>1 of 4</b> |

**1 Story, single family residence, concrete slab, attached garage, wood frame & stucco, occupied w/ composition roof.**

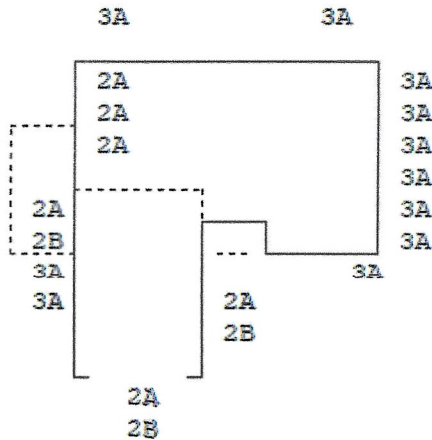
An inspection has been made of the structure(s) shown on the diagram in accordance with the Structural Pest Control Act. Detached porches, detached steps, detached decks and any other structures not on the diagram were not inspected.

2A. FINDING: Infestation by drywood termites noted in garage door, fascia boards, rafter tails, blocks and bedroom wall. Infestation appears to extend into inaccessible areas.
