# WOOD DESTROYING PESTS AND ORGANISMS INSPECTION REPORT

## **COMPLETE W.D.O. REPORT**

**for**  
**4689 N. Feland Ave, Fresno CA 93722**

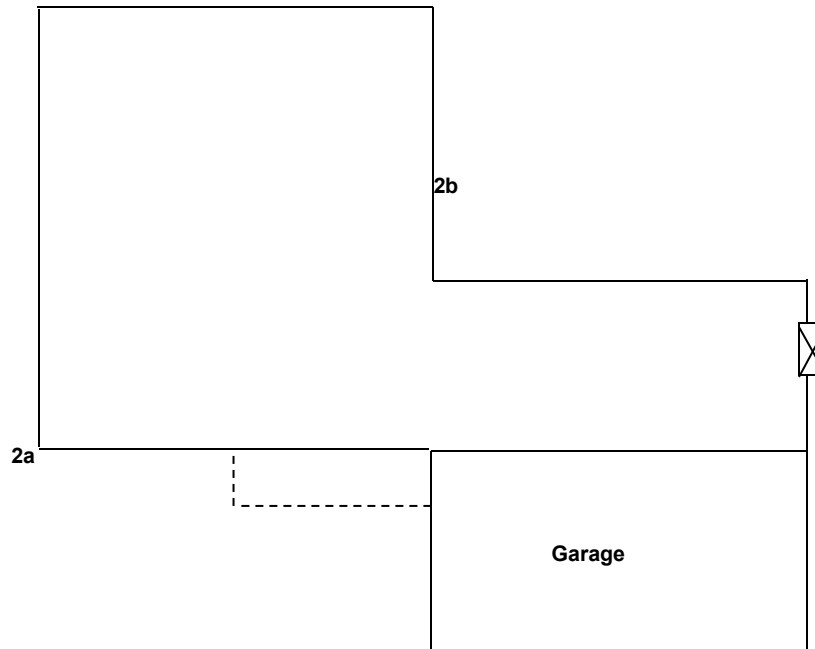
**Drawing Not to Scale**

- 2a. **Finding:** Soil levels too high and in contact with the siding were noted in the front of the home as noted on the diagram.

- 2b. Finding:** Bubbling or damaged stucco was noted in the rear of the home as noted on the diagram.

**Recommendation:** Re-grade the soil or rocks in the area to below the top of the foundation and to break direct contact with the siding.

**Recommendation:** The damage may be due to the unique drainage conditions in the area. Engage a contractor to inspect the areas, to repair the stucco, and to make any necessary corrections in the grade conditions needed to facilitate drainage away from the home.
