WOOD DESTROYING PESTS AND ORGANISMS INSPECTION REPORT

Building No. 1521	Street Montgomery st.	City Oroville	ZIP 95966	Date of Inspection 03/13/2026	Number of Pages 5
Hobbs Pest Solutions, Inc P. O. Box 2486 Oroville CA 95965 (530) 624-5390 bhobbs@hobbspestsolutions.com				Report # : 13765 Registration # : PR 7460 Escrow # : <input type="checkbox"/> CORRECTED REPORT	
Ordered by: Tara Iorg-Atteberry* Better Homes and Gardens		Property Owner and Party of Interest: Jeff McClure		Report sent to:	
COMPLETE REPORT <input checked="" type="checkbox"/>		LIMITED REPORT <input type="checkbox"/>		SUPPLEMENTAL REPORT <input type="checkbox"/>	
GENERAL DESCRIPTION: One story, single family residence, raised foundation, wood siding, composite roofing, occupied/ furnished, detached garage				Inspection Tag Posted: Subarea	
				Other Tags Posted:	
An inspection has been made of the structure(s) shown on the diagram in accordance with the Structural Pest Control Act. Detached porches, detached steps, detached decks and any other structures not on the diagram were not inspected.

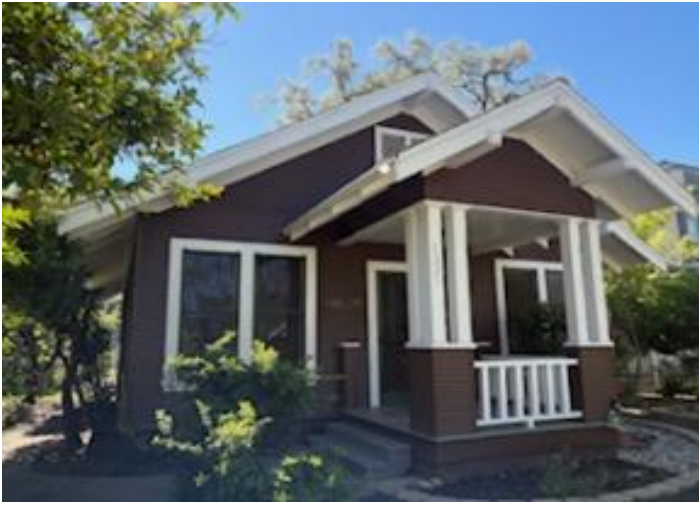
9A

FINDINGS - Excessive moisture damage, fungus/ dry rot noted to deck boards at various locations.

RECOMMENDATION -Cut out excessive moisture damages to wood members (dry rot and/or fungus), treat with state approved fungicide and repair/replace as needed. (no paint) If further damages are found at time of repairs, a supplemental report will be submitted

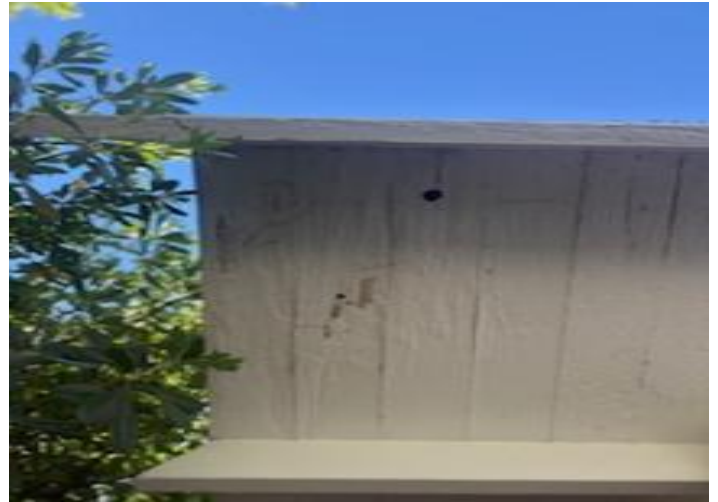
11B

FINDINGS - Excessive moisture damage, fungus/ dry rot noted to eave sheeting at various locations.

RECOMMENDATION - Owner/agent should engage the services of a licensed roofing contractor to make any necessary repairs.

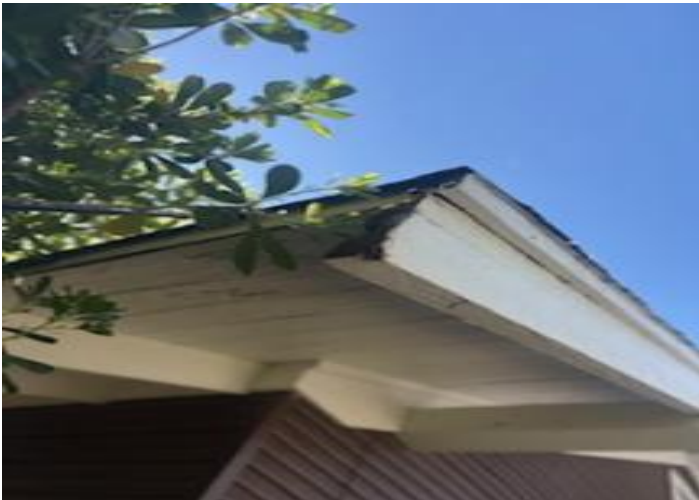
11A

FINDINGS - Excessive moisture damage, fungus/ dry rot noted to barge rafters/ shingle molding at various locations.

RECOMMENDATION - Cut back or cut out infected and or damaged wood members. Fill in, replace or repair as needed. Prime paint only upon owners request. scrape and treat with timbor as needed.

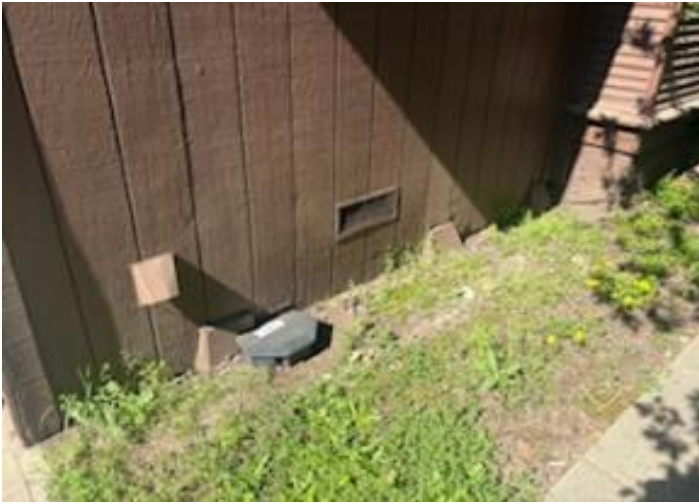
11D

FINDINGS - Excessive moisture damage, fungus/ dry rot noted to siding at various locations.

RECOMMENDATION- Remove and replace damaged siding or skirting with matching or harmonizing style material. Z-bar if often used when only lower portions of siding/skirting are replaced. If further damages are exposed during removal of infected/infested siding, a supplemental report will be submitted with new findings and recommendations for correction. Prime

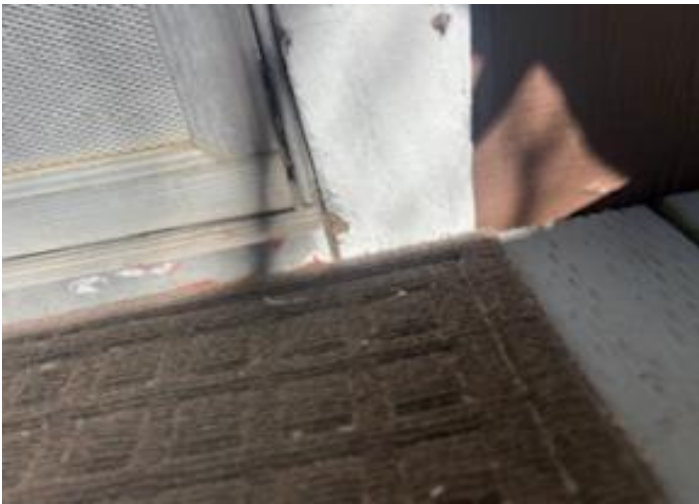
11C

FINDINGS - Excessive moisture damage, fungus/ dry rot noted to trim at various locations.

RECOMMENDATION -.Cut out excessive moisture damages to wood members (dry rot and/or fungus), treat with state approved fungicide and repair as needed. (Prime Paint Only) if hidden damages are revealed during repairs, a supplemental report will be submitted

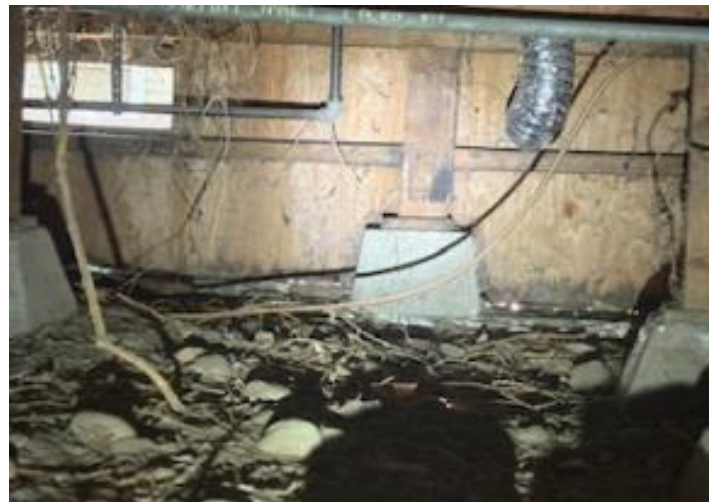
1A

FINDINGS - Surface fungus noted to inner siding and sub structure at various locations in sub area.

RECOMMENDATION - Remove wood destroying fungus and treat areas with an State approved fungicide per State regulations and label instructions.

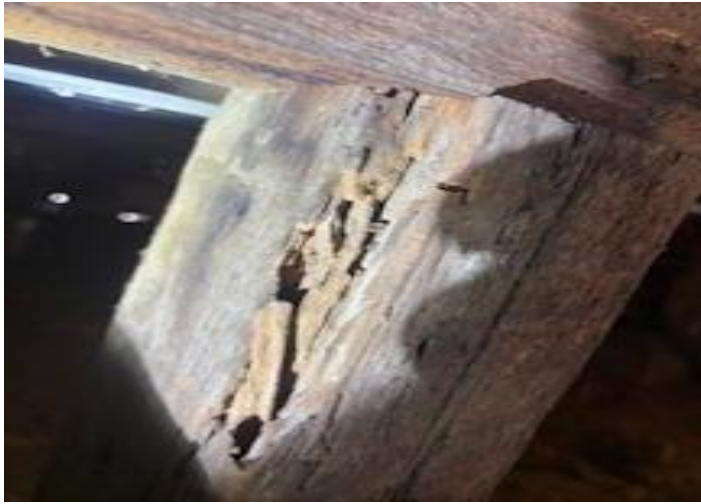
1C

FINDINGS - Subterranean termite evidence noted to sub structure.

RECOMMENDATION -Treat subsoil with an State approved chemical per State regulations and label instructions for control of subterranean termites. Hobbs Pest Solutions, Inc., will not be responsible for damage to hidden pipes, conduit, ducts or their repair.

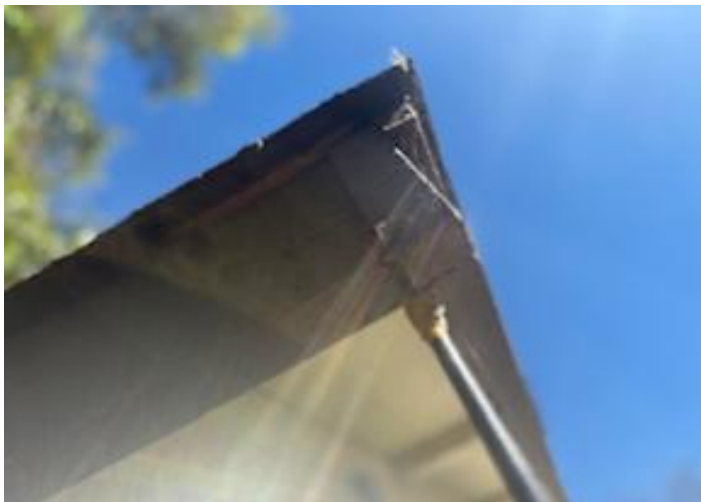
8A

FINDINGS - Excessive moisture damage, fungus/ dry rot noted to detached garage fascia at various locations.

RECOMMENDATION - Cut back or cut out infected and or damaged wood members. Fill in, replace or repair as needed. Prime paint only upon owners request. scrape and treat with timbor as needed.

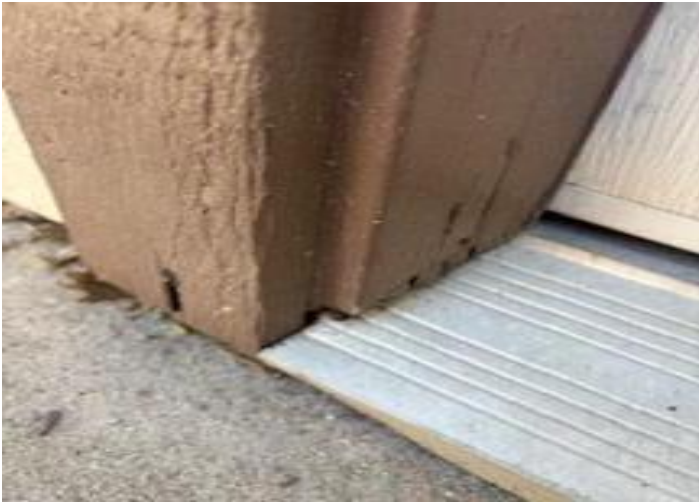
8B, 8C

FINDINGS - Excessive moisture damage, fungus/ dry rot noted to detached garage trim at various locations.

FINDINGS - Excessive moisture damage, fungus/ dry rot noted to detached garage door casings.

RECOMMENDATION -.Cut out excessive moisture damages to wood members (dry rot and/or fungus), treat with state approved fungicide and repair as needed. (Prime Paint Only) if hidden damages are revealed during repairs, a supplemental report will be submitted
