# WOOD DESTROYING PESTS AND ORGANISMS INSPECTION REPORT

| Building No.<br>1935 | Street<br>Spencer Street | City<br>Cambria | Zip<br>93428 | Date of Inspection<br>03/24/2026 | Number of Pages<br>1 of 6 |

**Report #: 113003**

## \*\*\*Complete Inspection Report\*\*\*

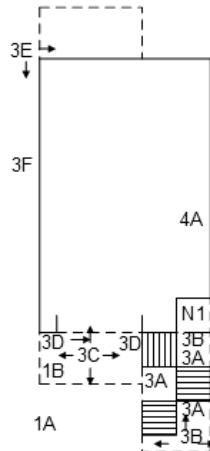
Diagram not to scale  
Finding locations approximate

Finding: 1A Evidence of Subterranean Termite infestation was found at the exterior and indicates an infestation in the soil below the structure.

Finding: 1B Subterranean Termite and Fungus damage was noted at the siding and trim.

Finding: 3A Fungus damage was found at the wood members of the deck.

Finding: 3B Fungus growth was found at the deck framing.

Finding: 3C Fungus infection and damage were found in the cantilever wood deck throughout the decking and framing.

Finding: 3D Fungus damage was found at the second level siding .

Finding: 3E Fungus damage was found at the trim and siding.  
Recommendation: Remove and replace the damaged portions of the trim and siding as needed to eliminate the fungus infection and damage.

Finding: 3F Fungus damage was found at the vent trim.  
Recommendation: Remove and replace the damaged portions of the vent trim as needed to eliminate the fungus infection and damage.

Recommendation: Drill through the concrete slab in areas of infestation and chemically treat soil below using Taurus SC (fipronil). Fill in the holes with concrete. Remove all the accessible evidence of Subterranean Termite infestation. In addition, an application will be made to the soil adjacent to the exterior wall around the complete perimeter of the structure. Holes may be drilled through concrete, paving or masonry adjacent to the foundation in areas such as, but not limited to; patios, sidewalks, porches and driveways, to allow for chemical treatment of the soil below. We will exercise reasonable caution when drilling but assume no liability for damage to hidden plumbing, electrical, or other utility below these areas. The location of such utilities should be identified prior to our arrival. Regardless of locations of Subterranean Termite infestation found, control of the entire structure is guaranteed. Control is guaranteed by Key Termite and Pest Control for a period of 5 years from the date of treatment. NOTE: Any exterior storage must be moved away at least 3 feet from the perimeter of the structure prior to our arrival.

Recommendation: Remove and replace the damaged wood members noted.

Recommendation: Remove and replace the damaged portions of the fascia, stair stringer, picket, cap and deck board as needed to eliminate the fungus infection and damage.

Recommendation: Remove the surface growth with a wire brush. Chemically treat the infected wood members with disodium octaborate tetrahydrate.

Recommendation: Remove and replace the damaged wood members of the deck. This will most likely involve complete replacement of the wood deck. In areas where a sound wood member is not replaced and VERY MINOR surface fungus growth is present but no detectable deterioration has occurred, scrape away the surface growth with a wire brush and chemically treat the wood member with disodium octaborate tetrahydrate or copper naphthenate. Repair includes replacement with nailed con-common redwood decking and doug-fir framing. Additional costs for upgrades to deck screws, con-heart, deck-heart, synthetic decking or pressure treated framing will be quoted upon request.

Recommendation: Remove and replace the damaged portions of the siding as needed to eliminate the fungus infection and damage.

Note: Cost included in item 1B.

Price: \$204.00
