WOOD DESTROYING PESTS AND ORGANISMS INSPECTION REPORT

Building No. 18	Street Oak Hill Dr.	City Oroville	ZIP 95966	Date of Inspection 03/16/2026	Number of Pages 5
Hobbs Pest Solutions, Inc P. O. Box 2486 Oroville CA 95965 (530) 624-5390 bhobbs@hobbspestsolutions.com				Report # : 13773 Registration # : PR 7460 Escrow # : <input type="checkbox"/> CORRECTED REPORT	
Ordered by: Lesley Nickelson Professional Realty Services Oroville CA		Property Owner and Party of Interest: Mercedes Pilgrim		Report sent to:	
COMPLETE REPORT <input checked="" type="checkbox"/> LIMITED REPORT <input type="checkbox"/> SUPPLEMENTAL REPORT <input type="checkbox"/> REINSPECTION REPORT <input type="checkbox"/>					
GENERAL DESCRIPTION: Manufactured home, raised foundation, vinyl and wood exterior, composition roofing, garage, vacant					Inspection Tag Posted: N/A
An inspection has been made of the structure(s) shown on the diagram in accordance with the Structural Pest Control Act. Detached porches, detached steps, detached decks and any other structures not on the diagram were not inspected.

18	Oak Hill Dr.	Oroville	CA	95966
Address of Property Inspected		City	State	ZIP
03/16/2026	13773			
Date of Inspectio

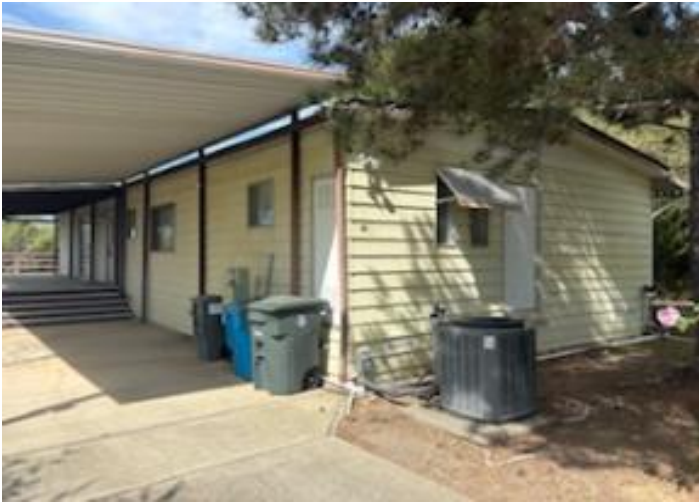
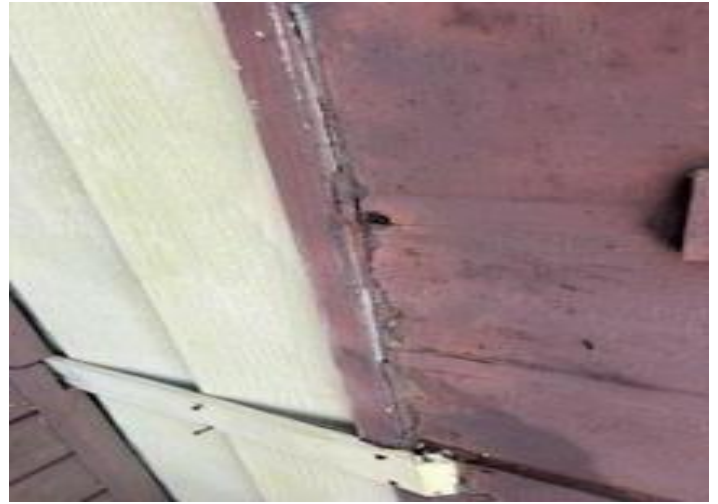
11A

FINDINGS - excessive moisture damage, fungus and/or dry rot noted to siding at various locations

RECOMMENDATION- Remove and replace damaged siding or skirting with matching or harmonizing style material. Z-bar if often used when only lower portions of siding/skirting are replaced. If further damages are exposed during removal of infected/infested siding, a supplemental report will be submitted with new findings and recommendations for correction. Prime paint only

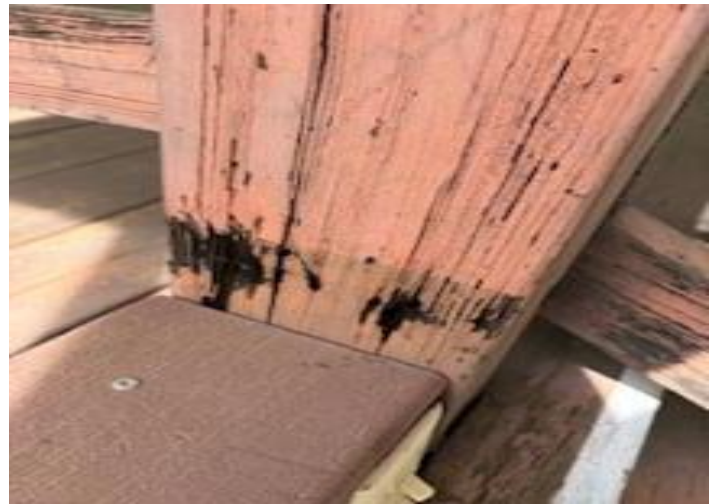
9A

FINDINGS - excessive moisture damage, fungus and/or dry rot noted to 4x6 deck posts at various locations

RECOMMENDATION -Cut out excessive moisture damages to wood members (dry rot and/or fungus), treat with state approved fungicide and repair/replace as needed. (no paint) If further damages are found at time of repairs, a supplemental report will be submitted

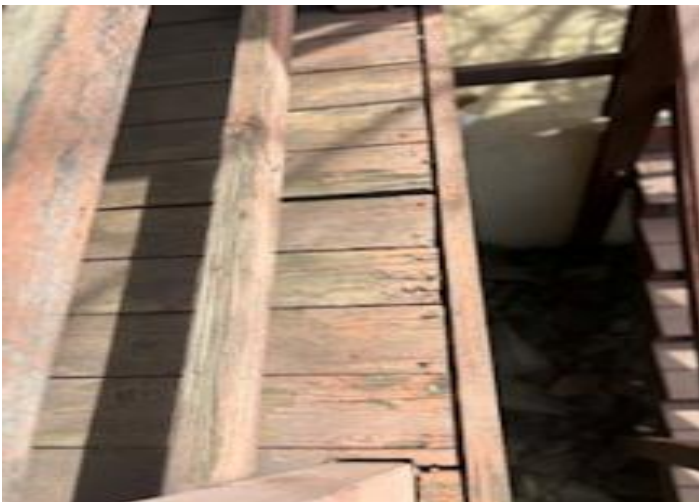
9B

FINDINGS - excessive moisture damage, fungus and/or dry rot noted to deck boards at various locations

RECOMMENDATION -Cut out excessive moisture damages to wood members (dry rot and/or fungus), treat with state approved

fungicide and repair/replace as needed. (no paint) If further damages are found at time of repairs, a supplemental report will be submitted

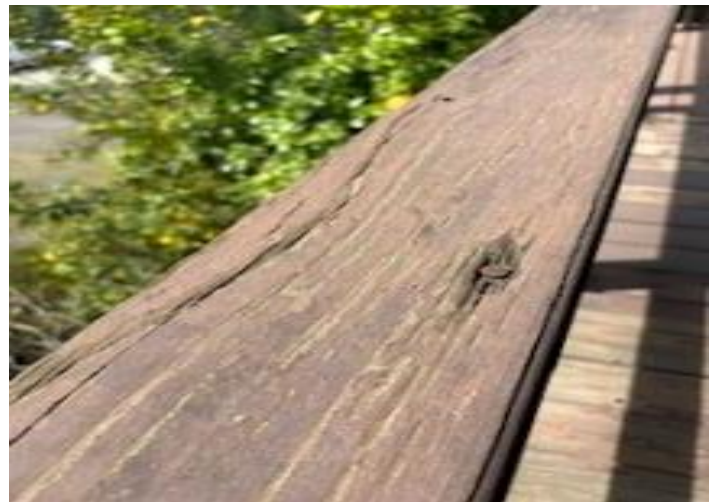
9C

FINDINGS - excessive moisture damage, fungus and/or dry rot noted to deck railing members at various locations

RECOMMENDATION -Cut out excessive moisture damages to wood members (dry rot and/or fungus), treat with state approved fungicide and repair/replace as needed. (no paint) If further damages are found at time of repairs, a supplemental report will be submitted

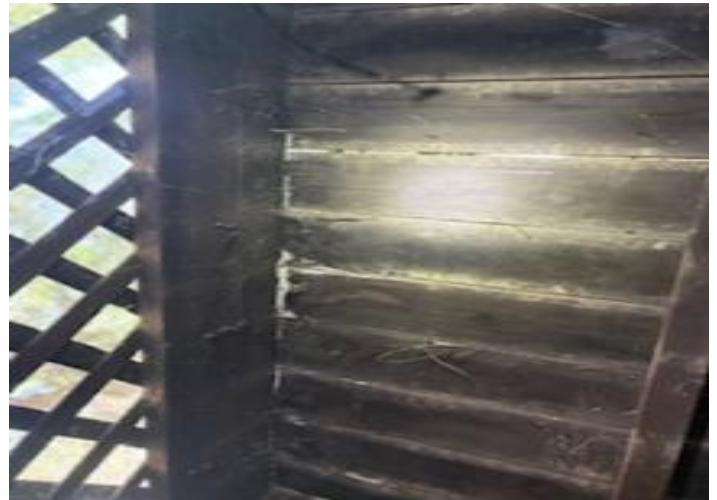
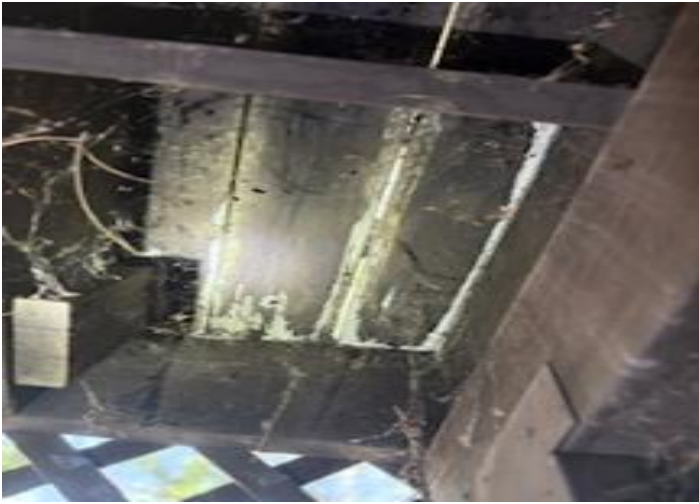
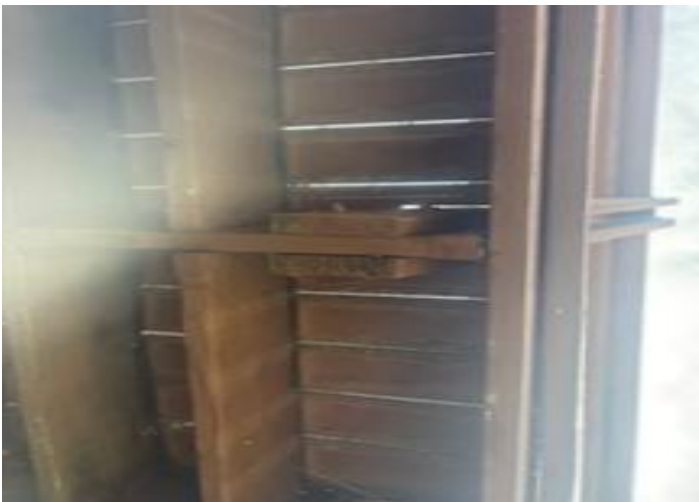
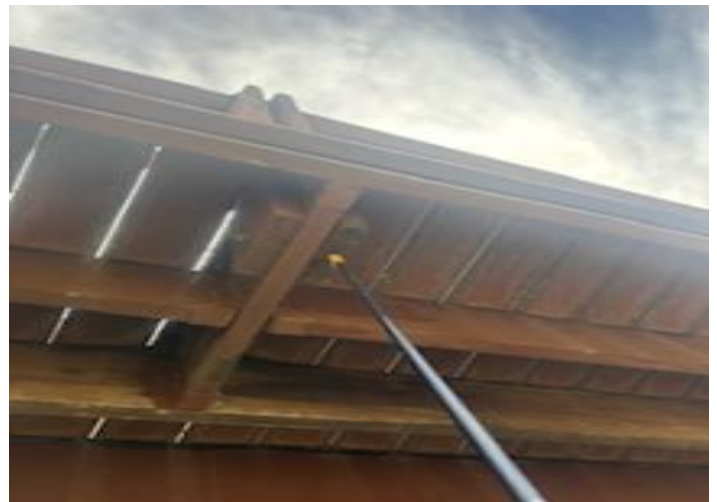
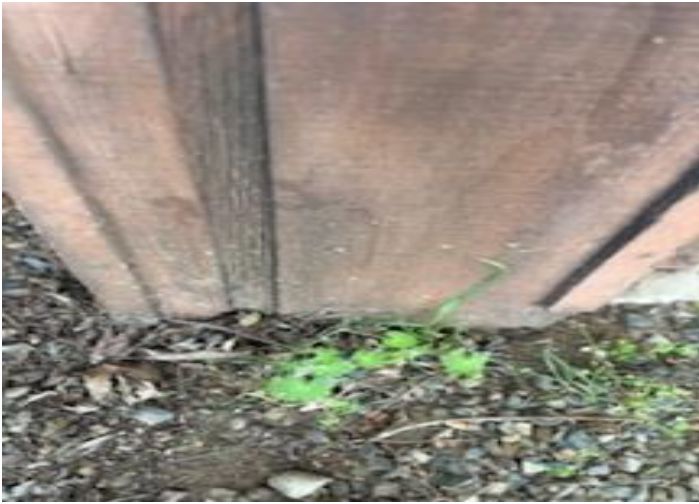
9E

FINDINGS - surface fungus noted to deck structure/sub structure at various locations

RECOMMENDATION - Remove wood destroying fungus and treat areas with an State approved fungicide per State regulations and label instructions.

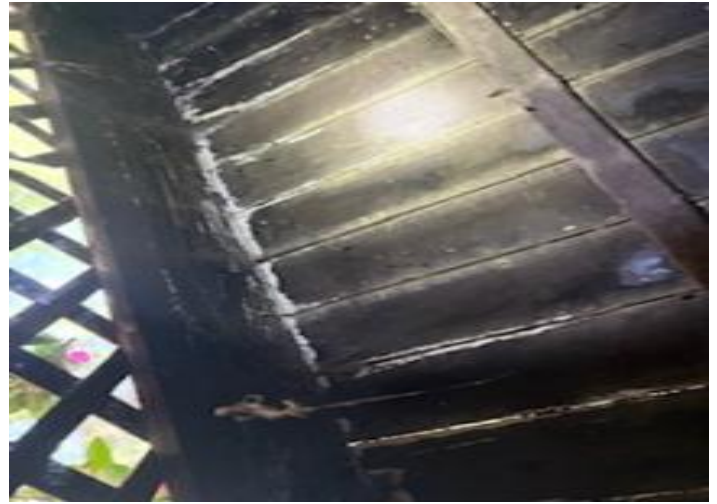
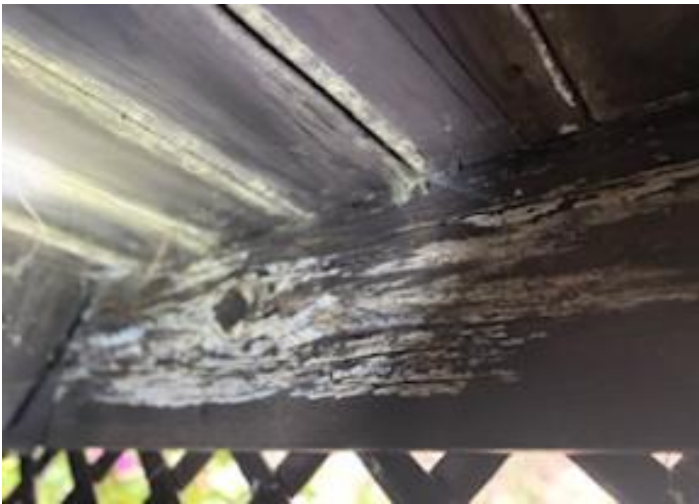
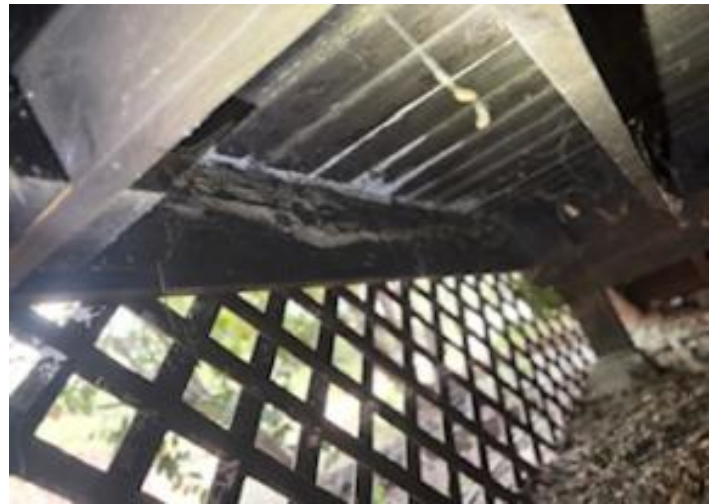
9D, 9E

FINDINGS - excessive moisture damage, fungus and/or dry rot noted to deck sub structure at various locations

RECOMMENDATION -Cut out excessive moisture damages to wood members (dry rot and/or fungus), treat with state approved fungicide and repair/replace as needed. (no paint) If further damages are found at time of repairs, a supplemental report will be submitted

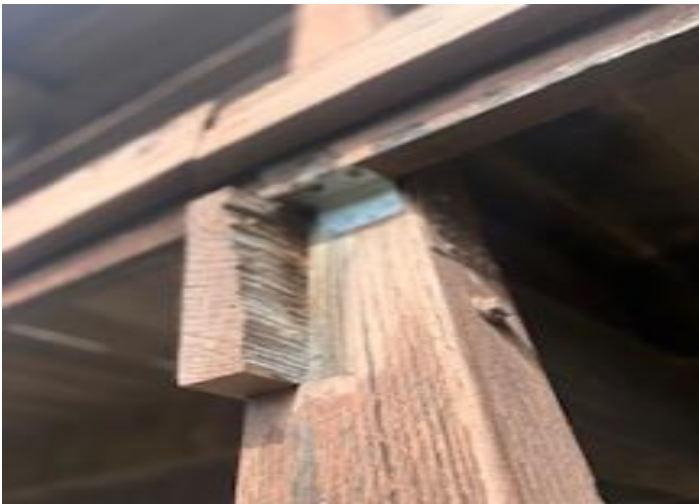
11A, 11B

FINDINGS - subterranean termite evidence noted to exterior

RECOMMENDATION -Treat subsoil with an State approved chemical per State regulations and label instructions for control of subterranean termites. Hobbs Pest Solutions, Inc., will not be responsible for damage to hidden pipes, conduit, ducts or their repair.

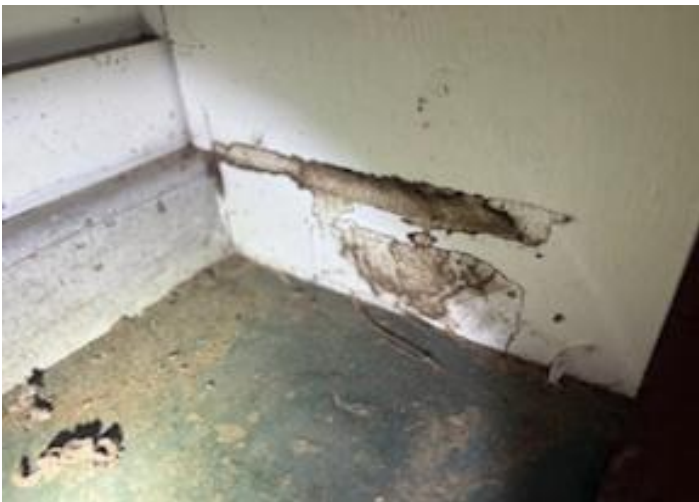
9F

FINDINGS - excessive moisture damage, fungus and/or dry rot noted to 2x6 deck posts at various locations

RECOMMENDATION -Cut out excessive moisture damages to wood members (dry rot and/or fungus), treat with state approved fungicide and repair/replace as needed. (no paint) If further damages are found at time of repairs, a supplemental report will be submitted

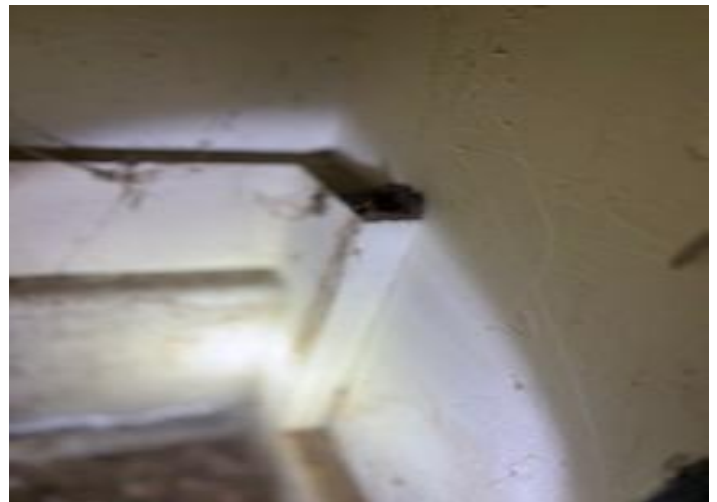
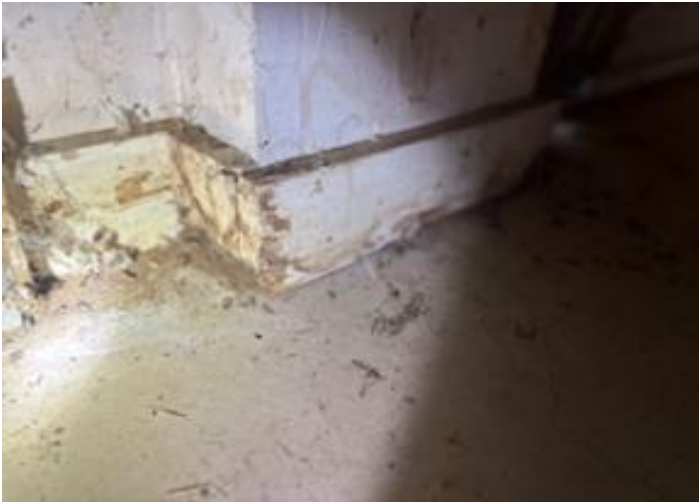
8A

FINDINGS - subterranean termite evidence noted in garage and basement at various locations

RECOMMENDATION -Drill through slab foundation and Treat subsoil with a State approved chemical per State regulations and label instructions for control of subterranean termites. Hobbs Pest Solutions, Inc., will not be responsible for damage to hidden pipes, conduit, ducts or their repair.

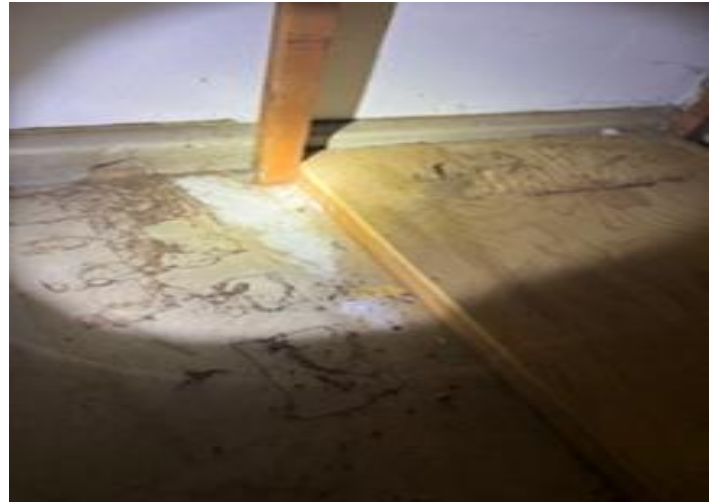
8B

FINDINGS - excessive moisture damage, fungus and/or dry rot noted to garage base boards

RECOMMENDATION -.Cut out excessive moisture damages to wood members (dry rot and/or fungus), treat with state approved fungicide and repair as needed. (Prime Paint Only) if hidden damages are revealed during repairs, a supplemental report will be submitted

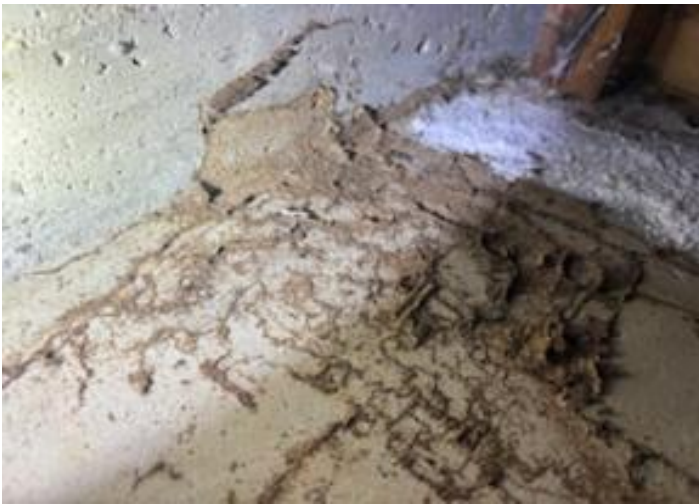
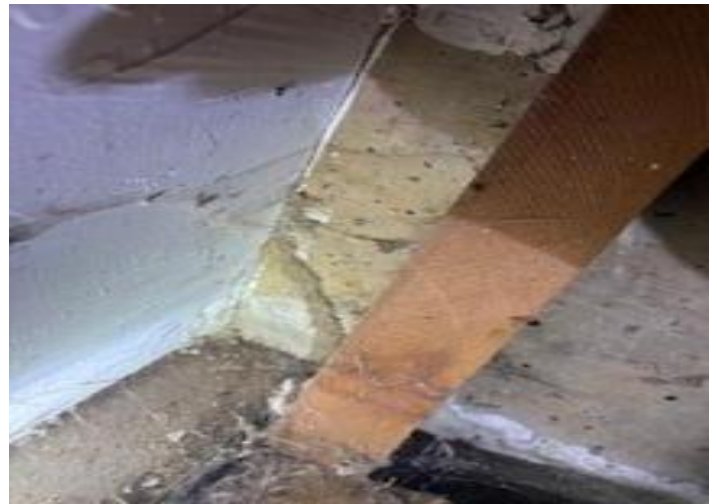
1A

FINDINGS - insulated sub floor noted from sub areas
