# WOOD DESTROYING PESTS AND ORGANISMS INSPECTION REPORT

| Building No.<br>409 | Street<br>4th St. | City<br>Corning | ZIP<br>96021 | Date of Inspection<br>08/05/2026 | Number of Pages<br>7 |
| GENERAL DESCRIPTION:<br>One story, single family residence, raised foundation, wood exterior, composition roofing, detached garage, occupied/furnished | | | | Inspection Tag Posted:<br>Subarea | |

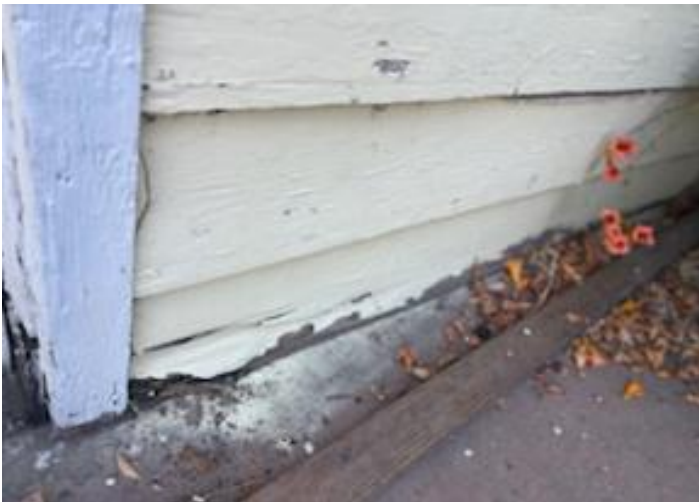
8A, 8B

FINDINGS - excessive moisture damage, fungus and/or dry rot noted to detached garage siding at various locations

FINDINGS - excessive moisture damage, fungus and/or dry rot noted to detached garage trim at various locations

RECOMMENDATION- Remove and replace damaged siding or skirting with matching or harmonizing style material. Z-bar if often used when only lower portions of siding/skirting are replaced. If further damages are exposed during removal of infected/infested siding, a supplemental report will be submitted with new findings and recommendations for correction. Prime paint only

RECOMMENDATION -.Cut out excessive moisture damages to wood members (dry rot and/or fungus), treat with state approved fungicide and repair as needed. (Prime Paint Only) if hidden damages are revealed during repairs, a supplemental report will be submitted

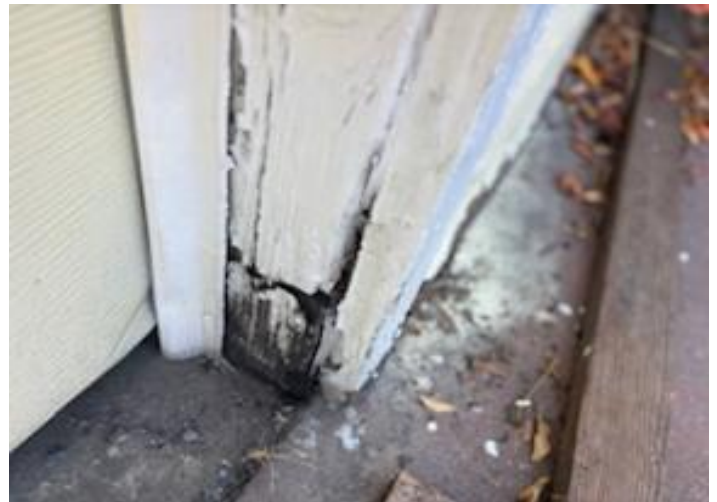
8C

FINDINGS - excessive moisture damage, fungus and/or dry rot noted to detached garage door casings at various locations

RECOMMENDATION - cut out infected areas of door casing/door/trim, disinfect with fungicide, repair as needed. Prime paint only. If hidden damages are revealed at time of repairs, a supplemental report will be submitted.

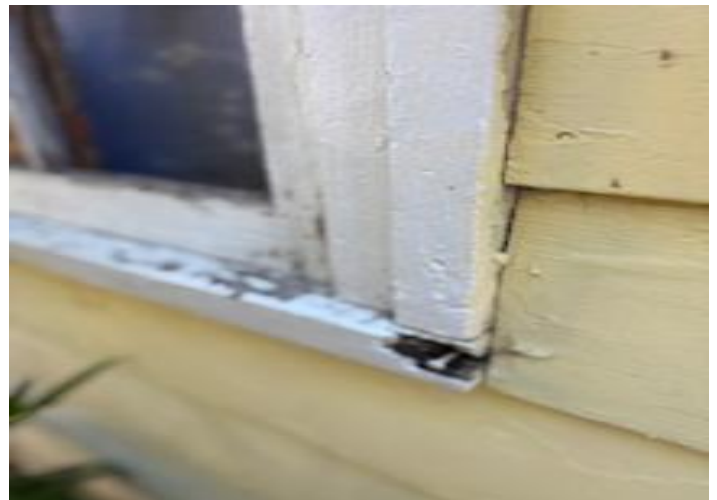
8D

FINDINGS - excessive moisture damage, fungus and/or dry rot noted to detached garage window sill/ledge/frame

RECOMMENDATION -.Cut out excessive moisture damages to wood members (dry rot and/or fungus), treat with state approved fungicide and repair as needed. (Prime Paint Only) if hidden damages are revealed during repairs, a supplemental report will be submitted

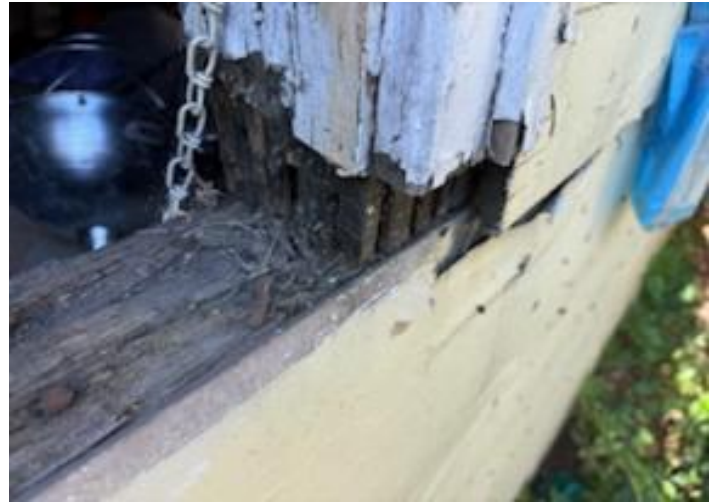
8A, 8G

FINDINGS - subterranean termite evidence noted to detached garage structure at various locations

RECOMMENDATION -Locally treat subsoil and/or area with evidence of infestation with an State approved chemical per State regulations and label instructions for control of subterranean termites. Hobbs Pest Solutions, Inc., will not be responsible for damage to hidden pipes, conduit, ducts or their repair.

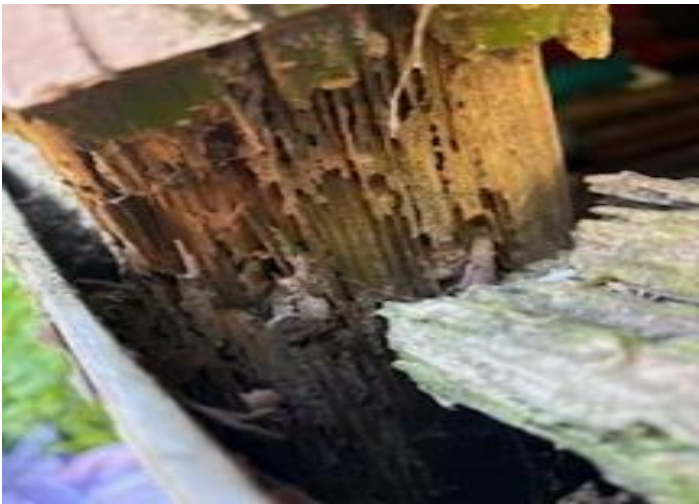
8F, 8G

FINDINGS - excessive moisture damage, fungus and/or dry rot noted to detached garage frame members at various locations

RECOMMENDATION -Cut out damages (fungus/dry rot) treat with fungicide and repair/replace as needed. If further damages are uncovered to areas with infections/infestations, a supplemental report will be submitted.

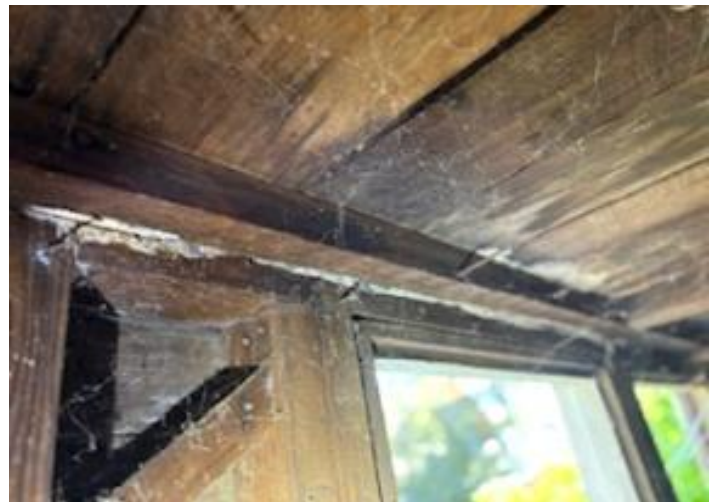
8K

FINDINGS - surface fungus noted to detached garage inner walls/siding at various locations

RECOMMENDATION - Remove wood destroying fungus and treat areas with an State approved fungicide per State regulations and label instructions.

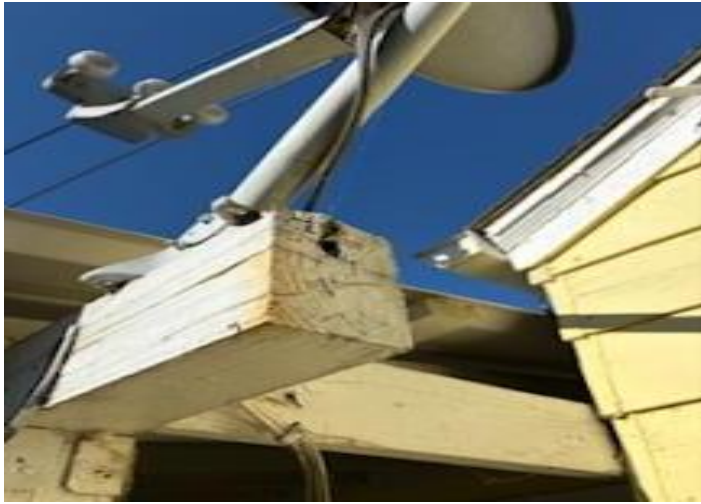
4A

FINDINGS - excessive moisture damage, fungus and/or dry rot noted to porch awning header

RECOMMENDATION - Cut back or cut out infected and or damaged (dry rot/fungus) wood members. Scrape and treat with fungicide to stop spread of infection. Fill in, replace or repair as needed. Prime paint only upon owners request. If further damages are uncovered at time of repairs, a supplemental report will be submitted.

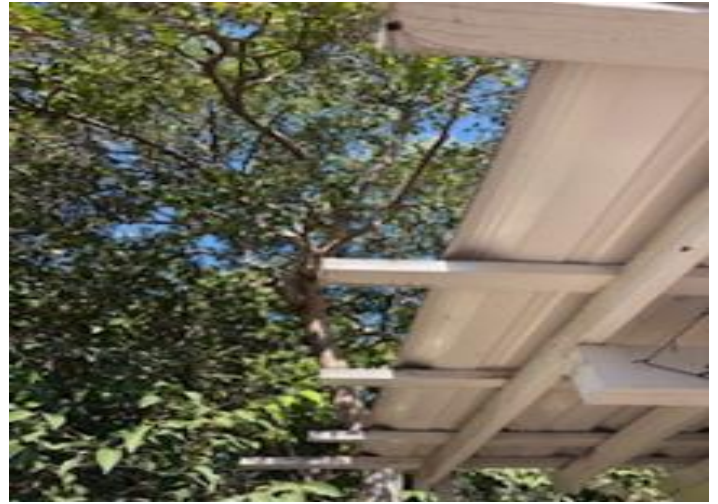
4B

FINDINGS - excessive moisture damage, fungus and/or dry rot noted to porch awning roof slats at various locations

RECOMMENDATION -Cut out damages (fungus/dry rot) treat with fungicide and repair/replace as needed. If further damages are uncovered to areas with infections/infestations, a supplemental report will be submitted.

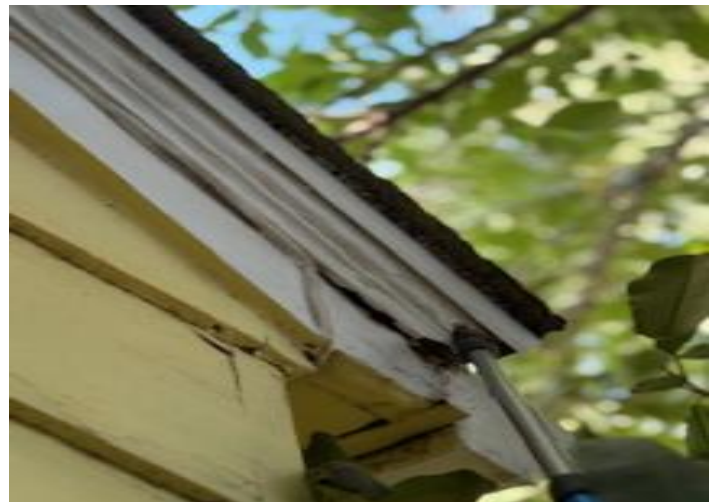
11D

FINDINGS - excessive moisture damage, fungus and/or dry rot noted to fascia/trim at various locations

RECOMMENDATION - Cut back or cut out infected and or damaged (dry rot/fungus) wood members. Scrape and treat with fungicide to stop spread of infection. Fill in, replace or repair as needed. Prime paint only upon owners request. If further damages are uncovered at time of repairs, a supplemental report will be submitted.

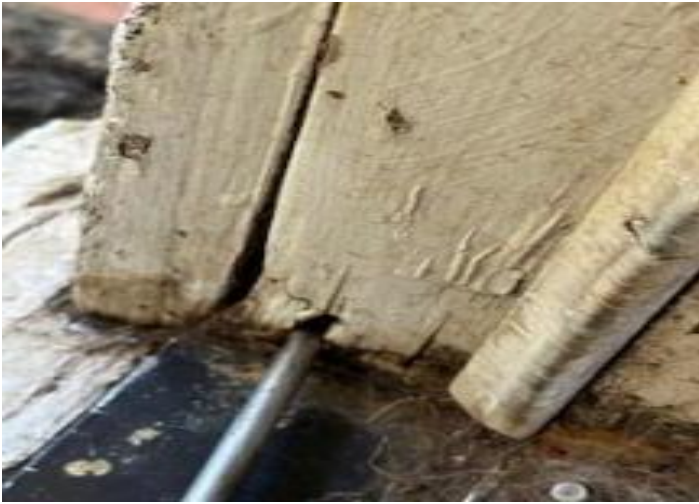
11E

FINDINGS - excessive moisture damage, fungus and/or dry rot noted to door casing

RECOMMENDATION - cut out infected areas of door casing/door/trim, disinfect with fungicide, repair as needed. Prime paint only. If hidden damages are revealed at time of repairs, a supplemental report will be submitted.

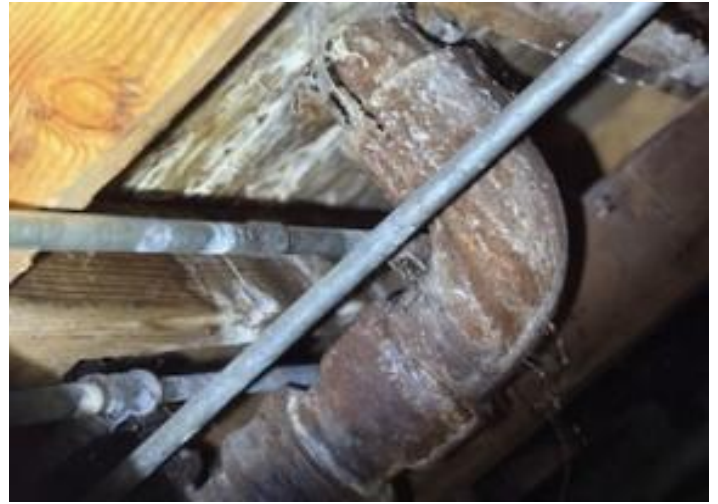
1B

FINDINGS - surface fungus noted to sub structure/sub floor in sub area

RECOMMENDATION - Remove wood destroying fungus and treat areas with an State approved fungicide per State regulations and label instructions. Repair/replace damaged sub flooring and/or joists as needed
