WOOD DESTROYING PESTS AND ORGANISMS INSPECTION REPORT

Building No. 5926	Street Gran Paseo Way	City Atascadero	Zip 93422-2726	Date of Inspection 07/01/2025	Number of Pages 1 of 4
----------------------	--------------------------	--------------------	-------------------	----------------------------------	---------------------------

Complete Inspection Report

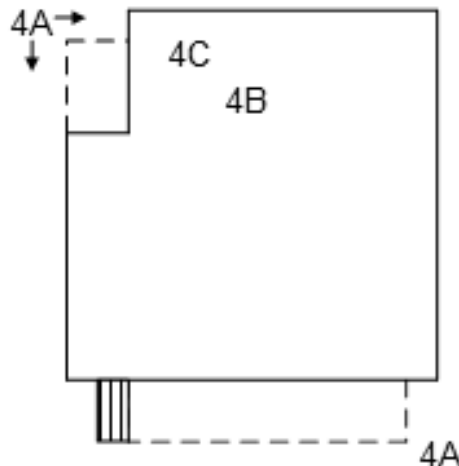
Diagram not to scale
 Finding locations approximate

Finding: 4A Earth to wood contact exists at the deck.
Recommendation: Lower the adjacent soil grade as necessary to eliminate the earth to wood contact.
Price: No Bid offered at this time. Owner should contact appropriate tradesman to complete recommended corrections.

Finding: 4B Moisture damage has occurred to the wood members of the interior baseboard due to a previous moisture condition.
Recommendation: Remove and replace or repair the damaged portions of the interior baseboard as needed.
Price: No Bid offered at this time. Owner should contact appropriate tradesman to complete recommended corrections.

Finding: 4C An excessive moisture condition exists due to an inadequate seal where the floor meets the tub at the first level bathroom.
Recommendation: Seal the edge of the floor where it meets the tub in the first level bathroom with a durable waterproof sealant.
Price: No Bid offered at this time. Owner should contact appropriate tradesman to complete recommended corrections.
