WOOD DESTROYING PESTS AND ORGANISMS INSPECTION REPORT

Building No. 6356	Street Imperial Way	City Magalia	ZIP 95954	Date of Inspection 01/13/2026	Number of Pages 7
Hobbs Pest Solutions, Inc P. O. Box 2486 Oroville CA 95965 (530) 624-5390 bhobbs@hobbspestsolutions.com				Report # : 13624 Registration # : PR 7460 Escrow # : <input type="checkbox"/> CORRECTED REPORT	
Ordered by: seller		Property Owner and Party of Interest: Monica Eaken		Report sent to: Andrew Acevedo* Thrive Real Estate	
COMPLETE REPORT <input checked="" type="checkbox"/>		LIMITED REPORT <input type="checkbox"/>		SUPPLEMENTAL REPORT <input type="checkbox"/>	
GENERAL DESCRIPTION: Manufactured home, raised foundation, wood exterior, composition roofing, detached garage, vacant				Inspection Tag Posted: Subarea	
				Other Tags Posted:	
An inspection has been made of the structure(s) shown on the diagram in accordance with the Structural Pest Control Act. Detached porches, detached steps, detached decks and any other structures not on the diagram were not inspected.

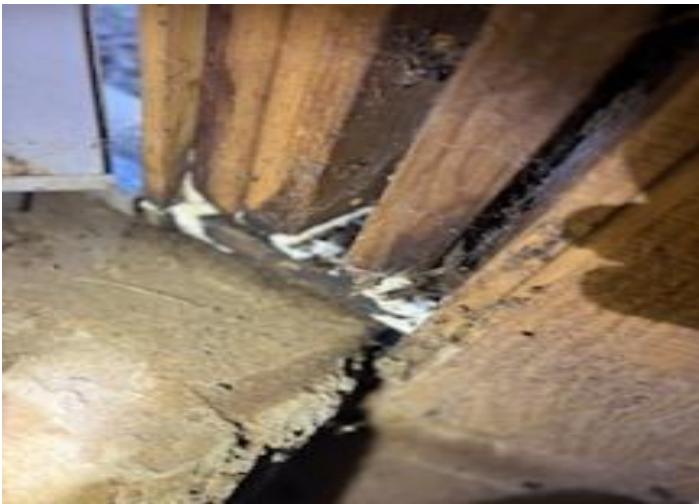
8G

FINDINGS - detached garage interior ceilings and walls insulated

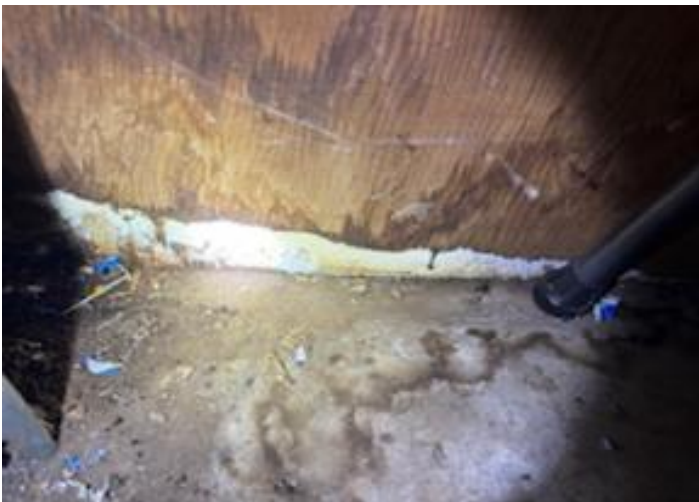
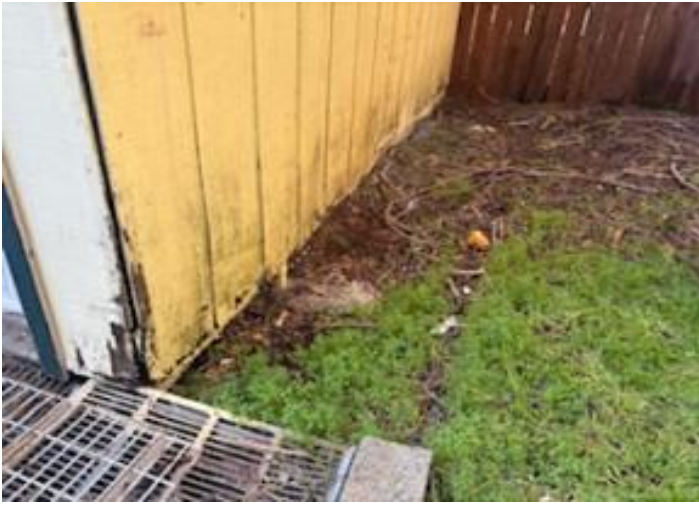
8A, 8B

FINDINGS - excessive moisture condition, chipped/peeling paint and/or bare/exposed wood noted to detached garage exterior at various locations

FINDINGS - excessive moisture damage, fungus and/or dry rot noted to detached garage fascia and/or barge rafters at various locations

RECOMMENDATION - Other trades to repair.

RECOMMENDATION - Cut back or cut out infected and or damaged wood members, scrape and treat with timbor as needed. Fill in, replace or repair as needed. Prime paint only upon owners request.

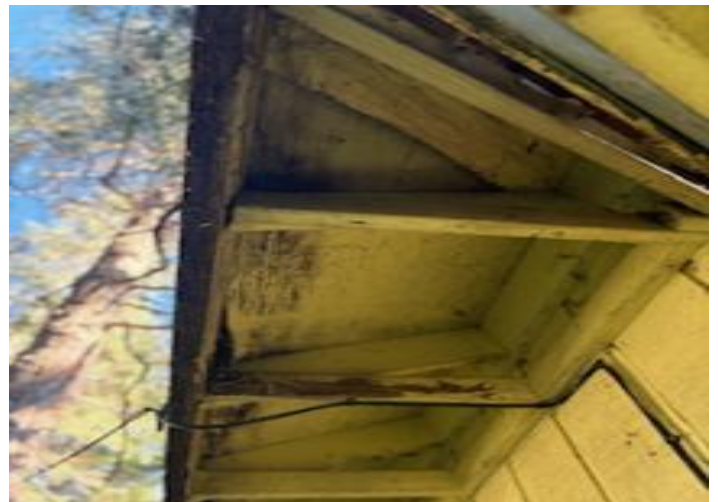
8A, 8D

FINDINGS - excessive moisture damage, fungus and/or dry rot noted to detached garage eave sheeting at various locations

RECOMMENDATION - Owner/agent should engage the services of a licensed roofing contractor to make any necessary repairs.

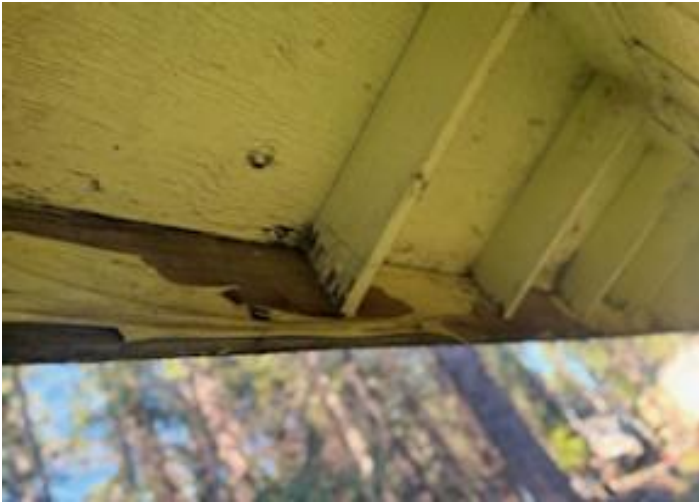
8C, 8E

FINDINGS - excessive moisture damage, fungus and/or dry rot noted to detached garage siding at various locations

FINDINGS - excessive moisture damage, fungus and/or dry rot noted to detached garage door casing/trim at various locations

RECOMMENDATION- Remove and replace damaged siding or skirting with matching or harmonizing style material. If further damage is exposed during removal of damaged siding, a supplemental report will be submitted with new findings and recommendations for correction.

RECOMMENDATION -.Cut out excessive moisture damages to wood members (dry rot and/or fungus), treat with state approved fungicide and repair as needed. (Prime Paint Only)

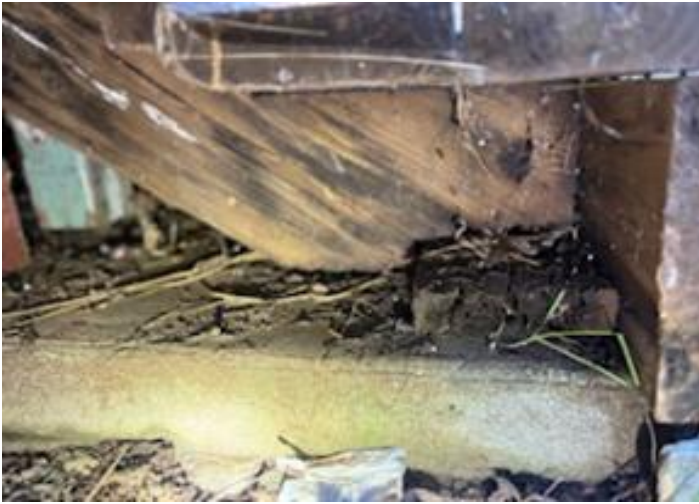
9F

FINDINGS - generator housing attached to decking

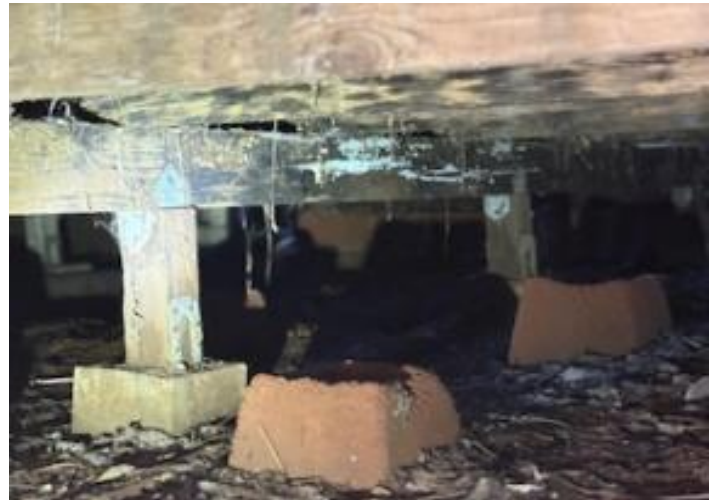
9A

FINDINGS - excessive moisture damage, fungus and/or dry rot noted to deck posts at various locations

RECOMMENDATION -Cut out excessive moisture damages to wood members (dry rot and/or fungus), treat with state approved fungicide and repair as needed. (no paint)

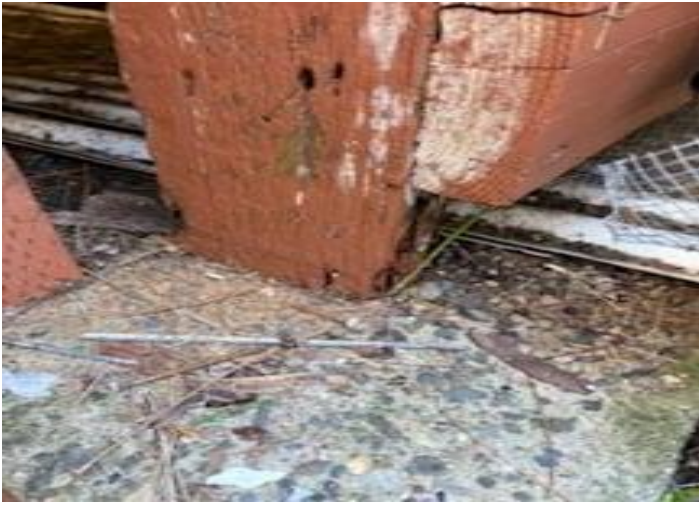
9B, 9D

FINDINGS - excessive moisture damage, fungus and/or dry rot noted to deck skirting at various locations

FINDINGS - excessive moisture damage, fungus and/or dry rot noted to deck boards at various locations

RECOMMENDATION- Remove and replace damaged siding or skirting with matching or harmonizing style material. If further damage is exposed during removal of damaged siding, a supplemental report will be submitted with new findings and recommendations for correction.

RECOMMENDATION -Cut out excessive moisture damages to wood members (dry rot and/or fungus), treat with state approved fungicide and repair as needed. (no paint)

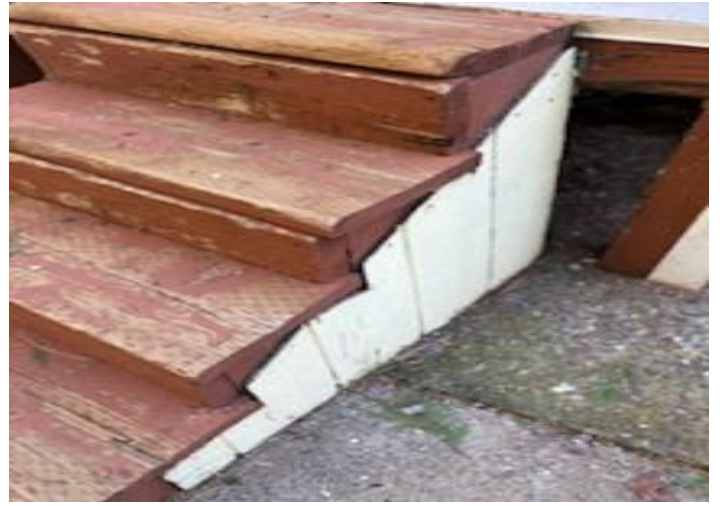
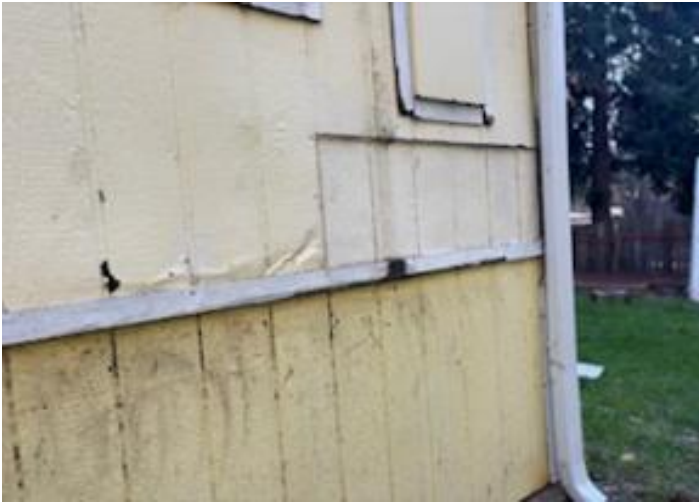
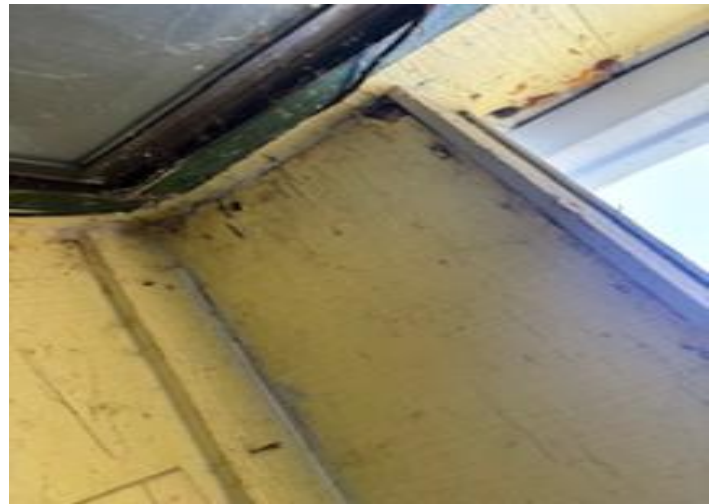
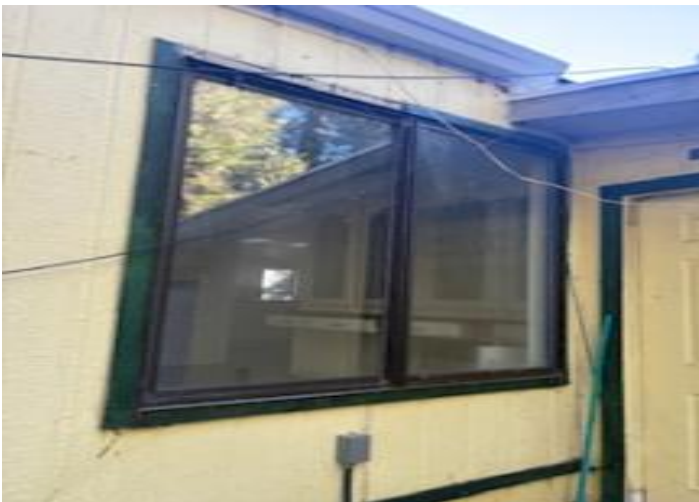
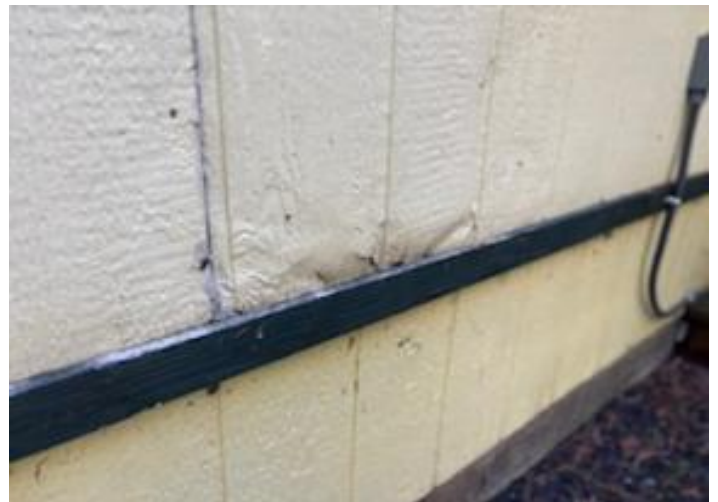
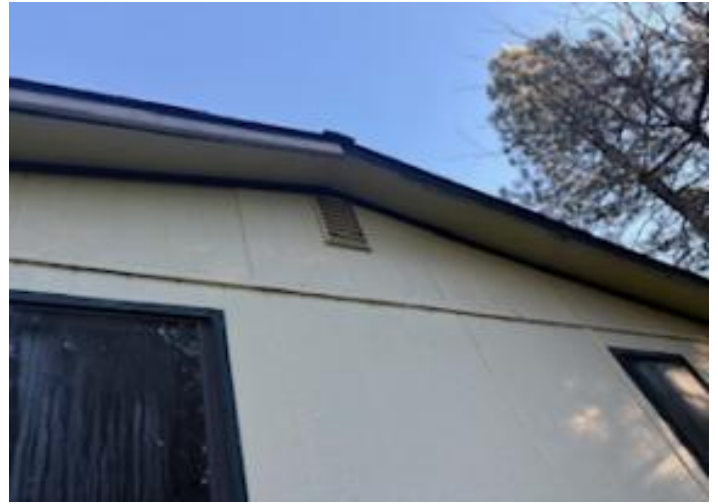
11A, 11B

FINDINGS - excessive moisture damage, fungus and/or dry rot noted to siding/skirting at various locations

FINDINGS - excessive moisture damage, fungus and/or dry rot noted to trim at various locations

RECOMMENDATION- Remove and replace damaged siding or skirting with matching or harmonizing style material. If further damage is exposed during removal of damaged siding, a supplemental report will be submitted with new findings and recommendations for correction.

RECOMMENDATION -.Cut out excessive moisture damages to wood members (dry rot and/or fungus), treat with state approved fungicide and repair as needed. (Prime Paint Only)

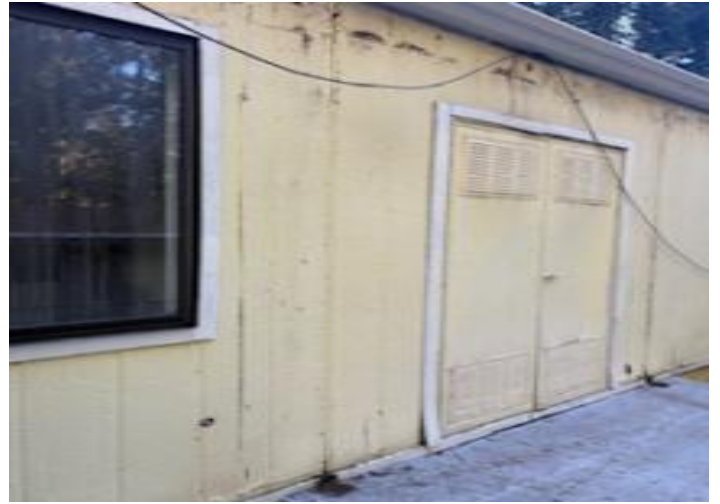
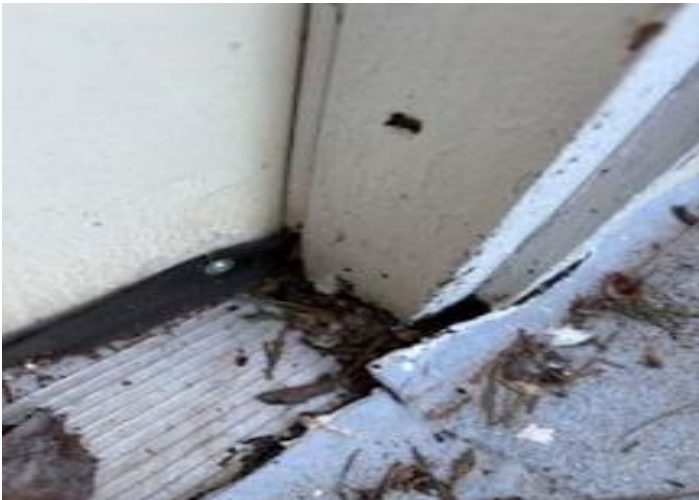
11G

FINDINGS - excessive moisture damage, fungus and/or dry rot noted to door casings at various locations

RECOMMENDATION -.Cut out excessive moisture damages to wood members (dry rot and/or fungus), treat with state approved fungicide and repair as needed. (Prime Paint Only)
