| <b>Hobbs Pest Solutions, Inc</b><br>P. O. Box 2486<br>Oroville CA 95965<br>(530) 624-5390<br>bhobbs@hobbspestsolutions.com | | | | Report # : 13896<br>Registration # : PR 7460<br>Escrow # :<br><input type="checkbox"/> CORRECTED REPORT | |
| GENERAL DESCRIPTION:<br>Manufactured home, raised foundation, vinyl and wood exterior, composition roofing, vacant | | | | Inspection Tag Posted:<br>Subarea | |

# HOBBS PEST SOLUTIONS, INC

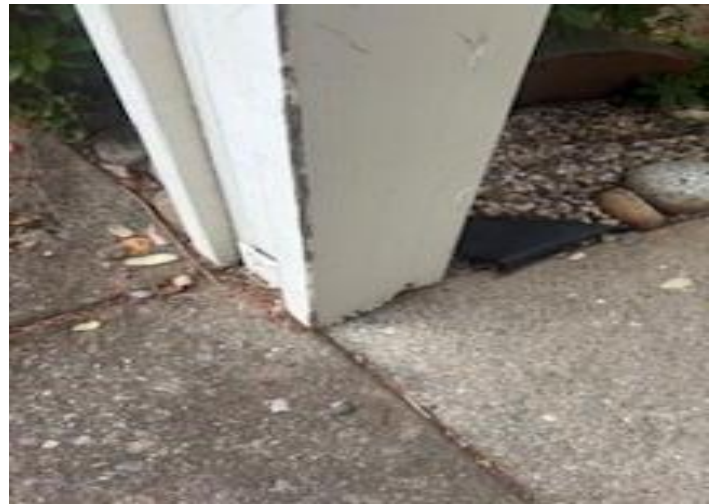
4A

FINDINGS - excessive moisture damage, fungus and/or dry rot noted to porch awning post

RECOMMENDATION -Cut out damages (fungus/dry rot) treat with fungicide and repair/replace as needed. If further damages are uncovered to areas with infections/infestations, a supplemental report will be submitted.

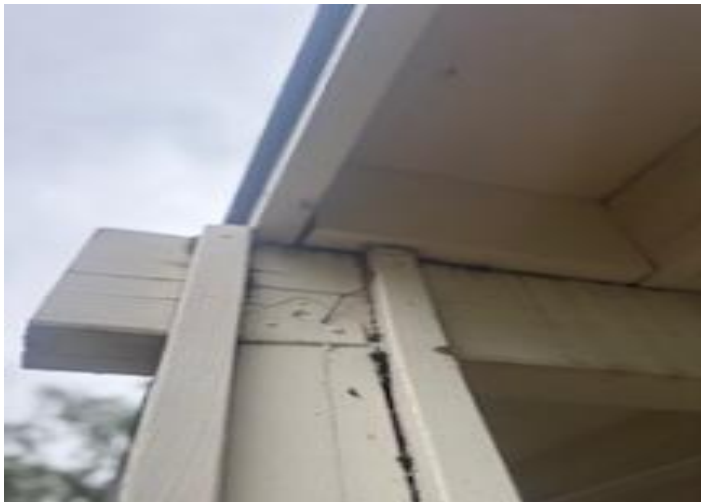
4B

FINDINGS - excessive moisture damage, fungus and/or dry rot noted to porch awning rafter at various locations

RECOMMENDATION - Cut back or cut out infected and or damaged wood members. Fill in, replace or repair as needed. Prime paint only

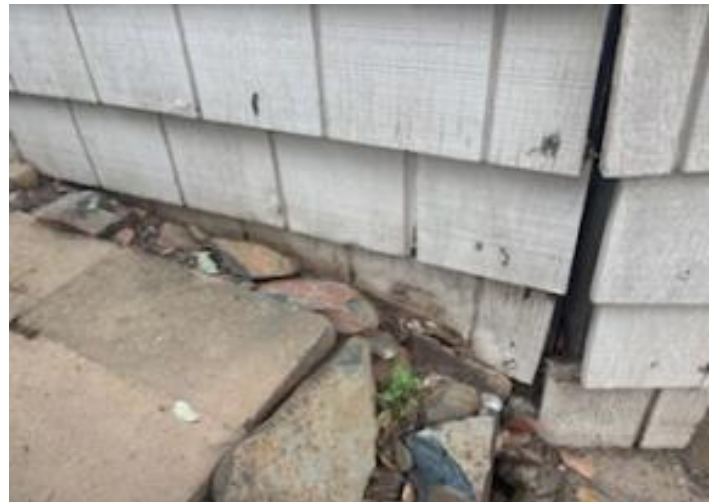
11A

FINDINGS - excessive moisture damage, fungus and/or dry rot noted to siding/skirting at various locations

RECOMMENDATION- Remove and replace damaged siding or skirting with matching or harmonizing style material. Z-bar if often used when only lower portions of siding/skirting are replaced. If further damages are exposed during removal of infected/infested siding, a supplemental report will be submitted with new findings and recommendations for correction. Prime paint only

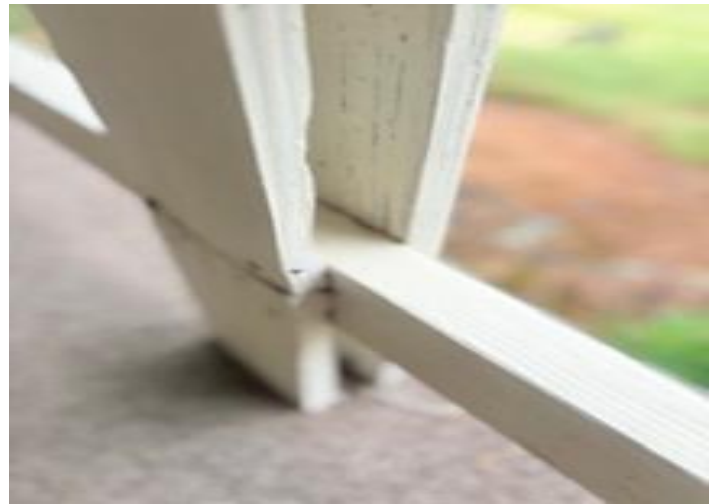
9A

FINDINGS - excessive moisture damage, fungus and/or dry rot noted to deck railing members at various locations

RECOMMENDATION -Cut out excessive moisture damages to wood members (dry rot and/or fungus), repair or replace and treat with state approved fungicide and repair/replace as needed. (no paint) If further damages are found at time of repairs, a supplemental report will be submitted

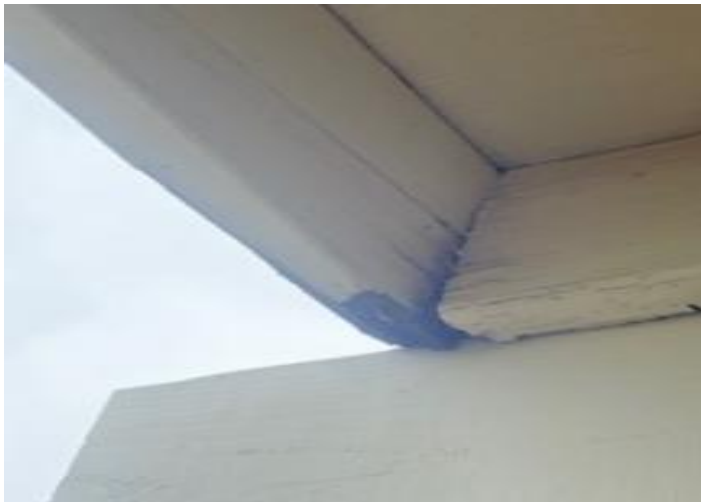
11B

FINDINGS - excessive moisture damage, fungus and/or dry rot noted to fascia and/or barge rafters at various locations

RECOMMENDATION - Cut back or cut out infected and or damaged wood members. Fill in, replace or repair as needed. Prime paint only

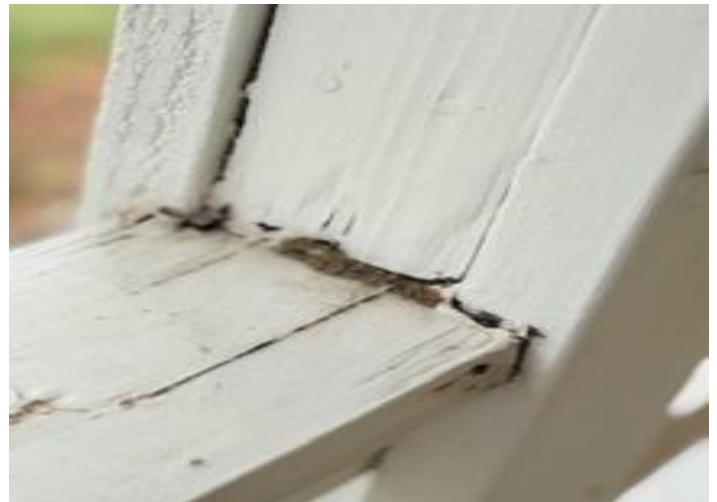
9A, 9B

FINDINGS - excessive moisture damage, fungus and/or dry rot noted to deck posts at various locations

RECOMMENDATION -Cut out damages (fungus/dry rot) treat with fungicide and repair/replace as needed. If further damages are uncovered to areas with infections/infestations, a supplemental report will be submitted.

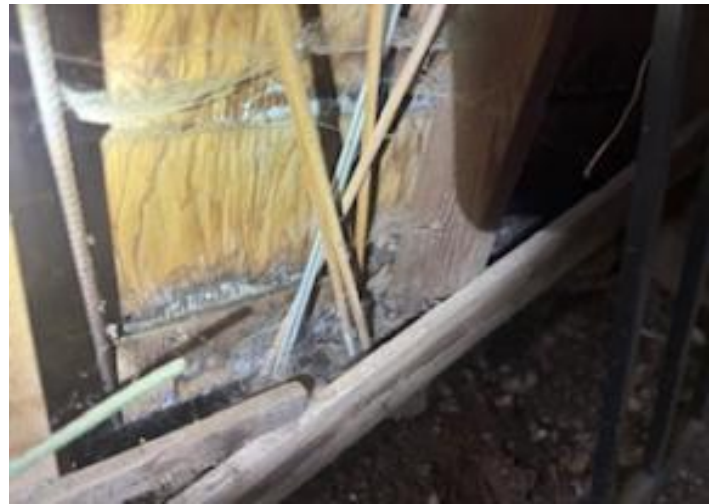
9D

FINDINGS - surface fungus noted to deck sub structure at various locations

RECOMMENDATION - Remove wood destroying fungus and treat areas with an State approved fungicide per State regulations and label instructions.

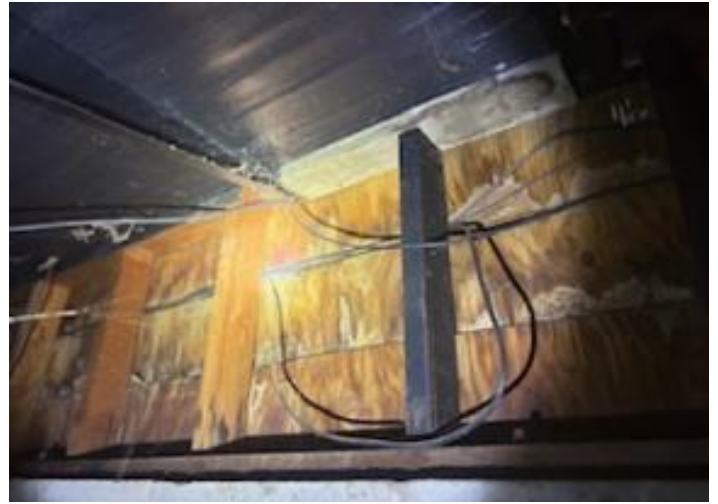
1B

FINDINGS - surface fungus noted to inner siding at various locations noted from sub area

RECOMMENDATION - Remove wood destroying fungus and treat areas with an State approved fungicide per State regulations and label instructions.
