# WOOD DESTROYING PESTS AND ORGANISMS INSPECTION REPORT

| Building No.<br>6687 | Street<br>Corte Eduardo | City<br>Carlsbad | ZIP<br>92009 | Date of Inspection<br>06/03/2026 | Number of Pages<br>5 |
| REINSPECTION REPORT <input type="checkbox"/> | | GENERAL DESCRIPTION:<br>2 Story single family residence furnished and occupied with attached garage and concrete tile roof. | | | |

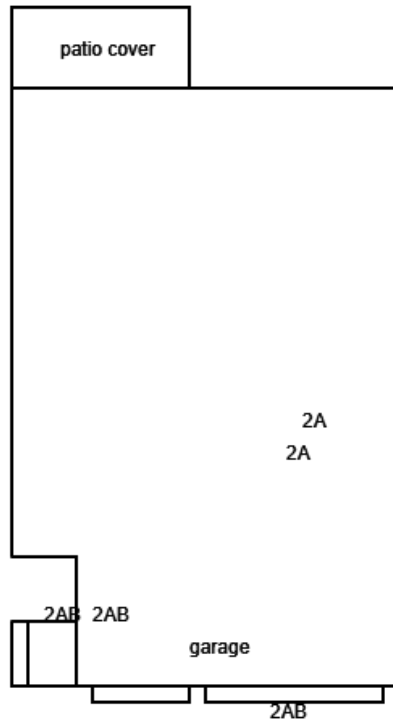
**Diagram Not To Scale**

FINDING - Evidence of Drywood termite infestation noted at Attic.

FINDING - Evidence of Drywood termite damage noted at Exterior of house.
