# WOOD DESTROYING PESTS AND ORGANISMS INSPECTION REPORT

| Building No.<br>6359 | Street<br>LAMBDA DR. | City<br>San Diego | ZIP<br>92120 | Date of Inspection<br>06/22/2026 | Number of Pages<br>7 |
| GENERAL DESCRIPTION:<br>MULTI-STORY SINGLE-FAMILY RESIDENCE, STUCCO EXTERIOR, TILE ROOF, ATTACHED GARAGE, ATTACHED PATIO, ON RAISED FOUNDATION. | | | | | Inspection Tag Posted:<br><br>Other Tags Posted: |

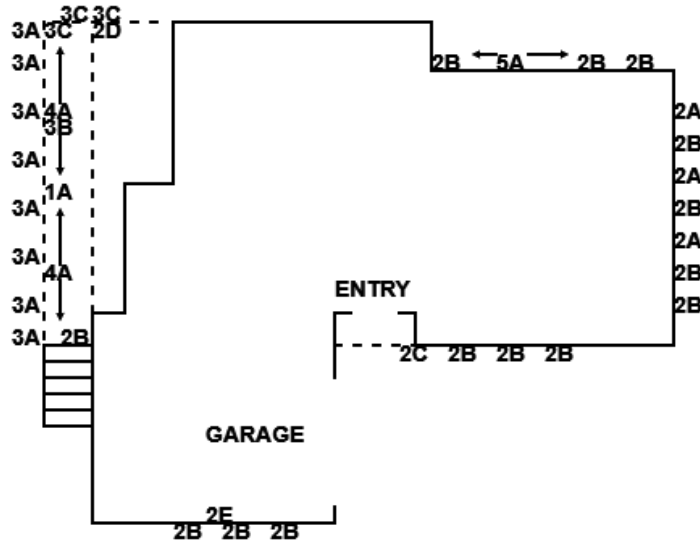
**Diagram Not To Scale**

Fungus infection, noted as 3B on diagram. location: SUB-AREA SIDING / POST / WINDOW TRIM.

water stains noted as 4A on diagram.

Scrape off visible fungus growth, cut out infected wood members and repair as necessary. We further recommend to treat area with approved fungicide.

Noted for information only.
