# WOOD DESTROYING PESTS AND ORGANISMS INSPECTION REPORT

| 7046 Murray Park Dr., San Diego, CA 92119 | | 01/15/2026 | 6 |
| General Description:<br>One story single family residence, slab foundation, shingle roof. | | Inspection Tag Posted:    Interior | |

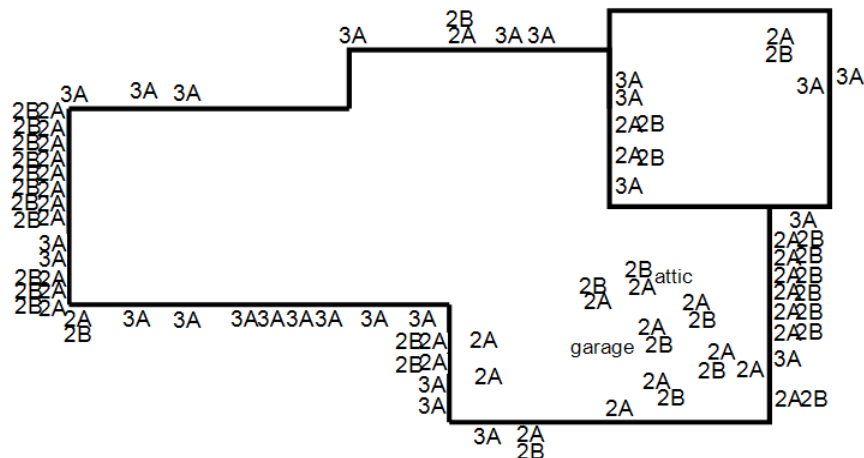
This Diagram is not to scale

- 2A      PRICE: \$800.00      (Section I)  
FINDINGS: Evidence of drywood termite infestation noted at roof eaves, roof sheathing, rafter, trim, garage door frame, siding, top plate, and 3x3 as indicated by 2A on the diagram.  
RECOMMENDATION: Chemically treat visible and accessible infestations. Remove or cover accessible pellets. 4-year guarantee.
- 2B      PRICE: \$4,750.00      (Section I)  
FINDINGS: Evidence of termite damage noted at roof eaves, roof sheathing, rafter, trim, garage door frame, siding, and 3x3 as indicated by 2B on the diagram.  
RECOMMENDATION: Repair or replace termite damage at roof eaves, roof sheathing, rafter, trim, garage door frame, siding, and 3x3. Diverse will apply one (1) coat of primer or similar matching paint to newly replaced/repaired wood member(s) at no additional charge. 4-year guarantee.

- 3A      PRICE: See 2B      (Section I)  
FINDINGS: Fungus damage and/or dry-rot noted at roof eaves, roof sheathing, trim, door jamb, siding, window frame, and 3x3 as indicated by 3A on the diagram.  
RECOMMENDATION: Replace fungus damage and/or dry-rot at roof eaves, roof sheathing, trim, door jamb, siding, window frame, and 3x3. Diverse will apply one (1) coat of primer or similar matching paint to newly replaced/repaired wood member(s) at no additional charge. 4-year guarantee.
-
