# WOOD DESTROYING PESTS AND ORGANISMS INSPECTION REPORT

| 930 | Suffolk Street | Cambria | 93428 | 06/24/2026 | 1 of 7 |

\*\*\*Complete Inspection Report\*\*\*

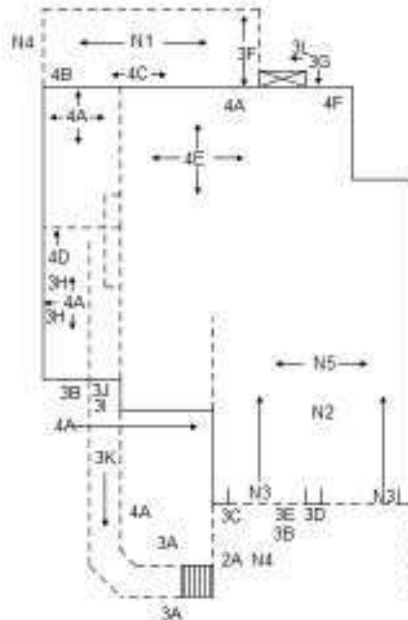
Diagram not to scale-Finding locations approximate

Finding: 2A Minor Drywood termite and fungus damage was found at the post.  
Recommendation: Repair the minor damage of the wood member with a wood filler.  
Price: \$153.00

Finding: 3A Fungus damage was found at the stair stringers.  
Recommendation: Remove and replace the damaged portions of the stair stringers as needed to eliminate the fungus infection and damage.

Finding: 3B Minor fungus damage was found at the sheathing. Replacement of the wood member appears to be impractical.  
Recommendation: Remove the minor damage with a wood chisel. Fill the void with an exterior wood filler.  
Price: \$408.00

Finding: 3C Minor fungus damage was found at the siding. Replacement of the wood member appears to be impractical.  
Recommendation: Remove the minor damage with a wood chisel. Fill the void with an exterior wood filler.  
Price: \$306.00

Finding: 3D Fungus damage was found at the wood siding.  
Recommendation: Replace the damaged portions of the wood siding. Note: In cases of plywood siding, repair may involve installing wood trim in place of siding removed and/or metal flashing at cut sections of siding replacement. Additional costs will apply if replacement of full sheet(s) of plywood siding is desired by the parties in interest.

Finding: 3E Minor fungus damage was found at the garage jamb. Replacement of the wood member appears to be impractical.  
Recommendation: Remove the minor damage with a wood chisel. Fill the void with an exterior wood filler.

Finding: 3F Fungus damage was found at the 2nd floor interior deck boards and joist.  
Recommendation: Remove and replace the damaged portions of the deck boards and joist as needed to eliminate the fungus infection and damage.  
Price: \$1,734.00

Finding: 3G Fungus damage was found at the chimney chase siding and trim.  
Recommendation: Remove and replace the damaged portions of the chimney and siding as needed to eliminate the fungus infection and damage.

Finding: 3H Fungus damage was found at the base of the deck/porch post.  
Recommendation: Cut the post at the base to remove the rotted portions of wood. Insert pressure treated wood pad(s).

Finding: 3I Fungus growth was found at the deck framing.  
Recommendation: Remove the surface growth with a wire brush. Chemically treat the infected wood members with disodium octaborate tetrahydrate.

Finding: 3J Fungus damage was found at the wood storage platform.  
Recommendation:

Finding: 3K Fungus damage was found at the deck joists.  
Recommendation: Remove and replace the damaged portions of the deck joists as needed to eliminate the fungus infection and damage.

Finding: 3L Fungus damage was found at the chimney chase and belly band.  
Recommendation: Remove and replace the damaged portions of the chimney chase and belly band as needed to eliminate the fungus infection and damage.

Finding: 4A Wood boring beetle infestation was found at the deck framing and sub structure framing.  
Recommendation: Seal the structure and fumigate with a gas lethal to Wood Boring Beetles (Sulfuryl Fluoride). All occupants and pets must vacate the structure until the fumigation is complete. This company will exercise reasonable caution, but cannot be held responsible for damage to plants, TV antennas or roofing due to the fumigation. Further terms and instructions will be supplied upon request or upon scheduling of the fumigation. Information may also be obtained from the fumigation page on our website at [www.keytermite.com](http://www.keytermite.com)  
**\*\*\*Fumigations are guaranteed for 5 years from the date completed\*\*\***

Finding: 4B Wood boring beetle infestation and damage were found at the dragnas brace.  
Recommendation: Remove and replace the damaged wood members to eliminate the beetle infestation and damage.

Finding: 4D Wood boring beetle infestation and damage were found.

Finding: 4C An existing and/or potential excessive moisture condition exists due to cracks to the deck coating and/or deteriorated of the deck flashing. The deck was not water tested at the time of this inspection.

Finding: 4E Evidence of excessive moisture was noted at the substructure wood members and indicates that the substructure ventilation is inadequate. Condensation of moisture may lead to infestation, infection and damage.

Finding: 4F Loose cellulose debris (wood scraps/paper) were found in the substructure area. This may lead to Subterranean termite infestation.
