# WOOD DESTROYING PESTS AND ORGANISMS INSPECTION REPORT

| Building No.<br>2366 | Street<br>Snowberry Ct | City<br>Avila Beach | Zip<br>93424-3541 | Date of Inspection<br>07/21/2026 | Number of Pages<br>1 of 7 |

**Report #: 114049**

## \*\*\*Complete Inspection Report\*\*\*

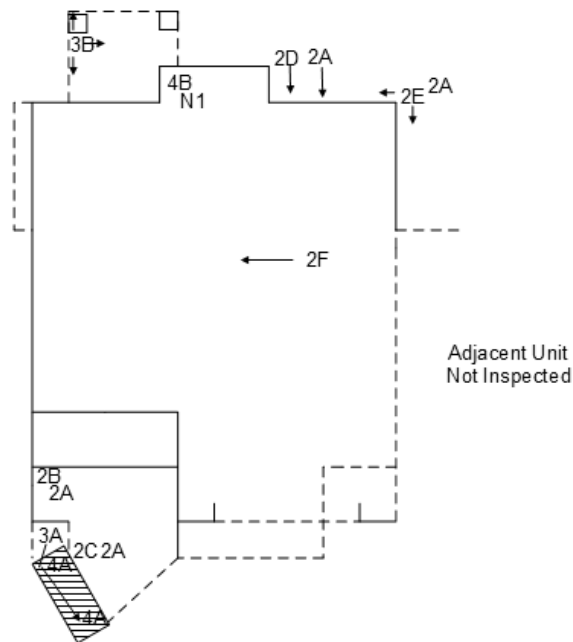
Diagram not to scale-Finding locations approximate

Evidence of Drywood Termite infestation was found at the exterior and appears to extend into inaccessible areas of the condominium unit.

Finding: 2B Minor Drywood Termite damage was found at the second level deck ledger beam.  
Recommendation: Repair the minor damage of the wood member with a wood filler.

Finding: 2C Minor Drywood Termite damage was found at the second level handrail post.  
Recommendation: Repair the minor damage of the wood member with a wood filler.

Finding: 2D Minor Drywood Termite damage was found at the second level fascia.  
Recommendation: Repair the minor damage of the wood member with a wood filler.

Finding: 2E Minor Drywood Termite damage was found at the fascia.  
Recommendation: Repair the minor damage of the wood member with a wood filler.

Finding: 2F Evidence of Drywood Termite infestation was found at the Attic.  
Recommendation: Refer to item 2A for recommendation. Cost included in item 2A.

Finding: 3A Fungus growth was found beneath the stairs.  
Recommendation: Remove the surface growth with a wire brush. Chemically treat the infected wood members with disodium octaborate tetrahydrate.

Finding: 3B Fungus growth was found beneath second level deck.  
Recommendation: Remove the surface growth with a wire brush. Chemically treat the infected wood members with disodium octaborate tetrahydrate.

Finding: 4A Moisture damage was noted at deck fascia (warping and cracking).  
Recommendation: Remove and replace or fill the damaged fascia.

PRIMARY RECOMMENDATION #1: Seal the structure and fumigate with a gas lethal to Drywood Termites (Sulfuryl Fluoride). All occupants and pets must vacate the structure until the fumigation is complete. This company will exercise reasonable caution, but cannot be held responsible for damage to plants, TV antennas or roofing due to the fumigation. Further terms and instructions will be supplied upon request or upon scheduling of the fumigation. Information may also be obtained from the fumigation page on our website at [www.keytermite.com](http://www.keytermite.com)

SECONDARY SUBSTANDARD RECOMMENDATION #2: As fumigation of the entire building appears to be impractical, a secondary recommendation is being offered in leu of the above recommendation to locally treat the accessible wood members of this unit showing signs of Drywood Termite infestation with Taurus Dry (Fipronil). Mask or remove accessible termite fecal pellets. This recommendation is being offered as a less expensive and less disruptive alternative to fumigation. Local treatment is not intended to be an entire structure treatment method. If infestations of wood-destroying pests extend or exist beyond the accessible area(s) of local treatment, they may not be exterminated. We guarantee limited control, in the accessible wood members treated only, for two years from the date of completion.

NOTE: Localized treatment is not intended to be a replacement for fumigation and will be stated as an exception to the "CERTIFICATION" of the structure for escrow purposes. Local Treatment Price \$889

Price: \$129.00

Price: \$98.00

Price: \$229.00

Price: \$136.00
