# WOOD DESTROYING PESTS AND ORGANISMS INSPECTION REPORT

| 399 | Wedgewood St | Cambria | 93428-4454 | 06/11/2026 | 1 of 8 |
| General Description:<br>Two story; Single family residence; Stucco exterior; Composition shingle roof; Vacant. | | | Inspection Tag Posted:<br>ATTIC | | |

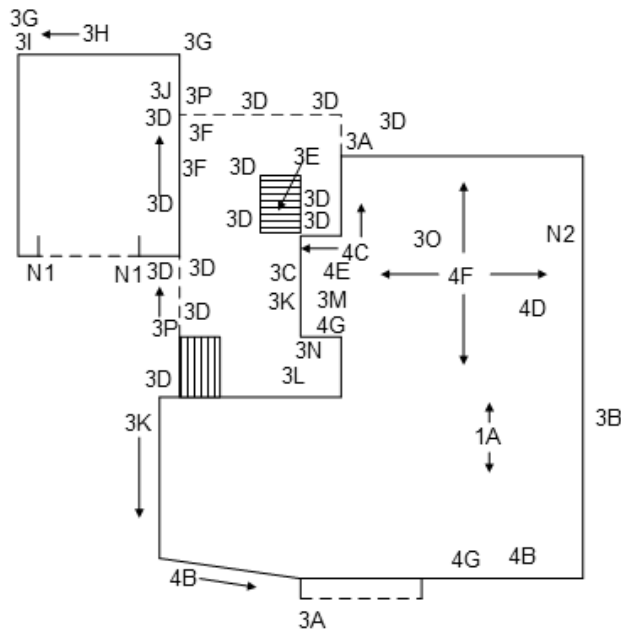
Diagram not to scale-Finding locations approximate

Finding: 1A Evidence of Subterranean Termite infestation was found at the substructure and indicates an infestation in the soil below the structure.

Finding: 3A Fungus damage was found at the fascia of the eave area.

Finding: 3B Minor fungus damage was found at the window trim . Replacement of the wood member appears to be impractical.

Finding: 3C Fungus damage was found at the door jamb.

Finding: 3D Fungus damage was found at the 1st and 2nd level handrail .

Finding: 3E Fungus growth was found at the stair framing.

Finding: 3F Minor fungus damage was found at the siding. Replacement of the wood member appears to be impractical.

Finding: 3G Fungus damage was found at the trim.  
Recommendation: Remove and replace the damaged portions of the trimas needed to eliminate the fungus infection and damage.  
Price: \$204.00

Finding: 3H Fungus damage was found at the wood siding.  
Recommendation: Replace the damaged portions of the wood siding. Note: In cases of plywood siding, repair may involve installing wood trim in place of siding removed and/or metal flashing at cut sections of siding replacement. Additional costs will apply if replacement of full sheet(s) of plywood siding is desired by the parties in interest.  
Price: \$306.00

Finding: 3I Fungus damage was found at the fascia and fascia runner.  
Recommendation: Remove and replace the damaged portions of the fascia and runner as needed to eliminate the fungus infection and damage.

Finding: 3J Fungus damage was found at the door spine.  
Recommendation: Remove and replace the damaged portions of the door spine as needed to eliminate the fungus infection and damage.  
Price: \$408.00

Finding: 3K Fungus damage was found at the window trim.  
Recommendation: Remove and replace the damaged portions of the window trimas needed to eliminate the fungus infection and damage.  
Price: \$867.00

Finding: 3L Fungus damage was found at the 2nd level door header and trim.  
Recommendation: Remove and replace the damaged portions of the door header and trimas needed to eliminate the fungus infection and damage.

Finding: 3M Minor fungus damage was found at the subfloor. Replacement of the wood member appears to be impractical.  
Recommendation: Remove the minor damage with a wood chisel. Fill the void with an exterior wood filler.  
Price: \$204.00

Finding: 3N Minor fungus damage was found at the siding below the deck. Replacement of the wood member appears to be impractical.  
Recommendation: Remove the minor damage with a wood chisel. Fill the void with an exterior wood filler.  
Price: \$204.00

Finding: 3O Fungus damage was found at the substructure cripple wall.  
Recommendation: Remove and replace the damaged portions of the cripple wall as needed to eliminate the fungus infection and damage.  
Price: \$204.00

Finding: 3P Fungus damage was found at the bottom plate to the deck skirting.

Finding: 4F Wood boring beetle infestation was found at the substructure framing.

Finding: 4G Dampwood Termite infestation was found in the substructure. Dampwood Termites will only infest sound wood when there is an adequate moisture source. Such moisture condition must be controlled.

Recommendation: Drill through the concrete slab in areas of infestation and chemically treat soil below using Taurus SC (fipronil). Fill in the holes with concrete. Remove all the accessible evidence of Subterranean Termite infestation. In addition, an application will be made to the soil adjacent to the exterior wall around the complete perimeter of the structure. Holes may be drilled through concrete, paving or masonry adjacent to the foundation in areas such as, but not limited to; patios, sidewalks, porches and driveways, to allow for chemical treatment of the soil below. We will exercise reasonable caution when drilling but assume no liability for damage to hidden plumbing, electrical, or other utility below these areas. The location of such utilities should be identified prior to our arrival. Regardless of locations of Subterranean Termite infestation found, control of the entire structure is guaranteed. Control is guaranteed by Key Termite and Pest Control for a period of 5 years from the date of treatment. NOTE: Any exterior storage must be moved away at least 3 feet from the perimeter of the structure prior to our arrival.

Recommendation: Replace the fungus damaged portions of fascia as needed.

Recommendation: Remove the minor damage with a wood chisel. Fill the void with an exterior wood filler.

Recommendation: Remove and replace the damaged portions of the door jamb as needed to eliminate the fungus infection and damage.

Recommendation: Remove and replace the damaged portions of the handrail as needed to eliminate the fungus infection and damage.

Recommendation: Remove the surface growth with a wire brush. Chemically treat the infected wood members with disodium octaborate tetrahydrate.

Recommendation: Remove and replace the damaged portions of the bottom plate as needed to eliminate the fungus infection and damage. Replace with pressure treated material.

Recommendation: Seal the structure and fumigate with a gas lethal to Wood Boring Beetles (Sulfuryl Fluoride). All occupants and pets must vacate the structure until the fumigation is complete. This company will exercise reasonable caution, but cannot be held responsible for damage to plants, TV antennas or roofing due to the fumigation. Further terms and instructions will be supplied upon request or upon scheduling of the fumigation. Information may also be obtained from the fumigation page on our website at [www.keytermite.com](http://www.keytermite.com)

Recommendation: Chemically treat the infested wood members using Taurus Dry (fipronil). The owner must locate the source of moisture and make the necessary corrections to control the moisture source.
