# WOOD DESTROYING PESTS AND ORGANISMS INSPECTION REPORT

| Building No.<br><b>191</b> | Street<br><b>Irish Way</b> | City<br><b>Pismo Beach</b> | Zip<br><b>93449-3505</b> | Date of Inspection<br><b>08/13/2026</b> | Number of Pages<br><b>1 of 6</b> |

**Report #: 114232**

| General Description:<br>Single story; Single family residence; Stucco exterior; Tile roof; Vacant. | Inspection Tag Posted:<br><div style="border: 1px solid black; padding: 5px; text-align: center;">GARAGE</div> |

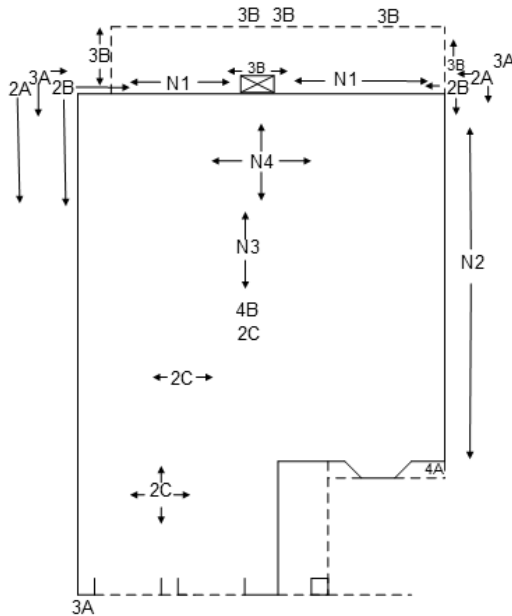
\*\*\*Complete Inspection Report\*\*\*  
 Diagram not to scale-Finding locations approximate

Evidence of Drywood Termite infestation was found at the exterior and appears to extend into inaccessible areas of the structure.

Drywood Termite damage was found at the fascia.

Finding: 2C Evidence of Drywood Termite infestation was found at the attic.  
Recommendation: Refer to item 2A for recommendation. Cost included in item 2A.  
Price: Included as noted in recommendation.

Finding: 3A Fungus damage was found at the fascia of the eave area.  
Recommendation: Replace the fungus damaged portions of fascia as needed.

Finding: 3B Fungus damage was found at the patio cover.  
Recommendation: Remove and replace the damaged portions of the patio cover as needed to eliminate the fungus infection and damage.

Finding: 4A A faulty grade condition exists where the soil grade extends above the weep screed at the base of the stucco. This condition may lead to infestation or infection.  
Recommendation: Lower the soil grade to allow 4" minimum clearance below the weep screed.

Seal the structure and fumigate with a gas lethal to Drywood Termites (Sulfuryl Fluoride). All occupants and pets must vacate the structure until the fumigation is complete. This company will exercise reasonable caution, but cannot be held responsible for damage to plants, TV antennas or roofing due to the fumigation. Further terms and instructions will be supplied upon request or upon scheduling of the fumigation. Information may also be obtained from the fumigation page on our website at [www.keytermite.com](http://www.keytermite.com)

Remove and replace the damaged portion of the fascia as needed.
