# WOOD DESTROYING PESTS AND ORGANISMS INSPECTION REPORT

| 201 | Five Cities Dr Spc 180 | Pismo Beach | 93449-3028 | 08/28/2026 | 1 of 5 |

**Report #: 114453**

| General Description:<br>Double wide mobile home; Metal siding; Metal roof; Furnished and occupied. | Inspection Tag Posted:<br><div style="border: 1px solid black; padding: 2px; text-align: center;">SUBSTRUCTURE</div> |

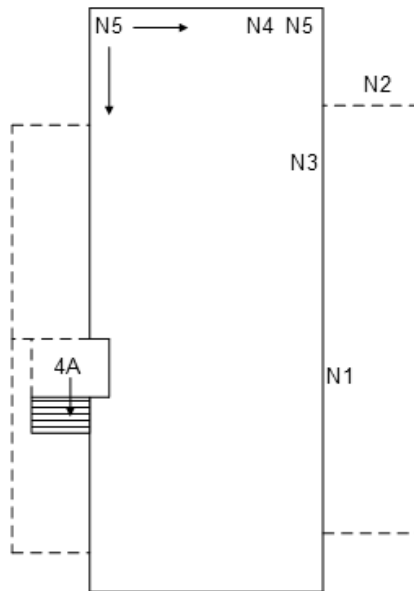
Diagram not to scale-Finding locations approximate

Finding: 4A      An excessive moisture condition exists due to indoor/outdoor carpeting on the deck. The carpeting will inhibit ventilation and may cause fungus growth and damage to the wood members of the deck.

INFORMATIONAL ITEM> N1: The stairs/landing is not attached and was not included in this report.

INFORMATIONAL ITEM> N2: The shed is not attached and was not included in this report.

INFORMATIONAL ITEM> N3: Moisture stains were noted at the interior ceiling and indicate previous roof leakage. The area was dry at the time of inspection. The stains may be old and the original cause may have already been corrected. The roofing was not inspected by our company. It was not possible to determine active leakage at the time of inspection. If repairs have not been made or cannot be verified, we recommend that a qualified Home Inspector and/or licensed Roofing Contractor be contacted for further evaluation and recommendation.

INFORMATIONAL ITEM> N4: Moisture stains were noted at the interior ceiling and indicate previous roof leakage. The area was dry at the time of inspection. The stains may be old and the original cause may have already been corrected. The roofing was not inspected by our company. It was not possible to determine active leakage at the time of inspection. If repairs have not been made or cannot be verified, we recommend that a qualified Home Inspector and/or licensed Roofing Contractor be contacted for further evaluation and recommendation.

INFORMATIONAL ITEM> N5: Drywood Termite fecal pellets were found at the substructure. The property was fumigated on 12/27/18 by Key Termite and Pest Control and the pellets appear to be from the previous infestation. The fumigation is guaranteed for 5 years from the date of completion. We recommend that the old evidence of the Drywood Termite infestation be masked or removed to avoid future misunderstanding as to the activity of the old infestation. This service will be completed by our company at no charge. Please contact our office to arrange an appointment.

Recommendation:      It would be best to remove the carpeting to allow adequate ventilation to the wood members of the deck. However, it may be desirable to leave the carpeting in place. If the carpeting is to be left in place, exposure to moisture should be avoided and the deck should be checked periodically for indications of fungus growth. No evidence of infestation or infection were noted at the time of this inspection. The recommendation is considered completed at the time of this inspection.
