# WOOD DESTROYING PESTS AND ORGANISMS INSPECTION REPORT

| 1211 | Montego St | Arroyo Grande | 93420-2434 | 09/09/2026 | 1 of 6 |

**Report #: 114609**

## \*\*\*Complete Inspection Report\*\*\*

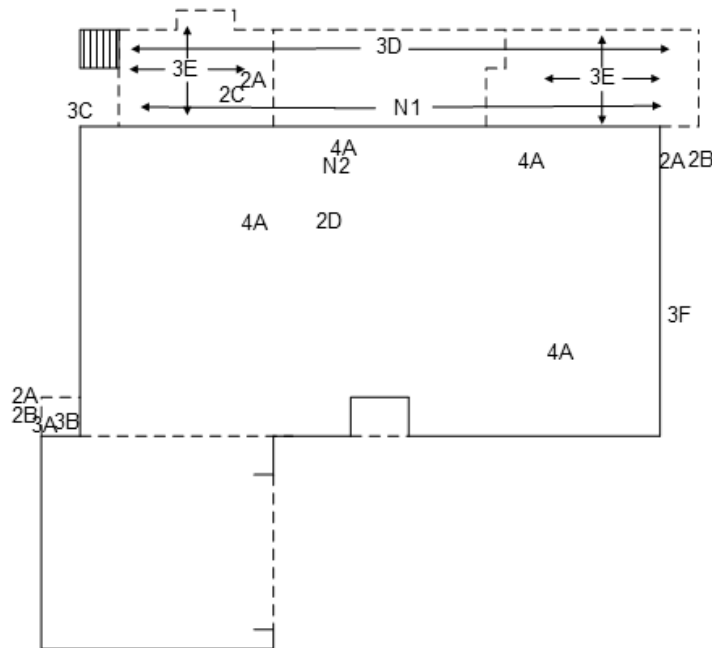
Diagram not to scale-Finding locations approximate

Finding: 2A Evidence of Drywood Termite infestation was found at the exterior and appears to extend into inaccessible areas of the structure.

Finding: 2B Drywood Termite damage was found at the trim.

Finding: 2C Drywood termite damage was found at the deck post pier .

Finding: 2D Evidence of Drywood Termite infestation was found at the substructure.

Finding: 3A Fungus damage was found at the roof sheathing of the eave area.

Finding: 3B Fungus damage was found at the exterior door frame.

Finding: 3C Fungus damage was found at the fascia of the eave area.  
Recommendation: Replace the fungus damaged portions of fascia as needed.  
Price: \$310.00

Finding: 3D Fungus damage was found at the deck cover framing and pickets.  
Recommendation: Remove and replace the damaged portions of the deck cover framing and pickets as needed to eliminate the fungus infection and damage.

Finding: 3E Fungus infection and damage were found in the wood deck throughout the decking and framing.  
Recommendation: Remove and replace the damaged wood members of the deck. This will most likely involve complete replacement of the wood deck. In areas where a sound wood member is not replaced and VERY MINOR surface fungus growth is present but no detectable deterioration has occurred, scrape away the surface growth with a wire brush and chemically treat the wood member with disodium octaborate tetrahydrate or copper naphthenate. Repair includes replacement with nailed con-common redwood decking and doug-fir framing. Additional costs for upgrades to deck screws, con-heart, deck-heart, synthetic decking or pressure treated framing will be quoted upon request.

Finding: 3F Fungus damage was found at the exterior wood trim.  
Recommendation: Replace the damaged portions of the trim as necessary.

Finding: 4A Loose cellulose debris (wood scraps/paper) were found in the substructure area. This may lead to Subterranean termite infestation.  
Recommendation: Remove and dispose of all loose cellulose debris from under the dwelling of such size that it will not pass through an ordinary garden rake.  
Price: \$235.00

Recommendation: Seal the structure and fumigate with a gas lethal to Drywood Termites (Sulfuryl Fluoride). All occupants and pets must vacate the structure until the fumigation is complete. This company will exercise reasonable caution, but cannot be held responsible for damage to plants, TV antennas or roofing due to the fumigation. Further terms and instructions will be supplied upon request or upon scheduling of the fumigation. Information may also be obtained from the fumigation page on our website at [www.keytermite.com](http://www.keytermite.com)  
**\*\*\*Fumigations are guaranteed for 5 years from the date completed\*\*\***

Recommendation: Remove and replace the damaged portion of the trim as needed.

Recommendation: Replace the Drywood termite damaged wood member.

Recommendation: Replace the fungus damaged portions of roof sheathing as needed.

Recommendation: Replace the damaged portions of the door frame as necessary.
